**DRAFT REPORT**

**REVISED WETLAND SURVEY  
BASED ON REVISIONS TO THE  
WATER RULE, JUNE 2020  
I-40 MEGA-SITE  
CITY OF WEST MEMPHIS, AR**

November, 2020

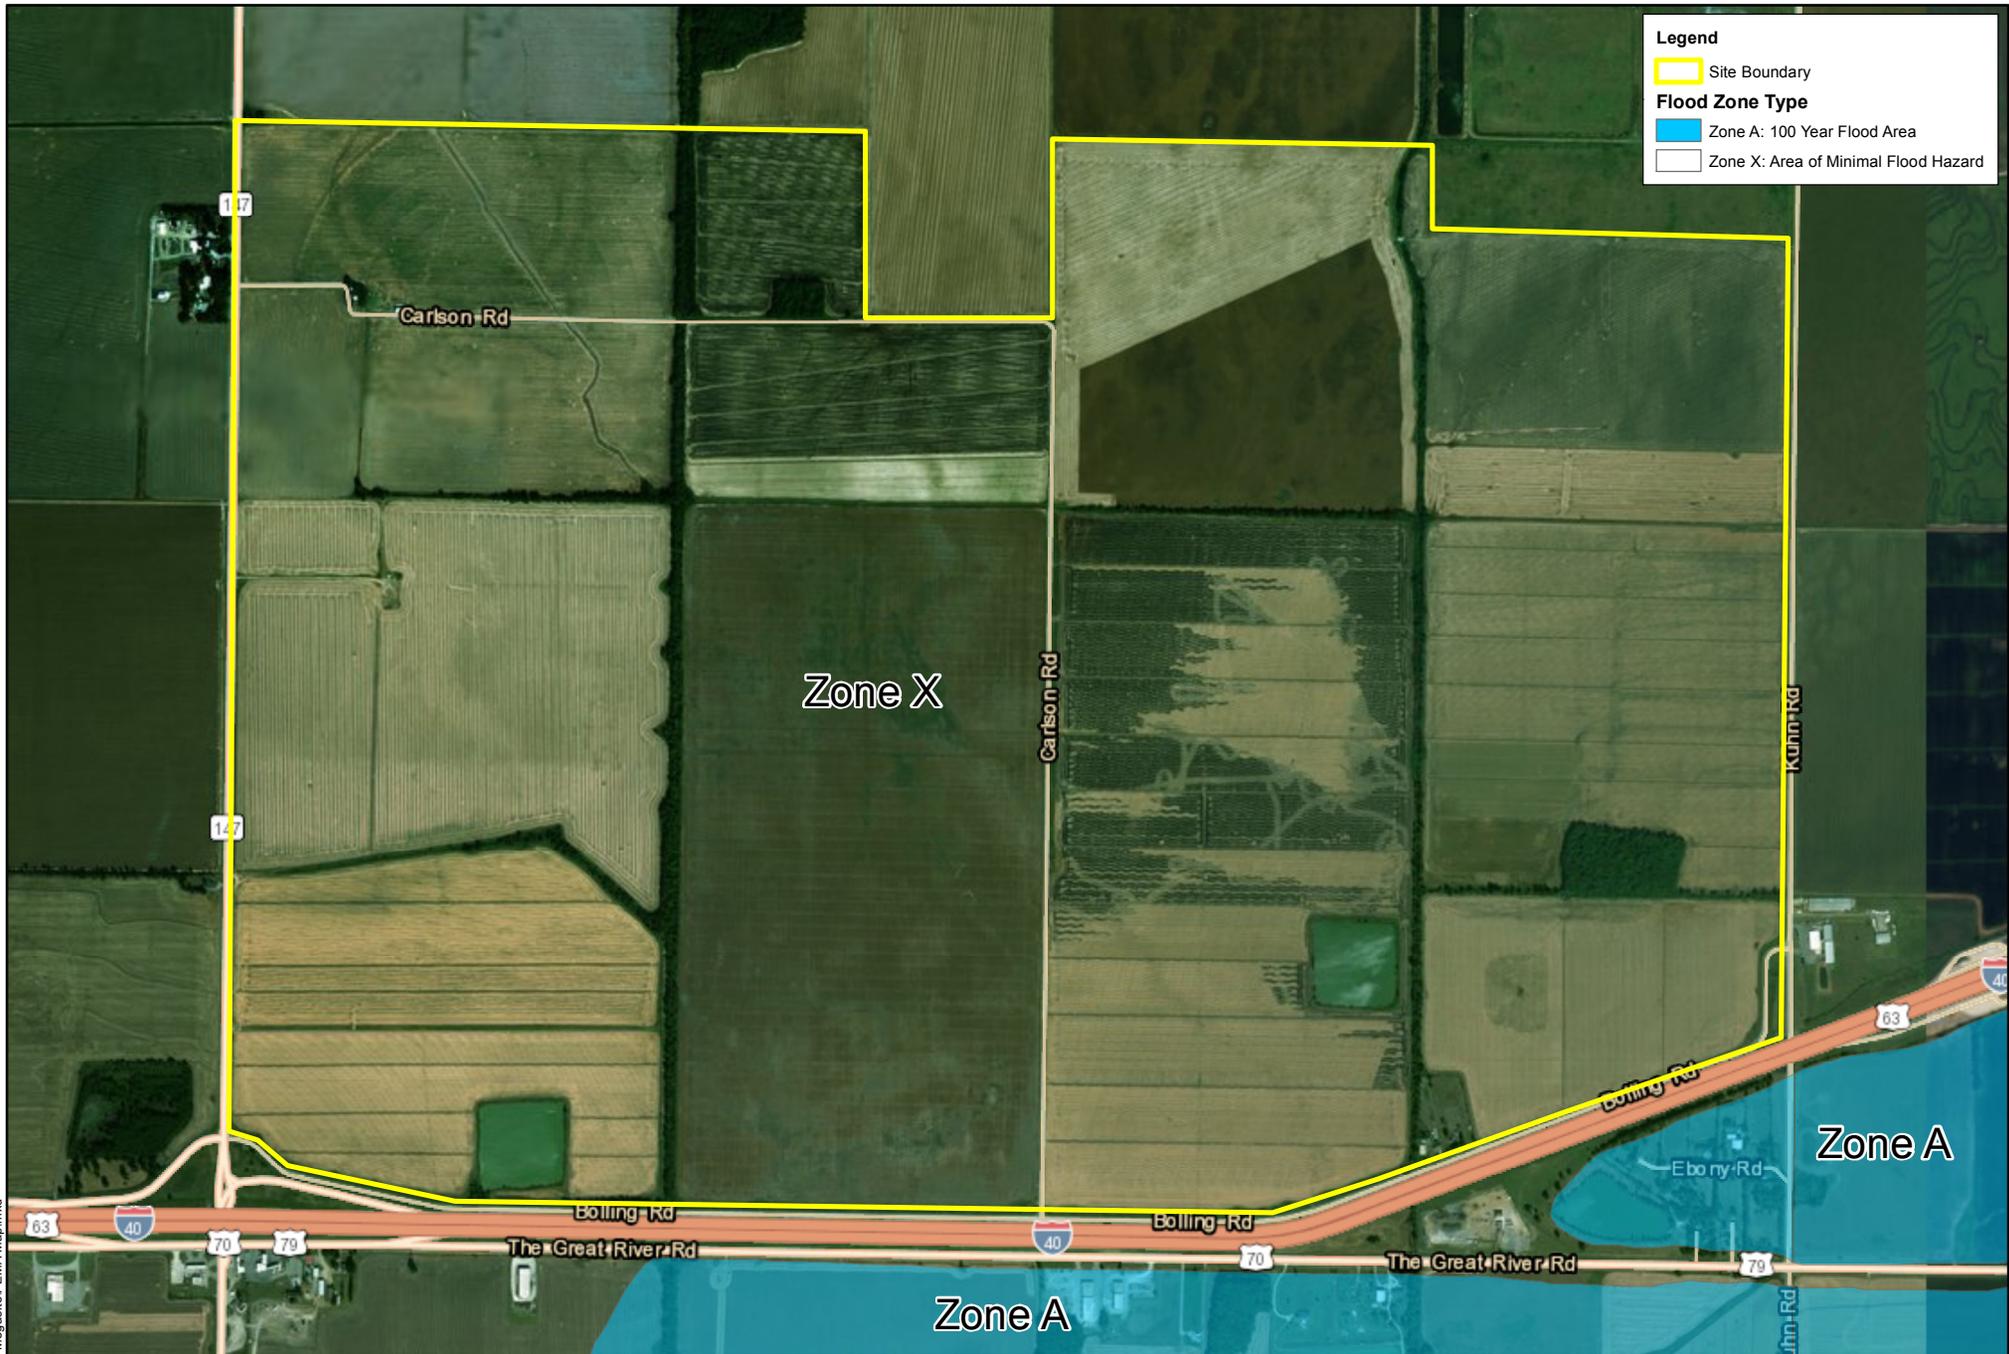
PROJECT NUMBER	60572497
DATE	April, 2018
FIGURE NUMBER	<b>2</b>

According to the FEMA flood insurance rate maps, the entire site lies in Zone X (area of minimal flood hazard). The 100-year flood zone (ZONE A) is located south of I-40, Figure 2 at an elevation range of 209 to 210. The elevation range at the property is from 210 to 219 msl. The entire property is flat and is in agricultural use with the exception of two small wooded areas, two irrigation ponds and two residents with small yards. All drainage on site leads south to Ditch 12 located on the south side of I-40.

I-40 Mega Site  
 FEMA Flood Zone Map

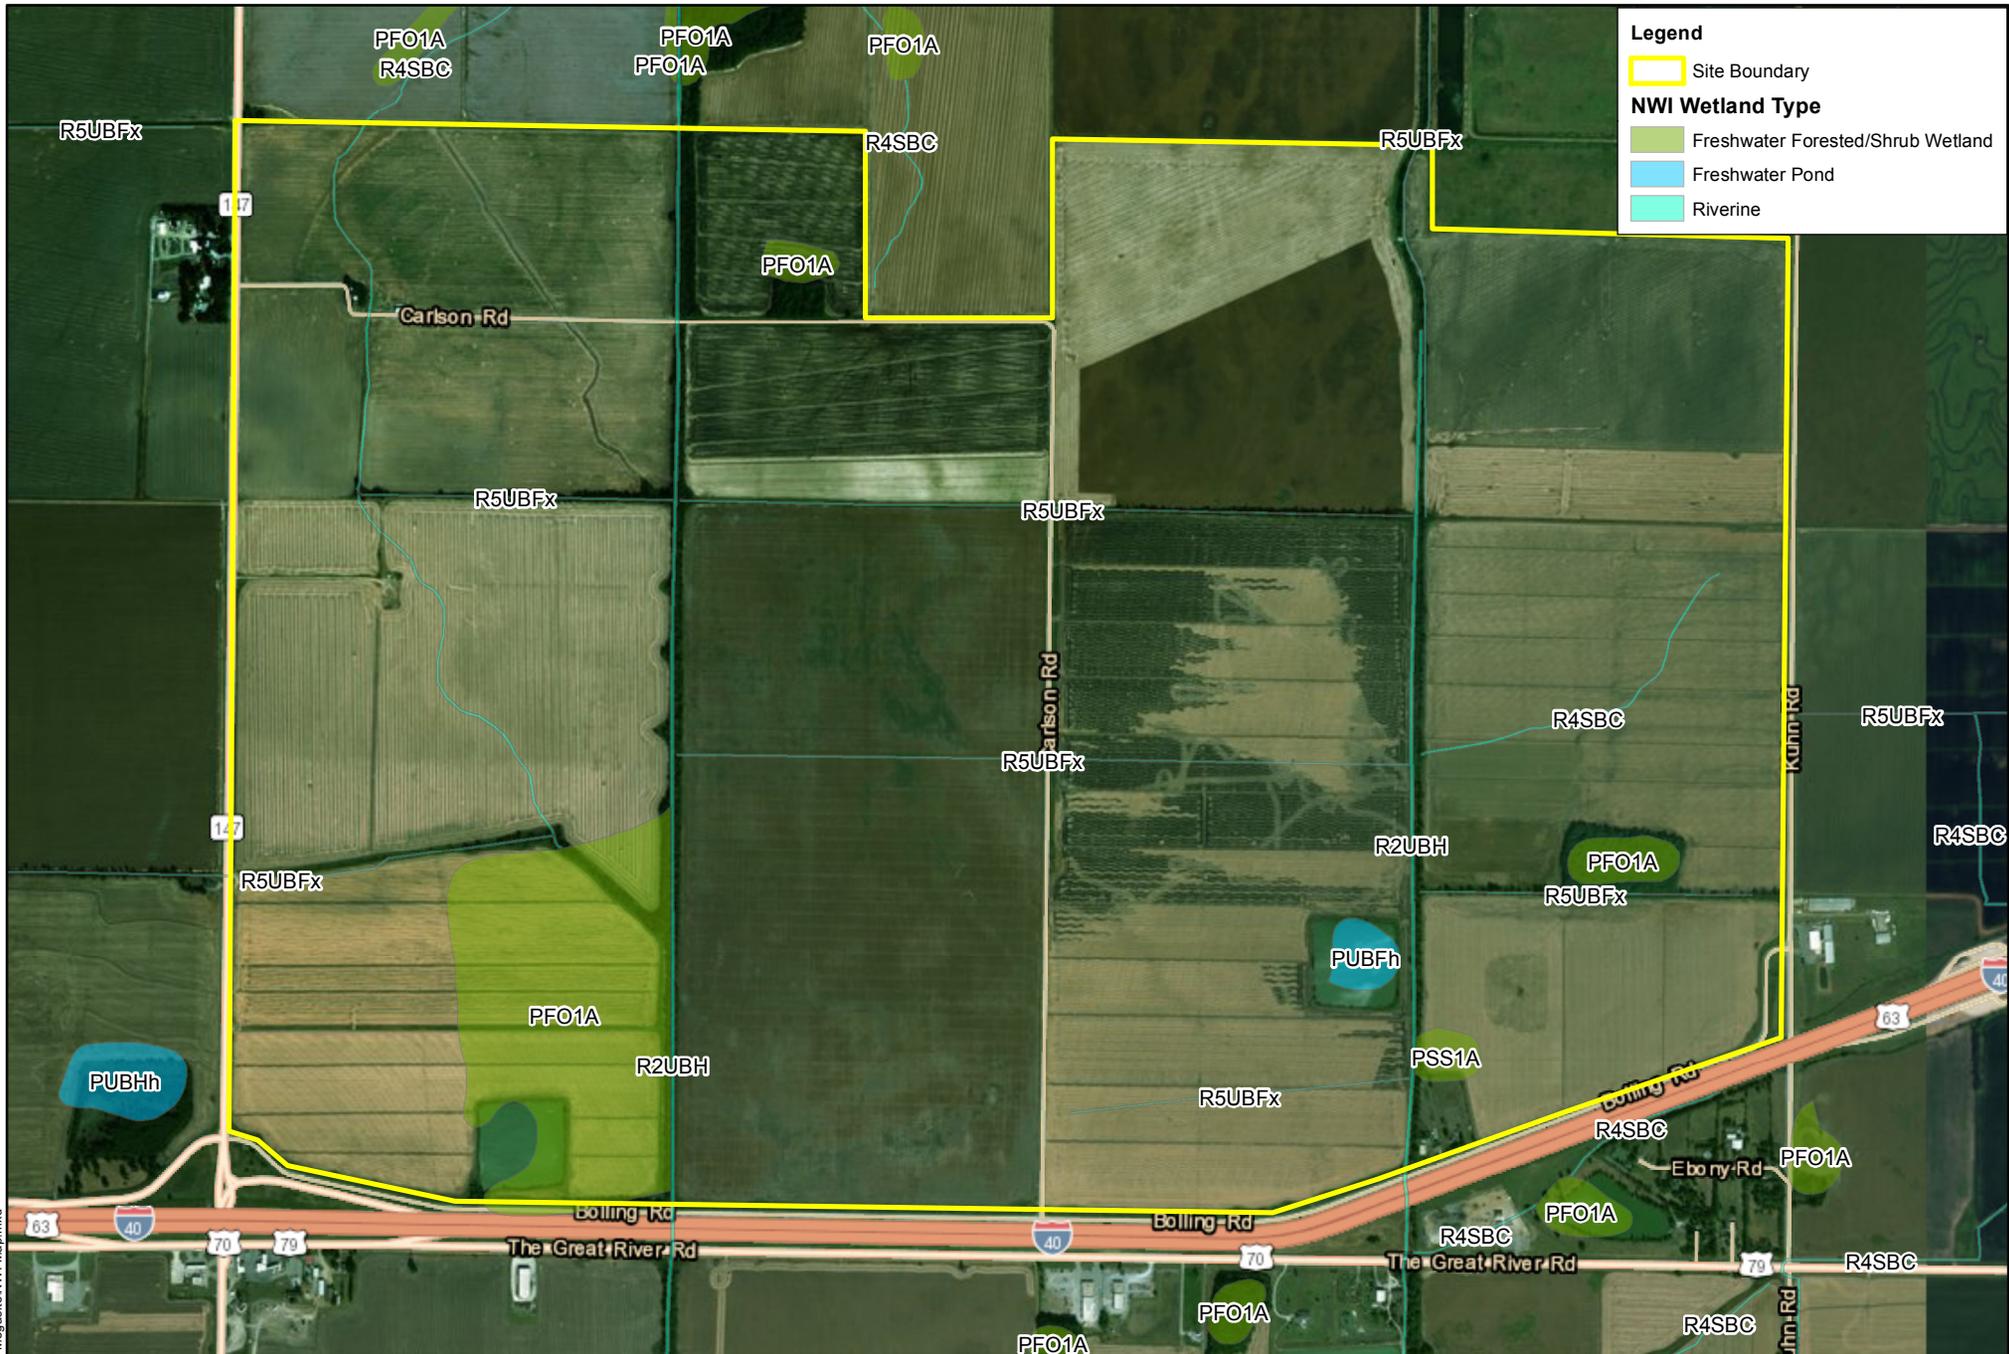
PROJECT NUMBER 60572497
DATE April, 2018
FIGURE NUMBER <b>3</b>

The potential for wetlands on the property was reviewed by viewing the United States Fish and Wildlife Service (USFWS) Wetland Inventory Map (NWI) as shown on Figure 3. Four areas of potential wetlands, one pond and a number of drainages were indicated on the property by the NWI. The National Resource Conservation Service (NRCS) website was utilized to determine the soil types present on the site as a potential indicator of hydric soils and wetlands, Figure 4.

A National Wetlands Inventory map (NWI) was downloaded from the US Fish and Wildlife Service NWI website (Figure 3). The map indicated three forested wetlands, one shrub scrub wetland, one pond and nine riverine wetlands (ditches) on the property.

**I-40 Mega Site  
 NWI Map**

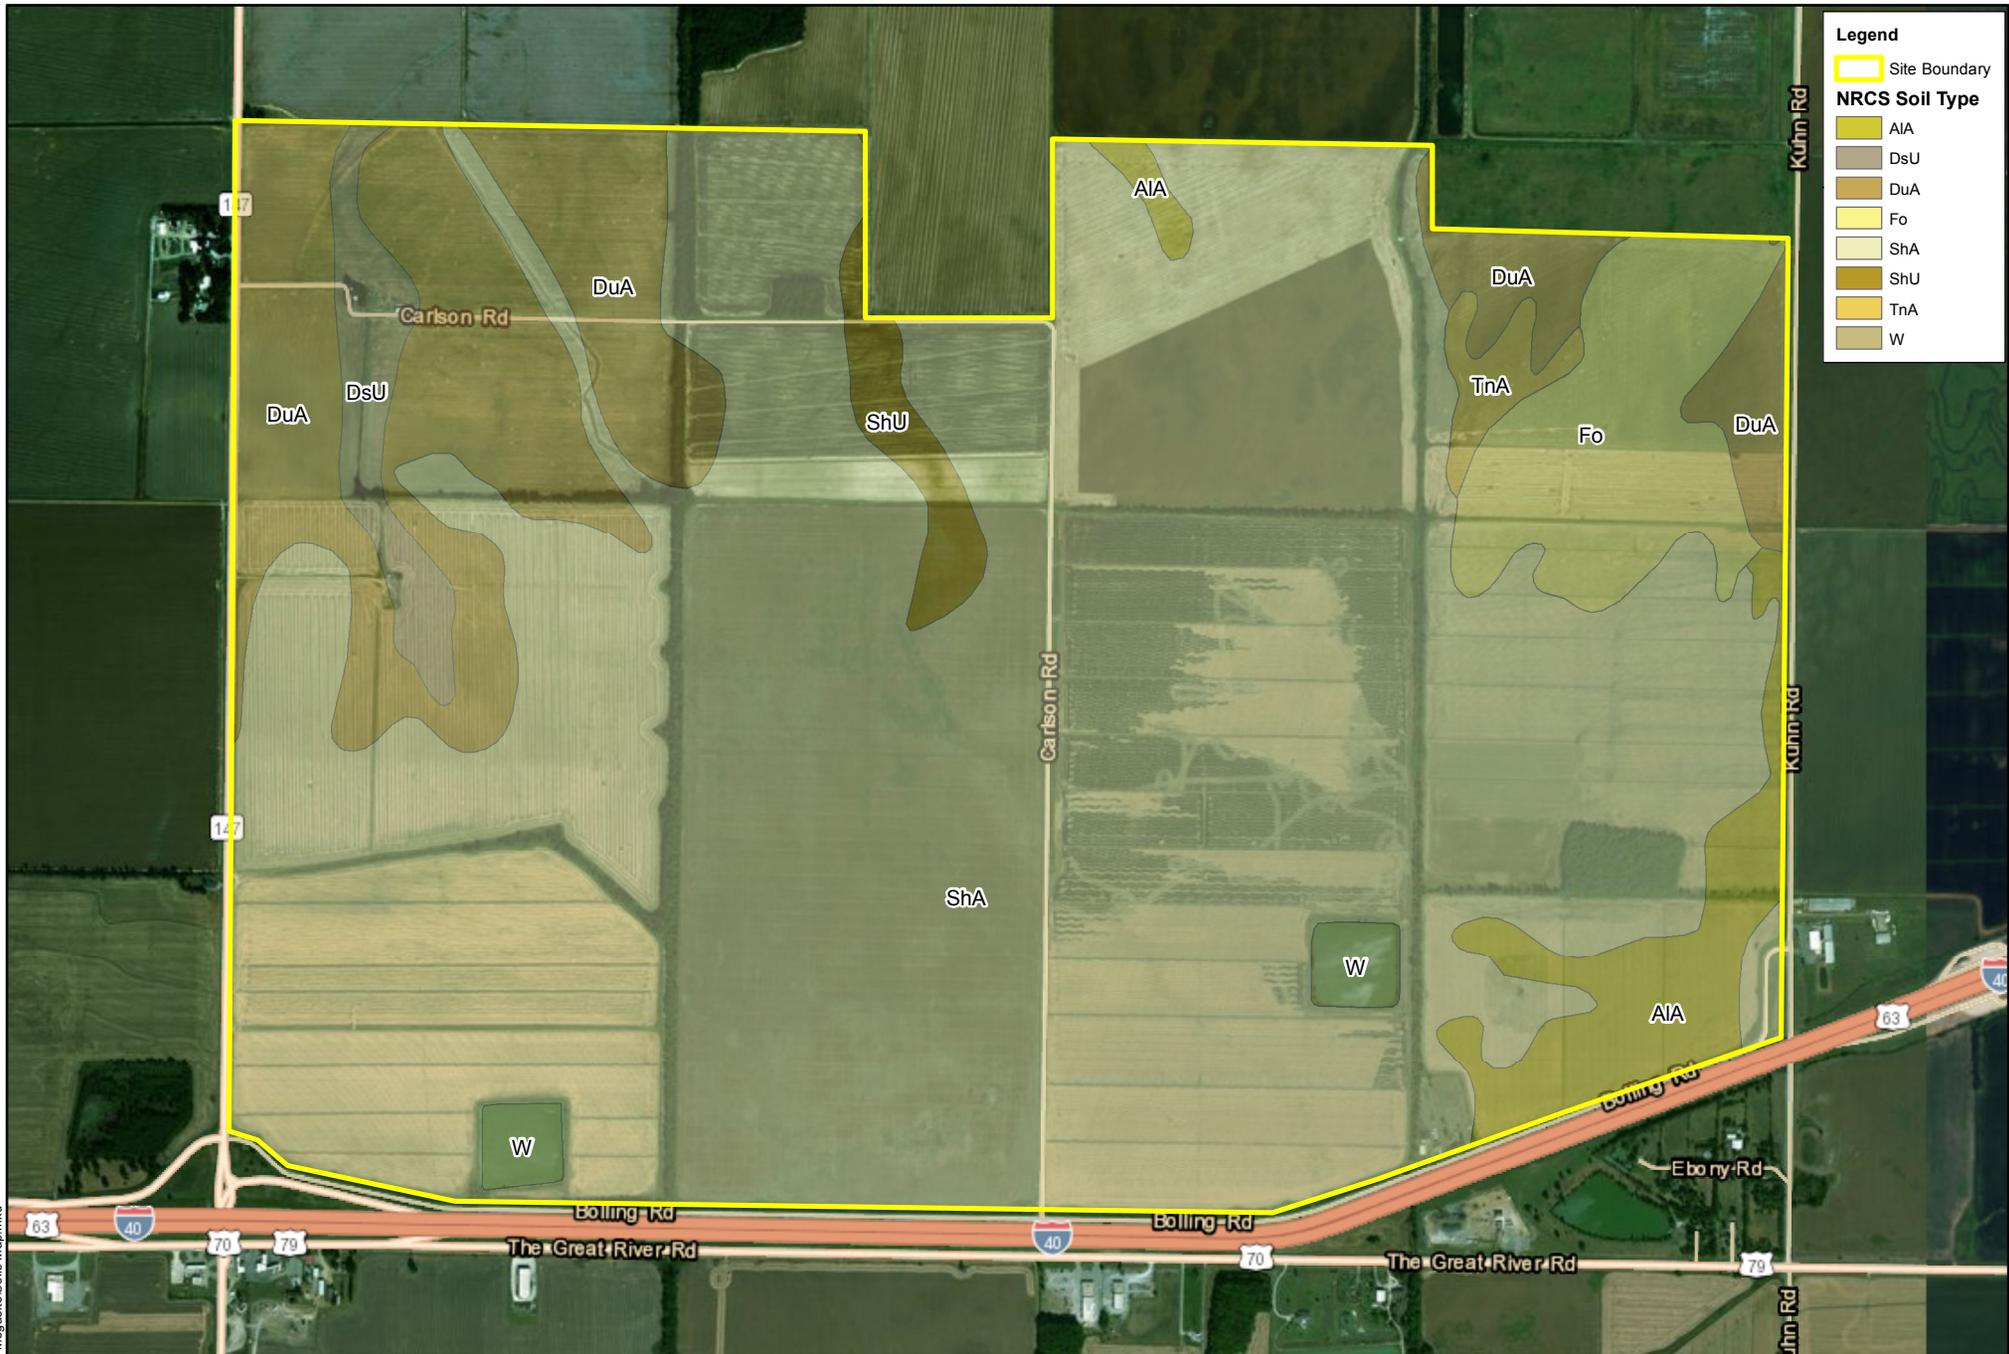
PROJECT NUMBER	60572497
DATE	April, 2018
FIGURE NUMBER	<b>4</b>

The soils survey for the site was reviewed from the National Resources Conservation Service (NRCS) Web Soil survey. The majority of the soils in the Project area are of three types, Sharkey silty clay, 0 to 1% slopes, Forestdale silty clay loam and Alligator silty clay, 0 to 1 percent slopes (Figure 4). These soils have very slow infiltration rates, are clayey, have a highwater table, or are shallow to an impervious layer. All three are considered hydric soils.

**I-40 Mega Site  
 NRCS Soil Map**

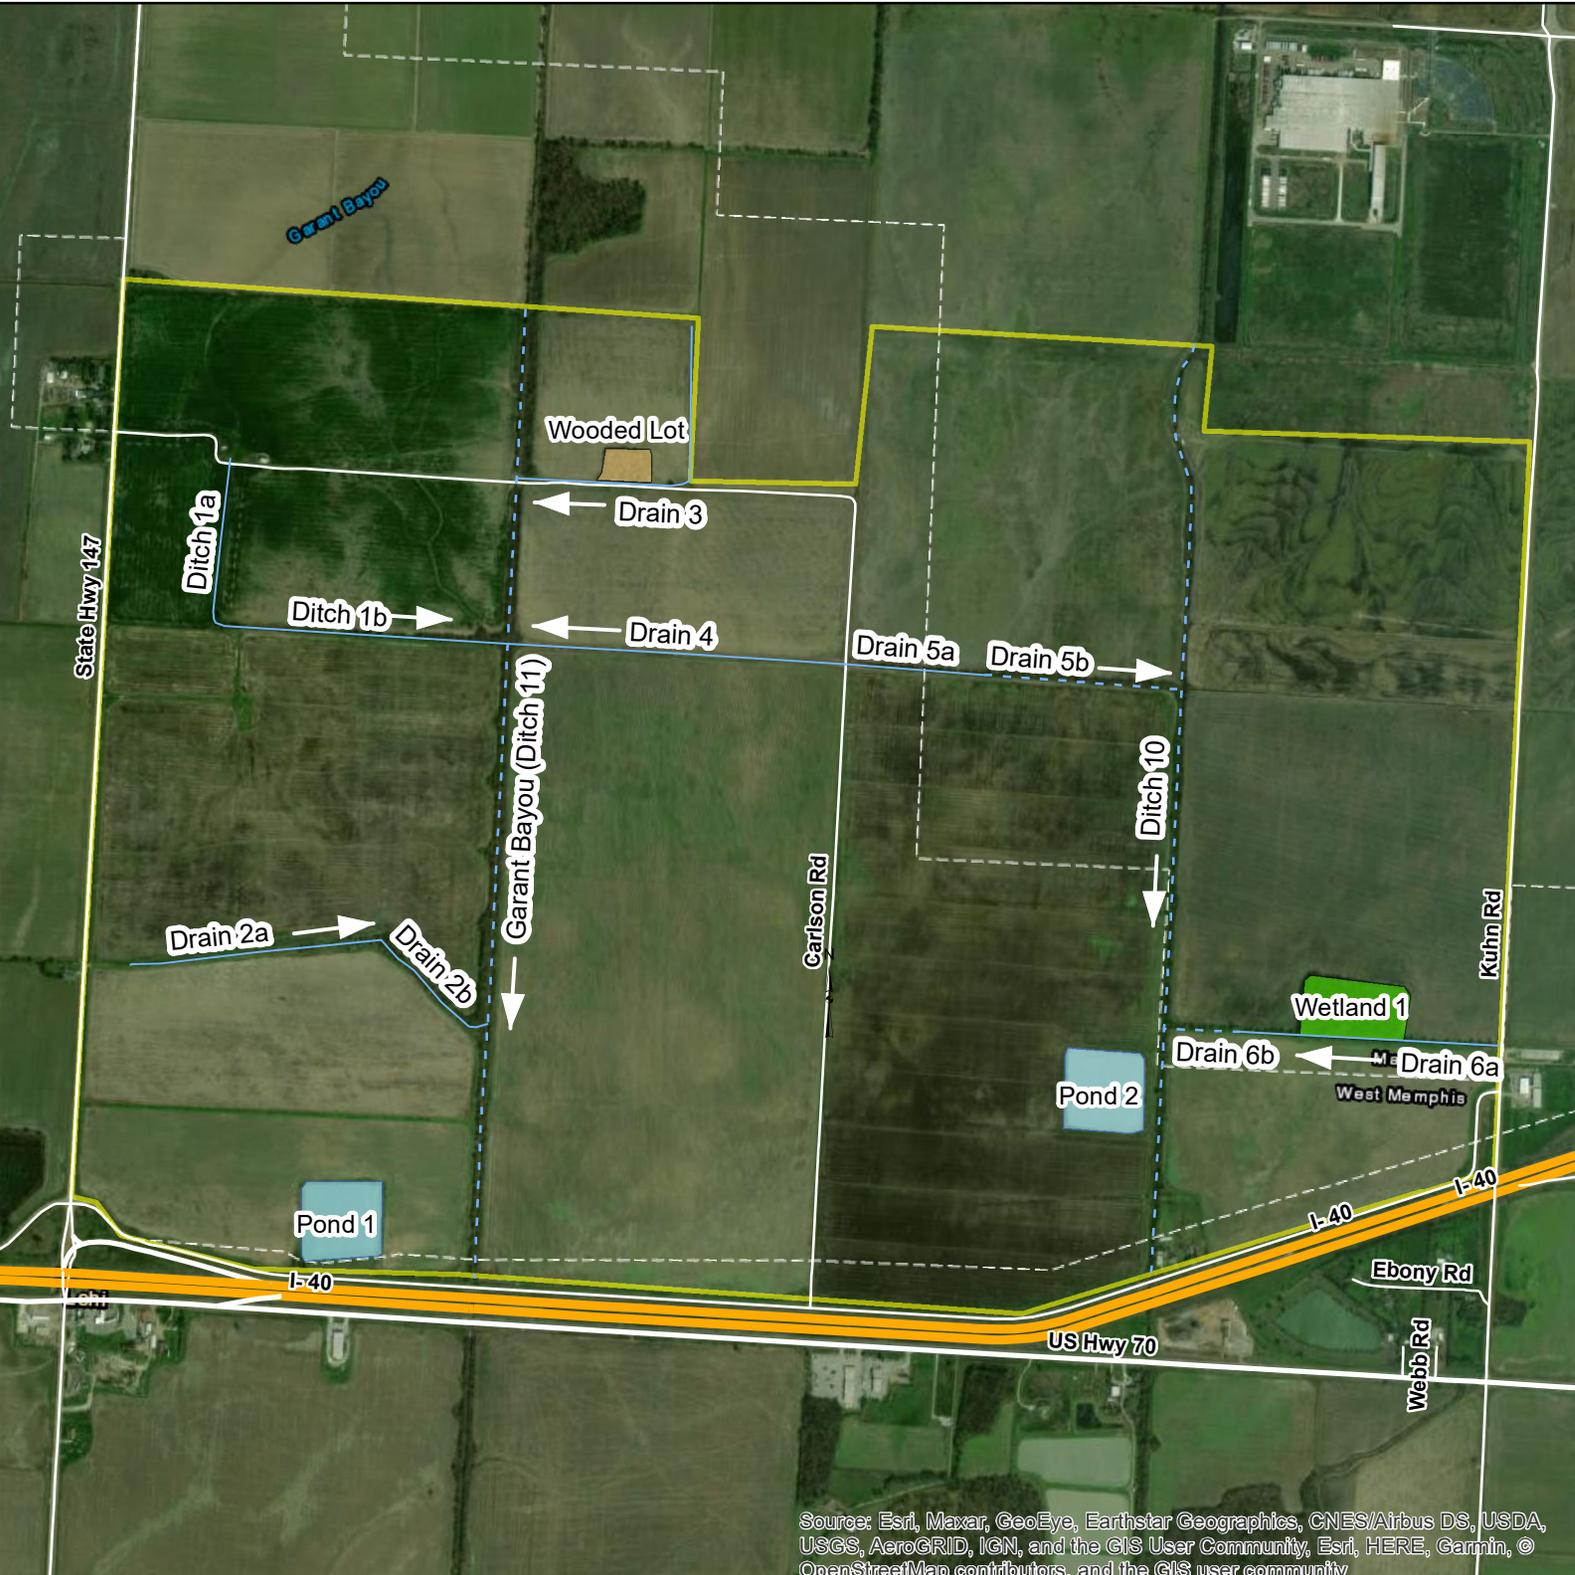
Figure 5

Photographs were taken of ditches. HD data forms were completed for each of the 4 ditches for both the dry and water reaches (Attachment 1). The revised ditch reaches are summarized in Figure 5.

SITE FEATURES

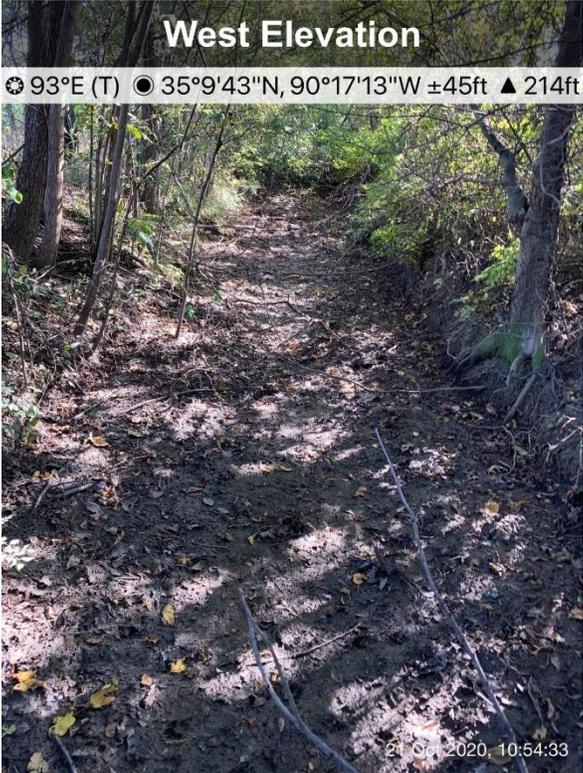
<b>Photo No.</b> <b>3</b>	<b>Date:</b> 10/20/20	<div style="text-align: center;"> <p><b>West Elevation</b></p> <p>☉ 93°E (T) ● 35°9'43"N, 90°17'13"W ±45ft ▲ 214ft</p>

<p style="text-align: right; font-size: small;">21 Oct 2020, 10:54:33</p> </div>
<b>Direction Photo Taken:</b>  West		
<b>Description:</b>  Ditch 1b - Dry

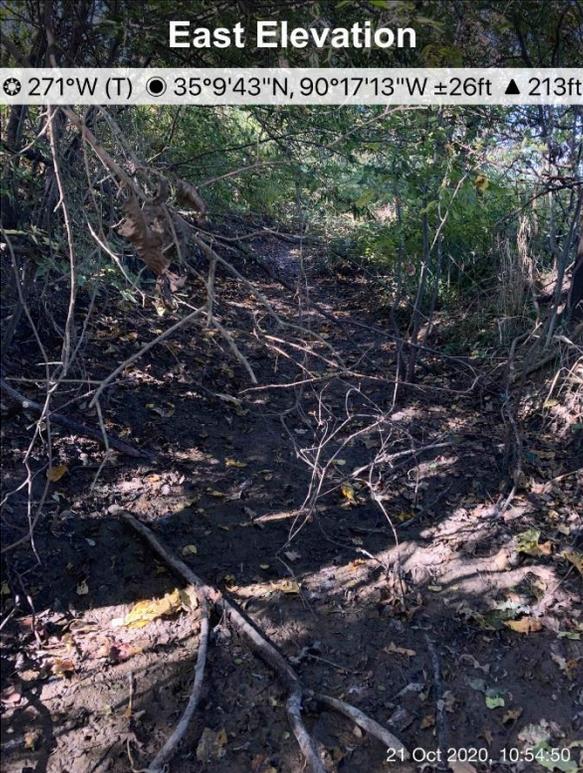
<b>Photo No.</b> <b>4</b>	<b>Date:</b> 10/20/20	<div style="text-align: center;"> <p><b>East Elevation</b></p> <p>☉ 271°W (T) ● 35°9'43"N, 90°17'13"W ±26ft ▲ 213ft</p>

<p style="text-align: right; font-size: small;">21 Oct 2020, 10:54:50</p> </div>
<b>Direction Photo Taken:</b>  East		
<b>Description:</b>  Ditch 1b - dry

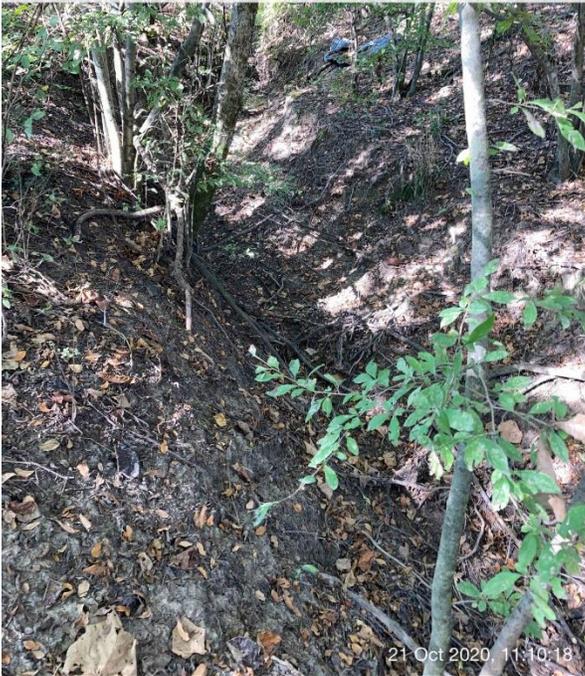
<b>Photo No.</b> <b>5</b>	<b>Date:</b> 10/20/20	<div data-bbox="706 323 1291 1106"> <p style="text-align: center;"><b>East Elevation</b></p> <p style="text-align: center;">☉ 270°W (T) ● 35°9'43"N, 90°16'57"W ±144ft ▲ 161ft</p>

<p style="text-align: right; font-size: small;">21 Oct 2020, 11:10:18</p> </div>
<b>Direction Photo Taken:</b>  east		
<b>Description:</b>  Ditch 1b near confluence with Ditch 11 - dry

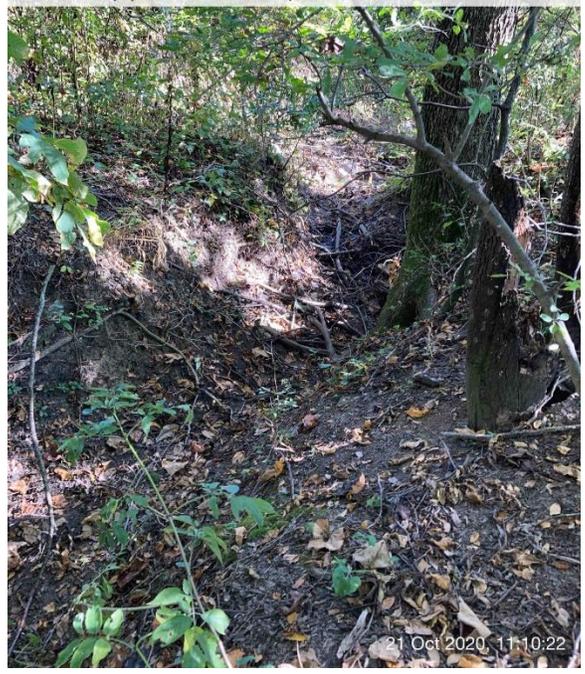
<b>Photo No.</b> <b>6</b>	<b>Date:</b> 10/20/20	<div data-bbox="706 1136 1291 1917"> <p style="text-align: center;"><b>South West Elevation</b></p> <p style="text-align: center;">☉ 68°NE (T) ● 35°9'43"N, 90°16'57"W ±29ft ▲ 214ft</p>

<p style="text-align: right; font-size: small;">21 Oct 2020, 11:10:22</p> </div>
<b>Direction Photo Taken:</b>  West		
<b>Description:</b>  Ditch 1b near confluence with Ditch 11

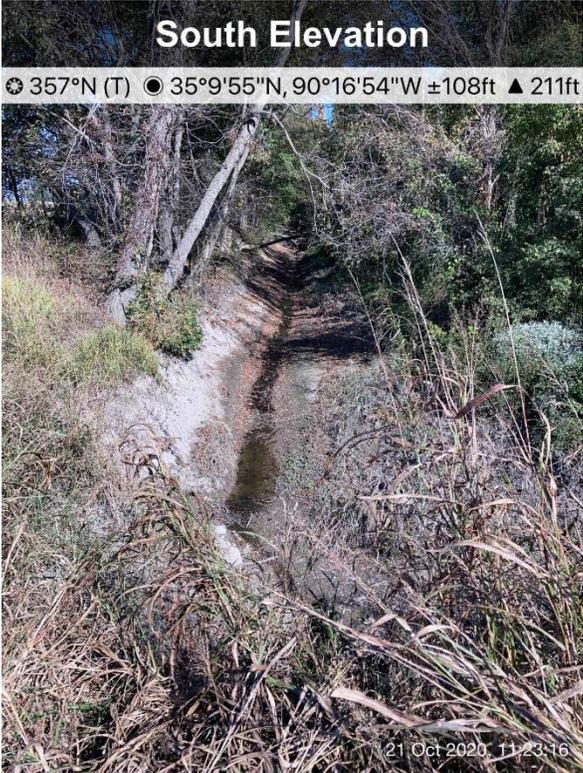
<b>Photo No.</b> <b>7</b>	<b>Date:</b> 10/20/20	<div style="text-align: center;"> <h3>South Elevation</h3> <p>                     📍 357°N (T) 📍 35°9'55"N, 90°16'54"W ±108ft ▲ 211ft                 </p>

<p style="text-align: right; font-size: small;">21 Oct 2020, 11:23:16</p> </div>
<b>Direction Photo Taken:</b>  North		
<b>Description:</b>  Ditch 11 upstream of Ditch 3 and 1

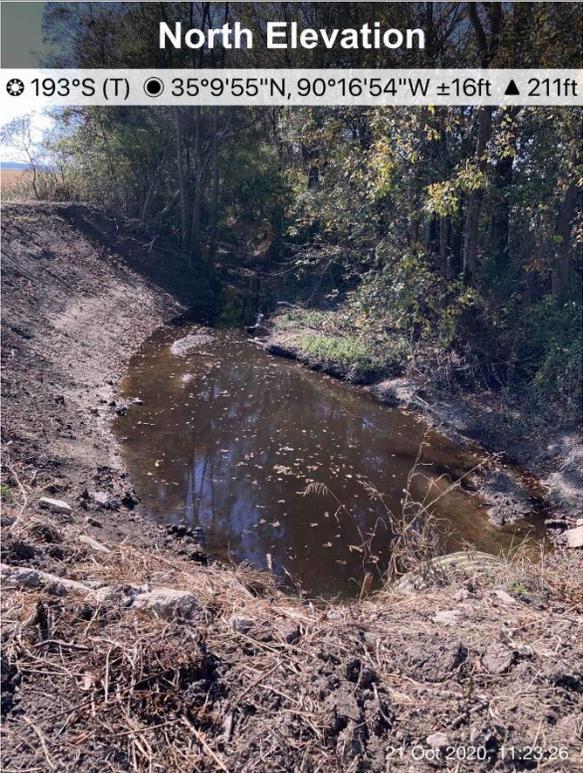
<b>Photo No.</b> <b>8</b>	<b>Date:</b> 10/20/20	<div style="text-align: center;"> <h3>North Elevation</h3> <p>                     📍 193°S (T) 📍 35°9'55"N, 90°16'54"W ±16ft ▲ 211ft                 </p>

<p style="text-align: right; font-size: small;">21 Oct 2020, 11:23:26</p> </div>
<b>Direction Photo Taken:</b>  South		
<b>Description:</b>  Ditch 11 upstream of Ditch 3 and 1

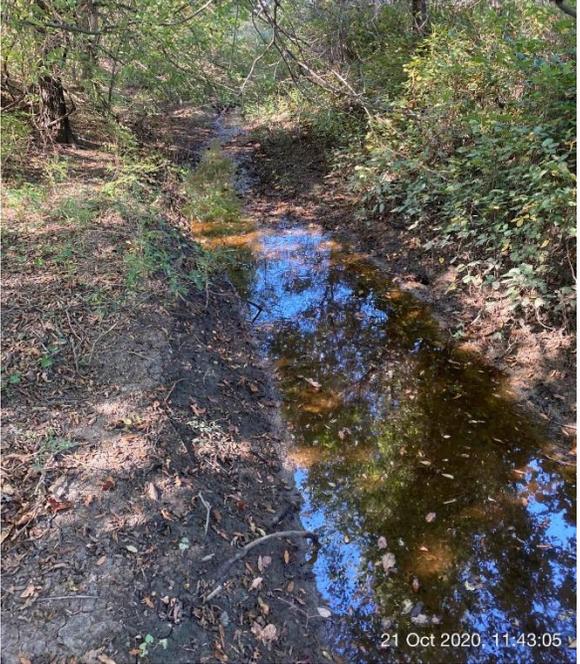
<b>Photo No.</b> <b>9</b>	<b>Date:</b> 10/20/20	<div data-bbox="711 331 1291 1100"> <p style="text-align: center;"><b>East Elevation</b></p> <p style="text-align: center;">☉ 284°W (T) ● 35°9'42"N, 90°16'7"W ±13ft ▲ 214ft</p>

<p style="text-align: right; font-size: small;">21 Oct 2020 11:43:05</p> </div>
<b>Direction Photo Taken:</b>  West		
<b>Description:</b>  Ditch 5a, start of back water from ditch 10

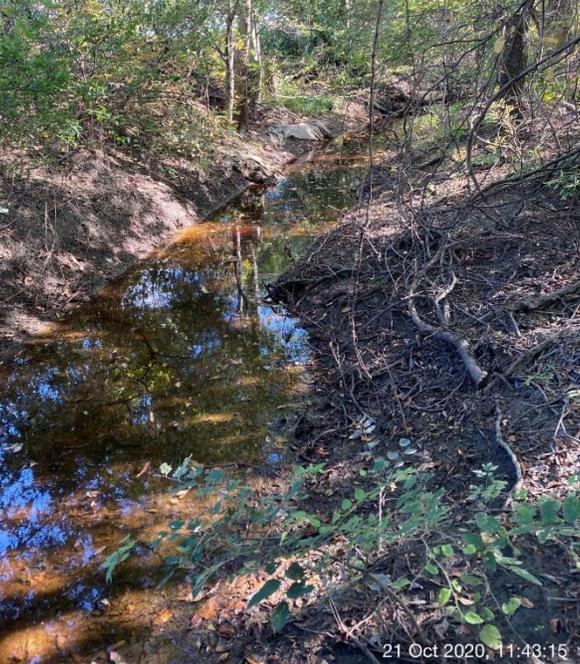
<b>Photo No.</b> <b>10</b>	<b>Date:</b> 10/20/20	<div data-bbox="711 1142 1291 1911"> <p style="text-align: center;"><b>West Elevation</b></p> <p style="text-align: center;">☉ 79°E (T) ● 35°9'42"N, 90°16'7"W ±19ft ▲ 213ft</p>

<p style="text-align: right; font-size: small;">21 Oct 2020 11:43:15</p> </div>
<b>Direction Photo Taken:</b>  East		
<b>Description:</b>  Ditch start of backwater in Ditch 5a facing east to Ditch 10

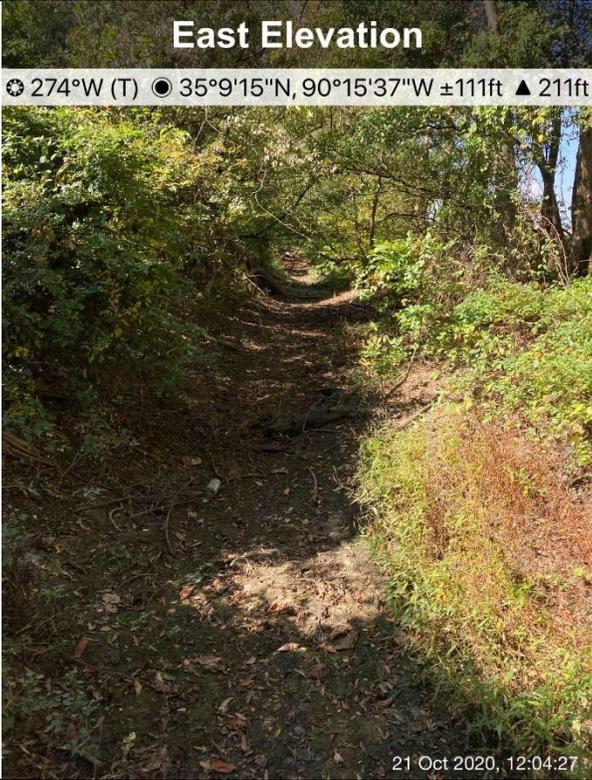
<b>Photo No.</b> <b>13</b>	<b>Date:</b> 10/20/20	<p style="text-align: center;"><b>East Elevation</b></p> <p style="text-align: center;">☉ 274°W (T) ● 35°9'15"N, 90°15'37"W ±111ft ▲ 211ft</p>

<p style="text-align: right;">21 Oct 2020, 12:04:27</p>
<b>Direction Photo Taken:</b>		
west		
<b>Description:</b>		
Ditch 6a facing west to Ditch 10 downstream of culvert from wetland 1

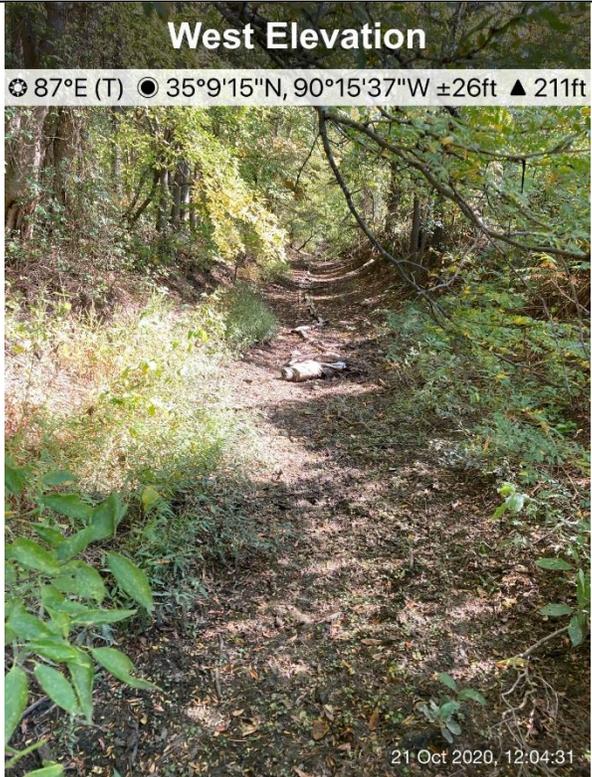
<b>Photo No.</b> <b>14</b>	<b>Date:</b> 10/20/20	<p style="text-align: center;"><b>West Elevation</b></p> <p style="text-align: center;">☉ 87°E (T) ● 35°9'15"N, 90°15'37"W ±26ft ▲ 211ft</p>

<p style="text-align: right;">21 Oct 2020, 12:04:31</p>
<b>Direction Photo Taken:</b>		
east		
<b>Description:</b>		
Ditch 6a upstream of culvert to wetland 1

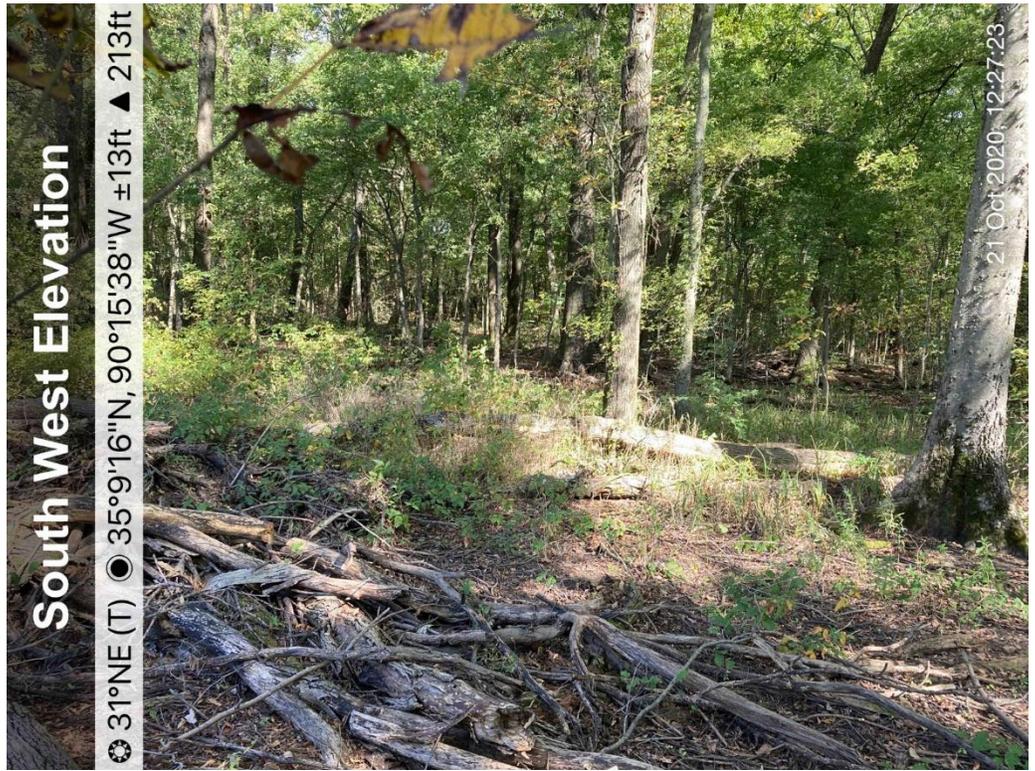
<b>Photo No.</b> <b>17</b>	<b>Date:</b> 10/20/20
<b>Direction Photo Taken:</b>  Northeast	
<b>Description:</b>  Wetland 1 current condition.

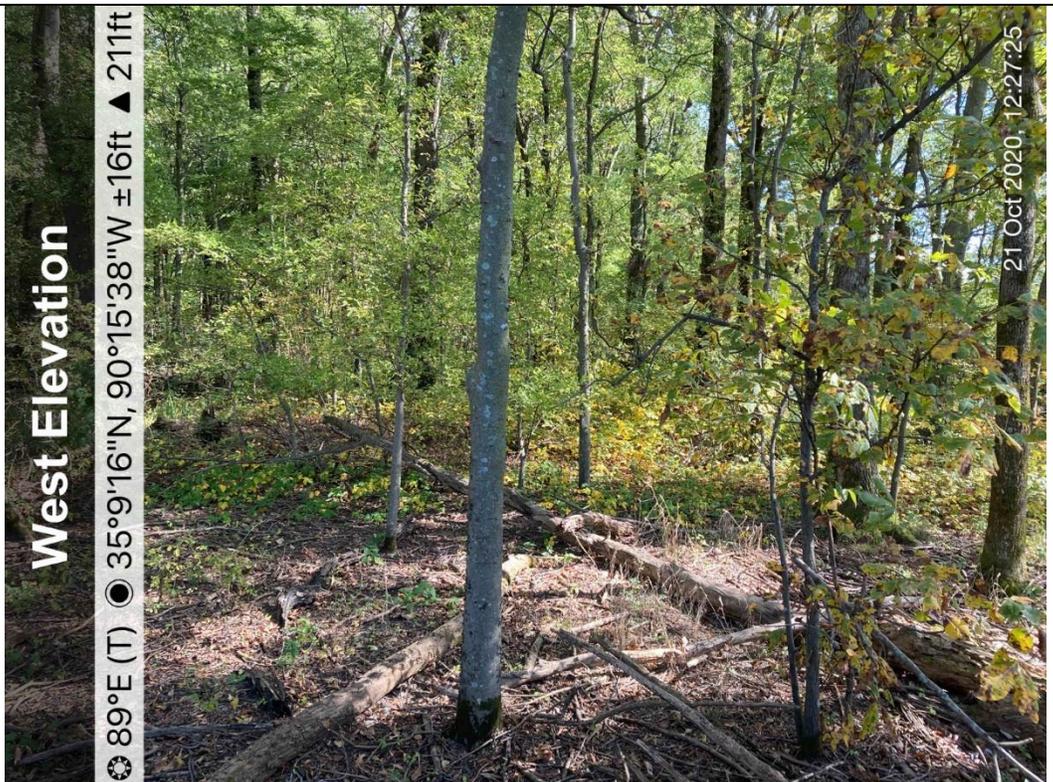
<b>Photo No.</b> <b>18</b>	<b>Date:</b> 10/20/20
<b>Direction Photo Taken:</b>  East	
<b>Description:</b>  Wetland 1, current condition
