**WETLAND DELINEATION REPORT  
PROJECT ID. 213084 SC\_04  
68-ACRE BRITCO SITE  
ASCENSION PARISH, LOUISIANA**

GEC Project Number: 0013.2122014.007

# **WETLAND DELINEATION REPORT 68-ACRE BRITCO SITE ASCENSION PARISH, LOUISIANA**

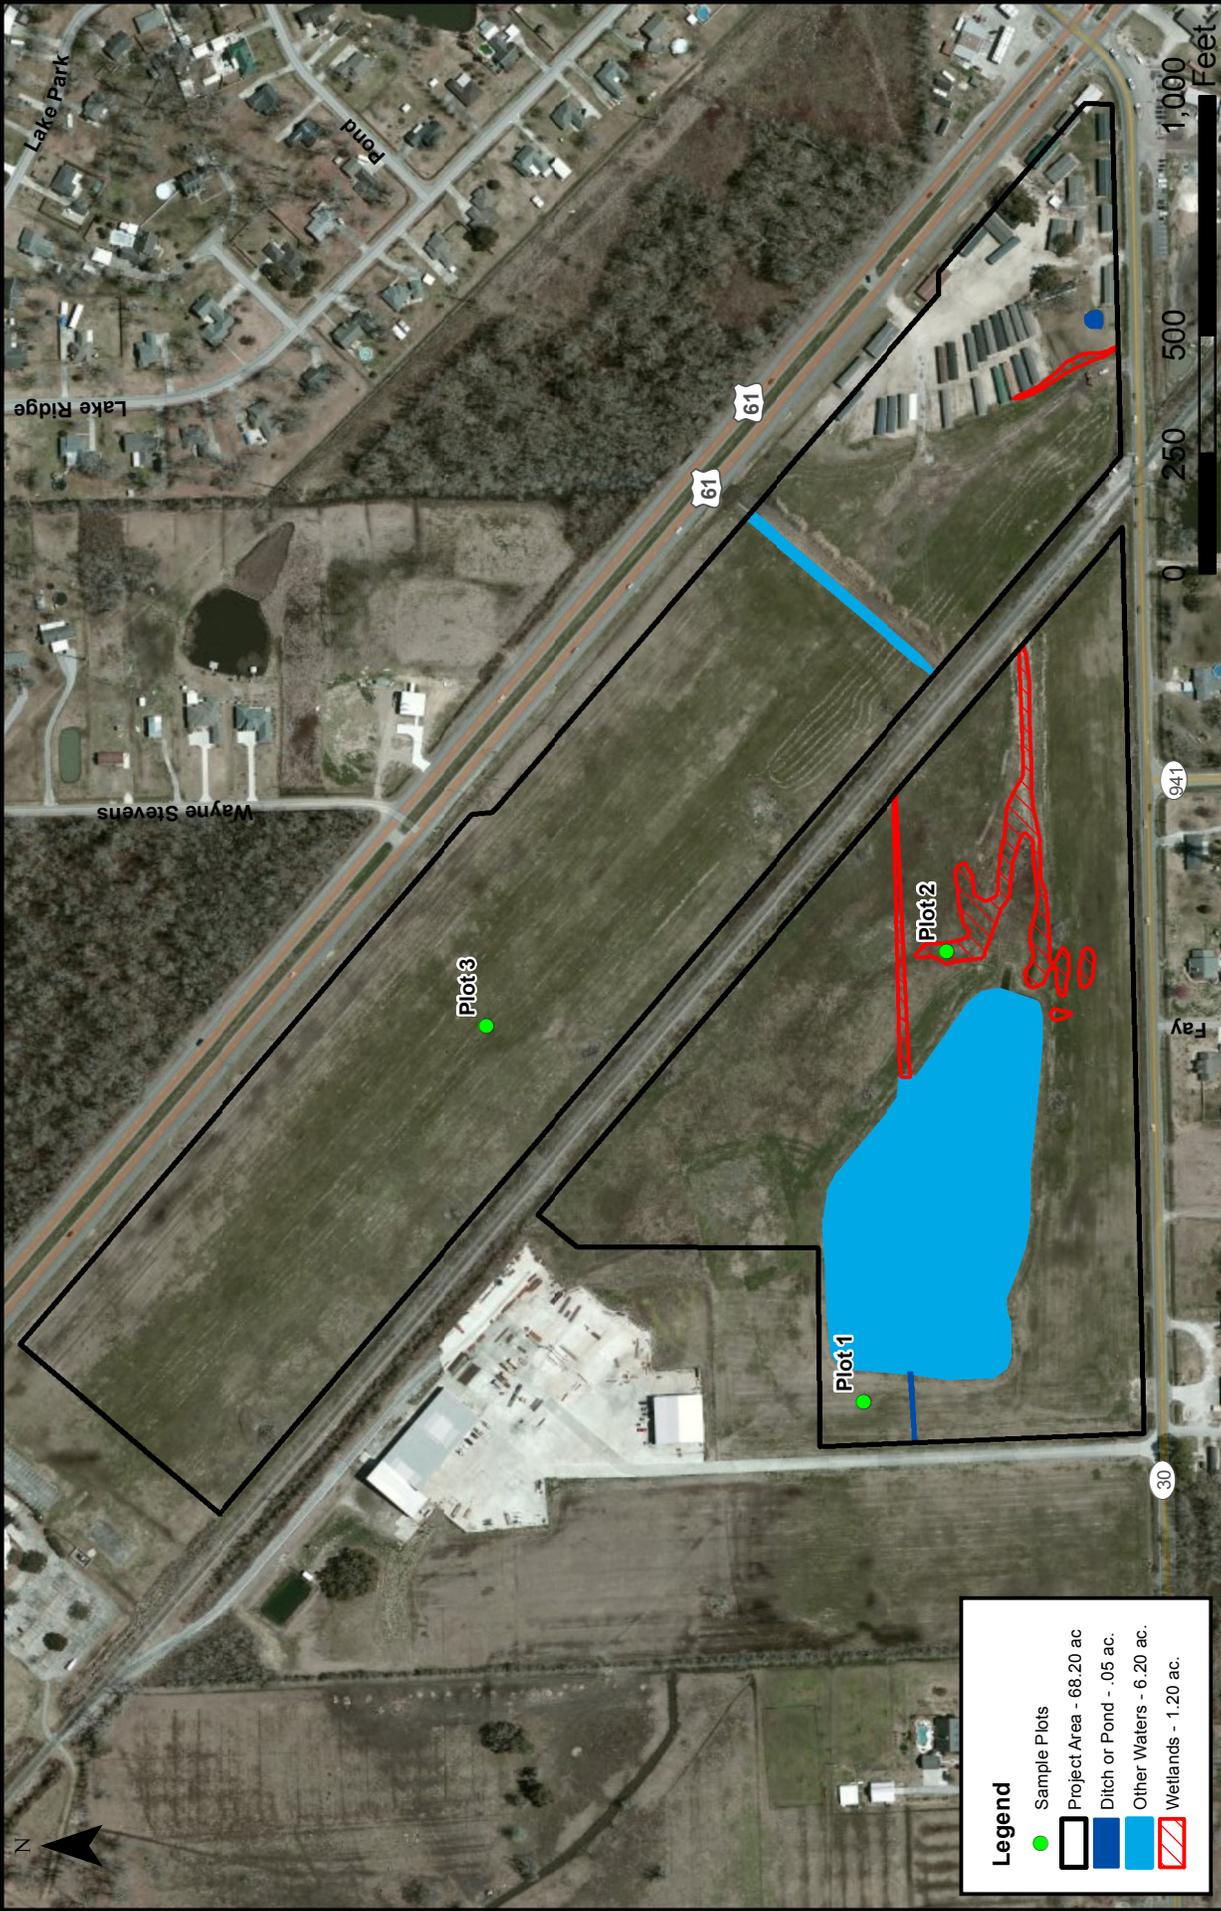
Figure: 3
Date: September 2014
Scale: 1:4,800
Source: ESR/GEC
Map ID: 00132122014007-3143

- Sample Plots
- Project Area - 68.20 ac
- Ditch or Pond - .05 ac.
- Other Waters - 6.20 ac.
- Wetlands - 1.20 ac.

**WETLAND MAP**  
 68-Acre BRITCO Site  
 PROJECT ID. 213084 SC\_04  
 Intersection of US HWY 61 & LA HWY 30  
 Ascension Parish, Louisiana

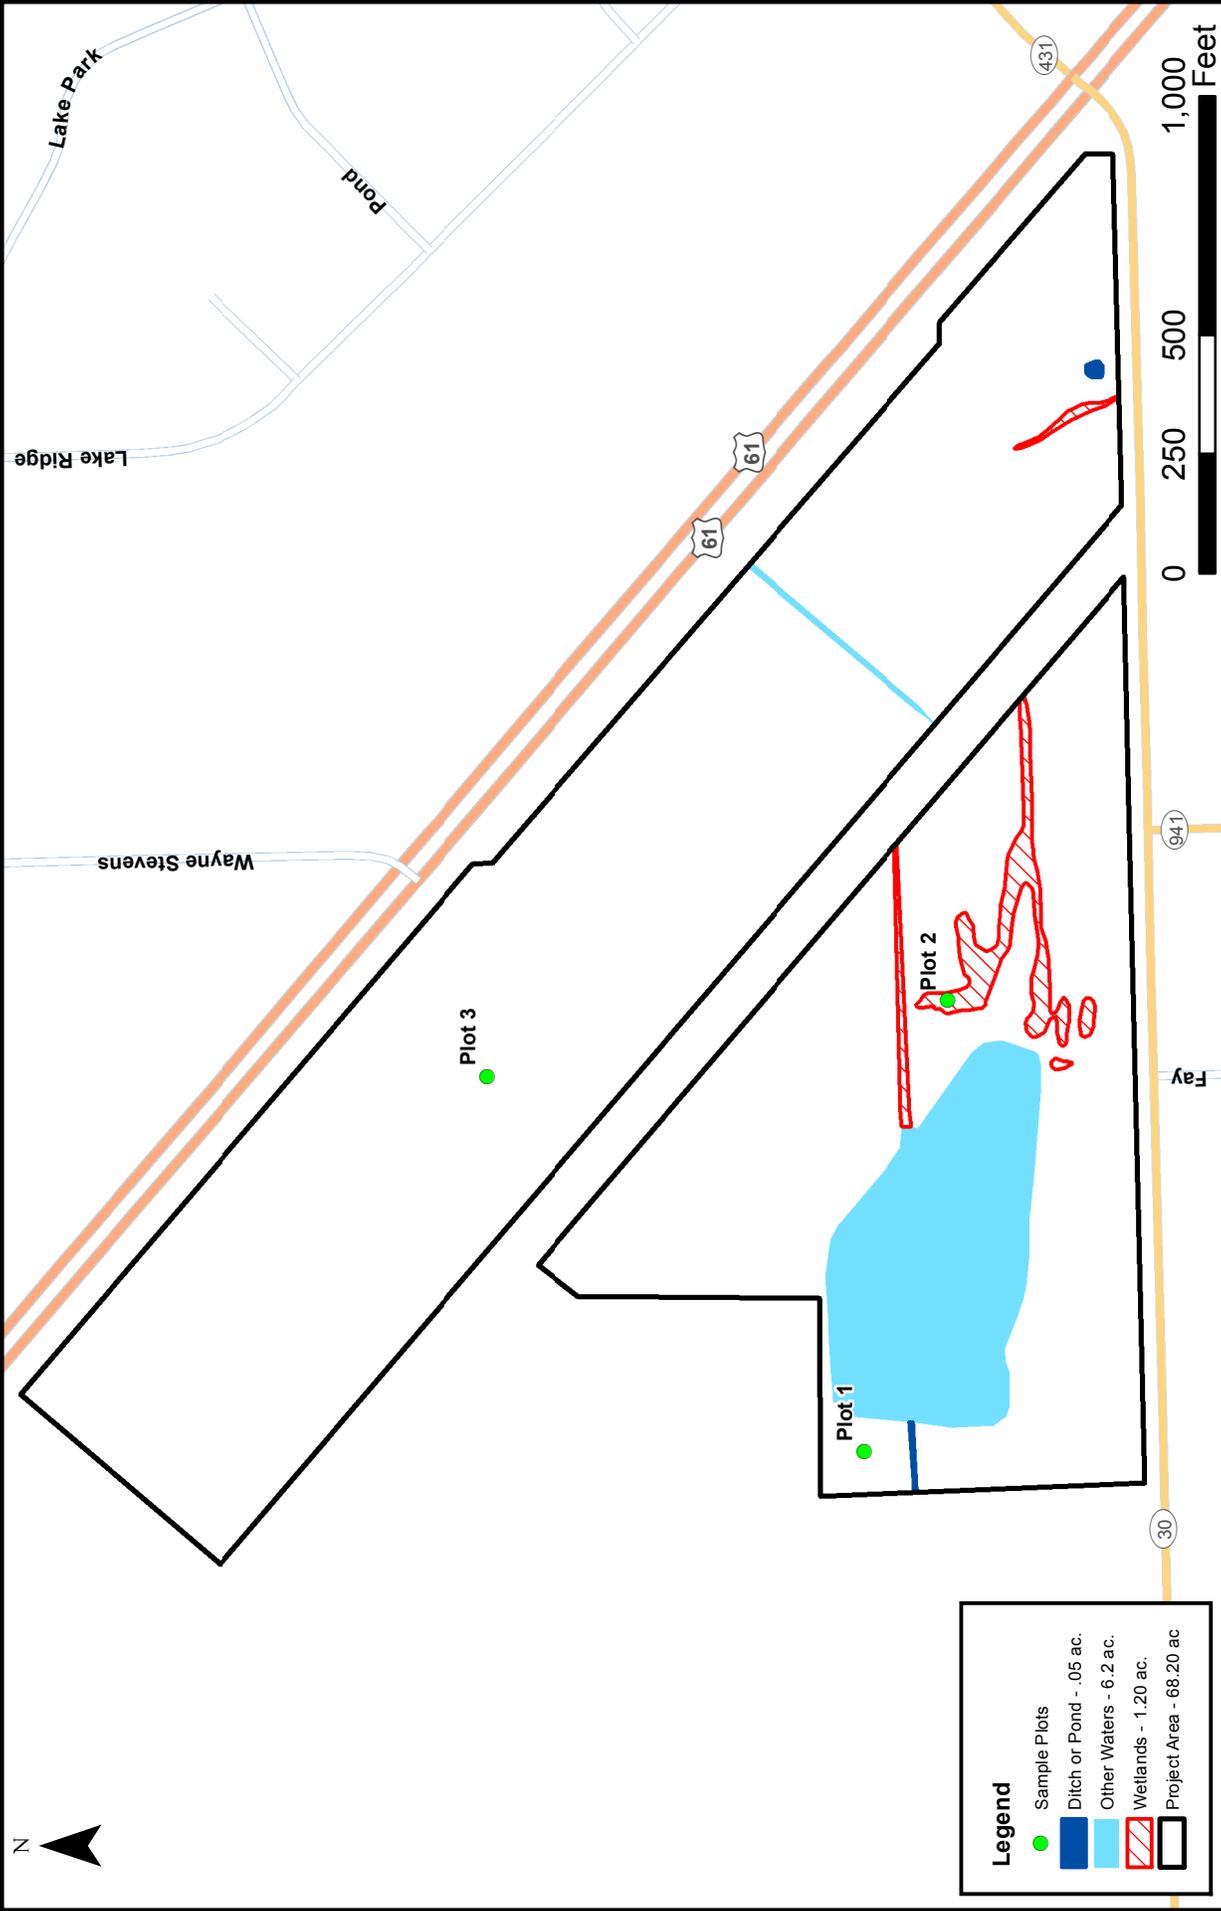
Figure: 4
Date: September 2014
Scale: 1:4,800
Source: GEC
Map ID: 00132122014007-3143

- Sample Plots
- Ditch or Pond - .05 ac.
- Other Waters - 6.2 ac.
- Wetlands - 1.20 ac.
- Project Area - 68.20 ac

**WETLAND MAP - JD**

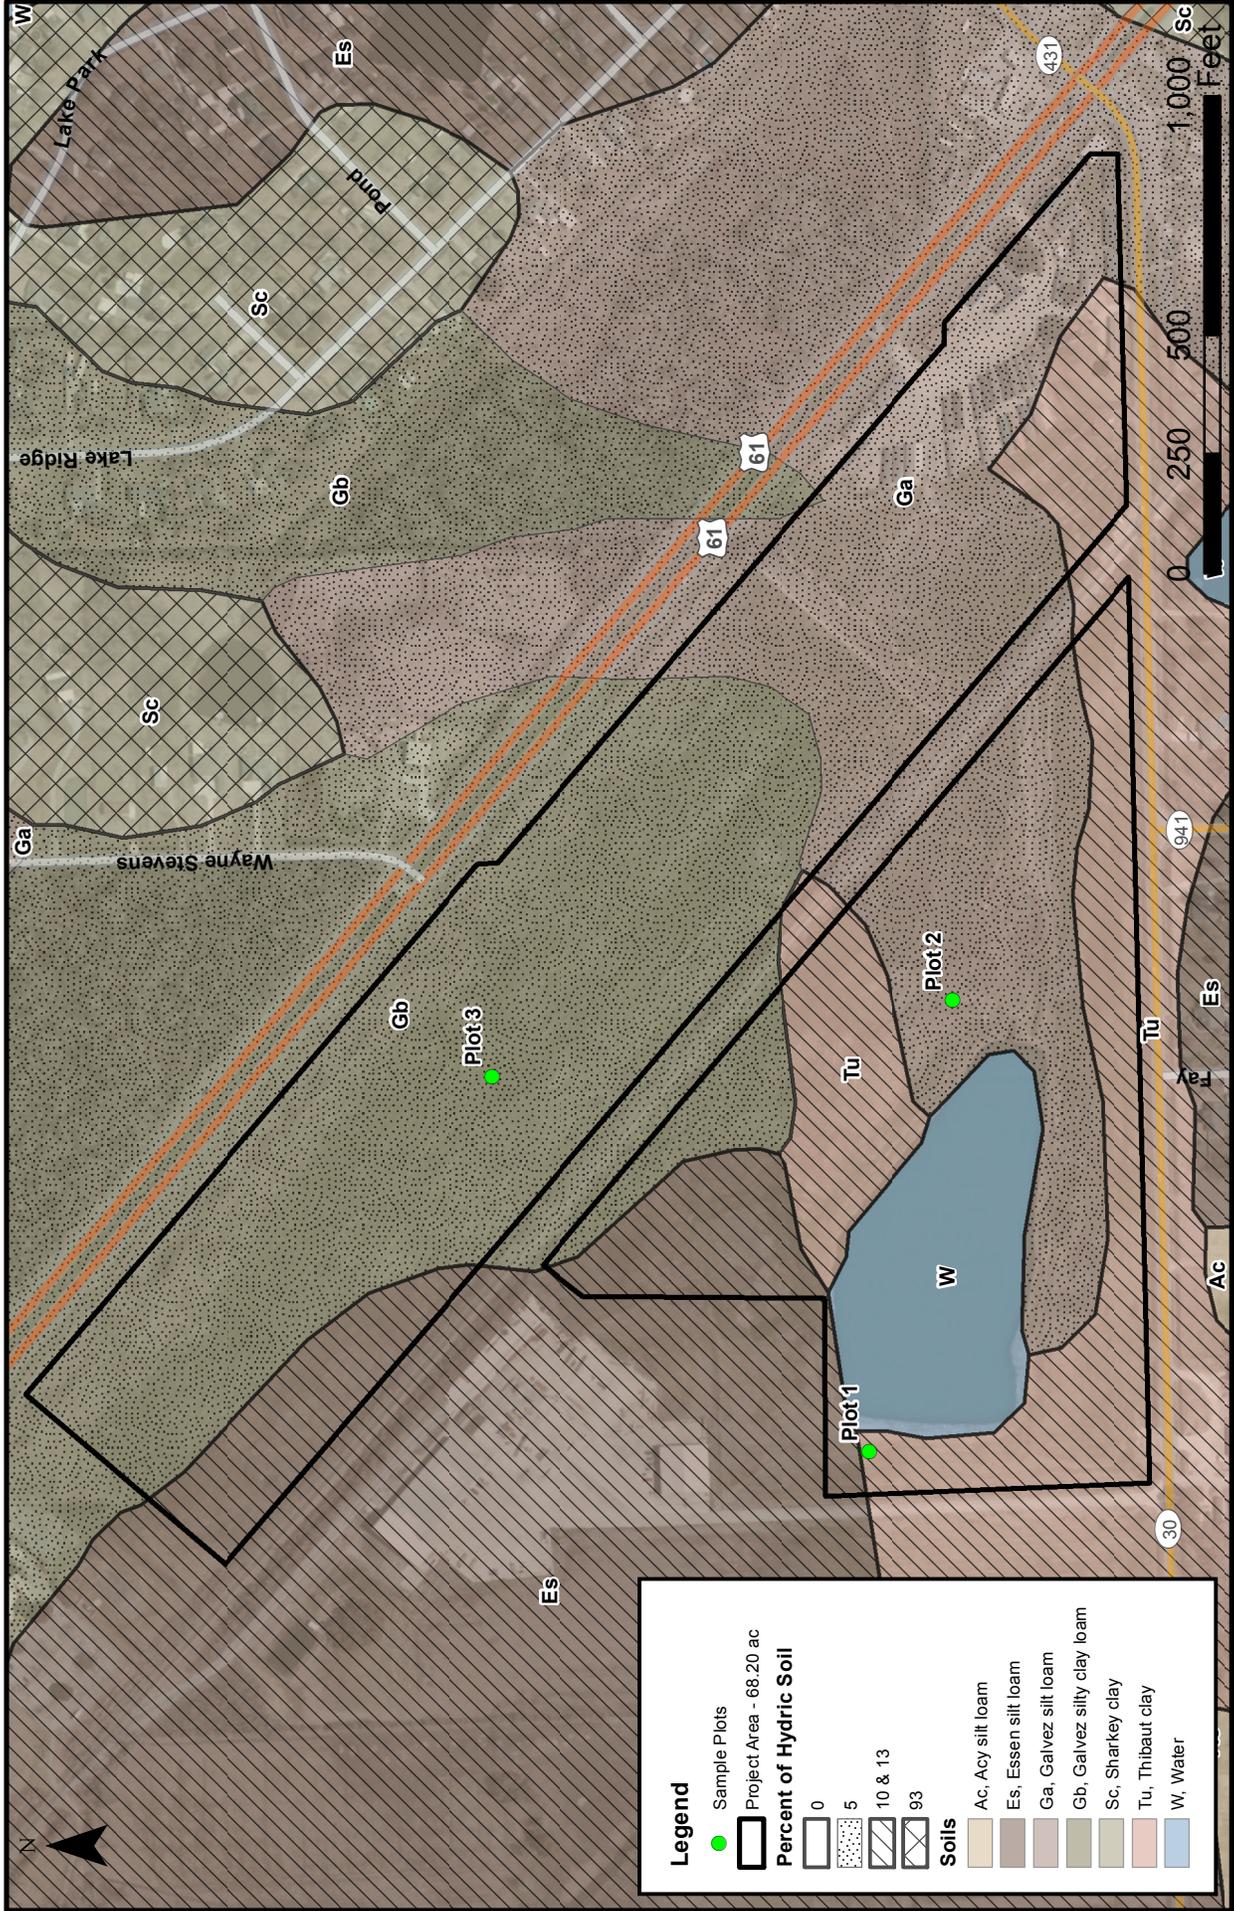
Figure: 5  
 Date: September 2014  
 Scale: 1:4,800  
 Source: NRCS/GEC  
 Map ID: 00132122014007-3143

- Sample Plots
  - Project Area - 68.20 ac
- Percent of Hydric Soil
  - 0
  - 5
  - 10 & 13
  - 93
- Soils
  - Ac, Acy silt loam
  - Es, Essen silt loam
  - Ga, Galvez silt loam
  - Gb, Galvez silty clay loam
  - Sc, Sharkey clay
  - Tu, Thibaut clay
  - W, Water

**SOIL MAP**  
 68-Acre BRITCO Site  
 PROJECT ID: 213084 SC\_04  
 Intersection of US HWY 61 & LA HWY 30  
 Ascension Parish, Louisiana

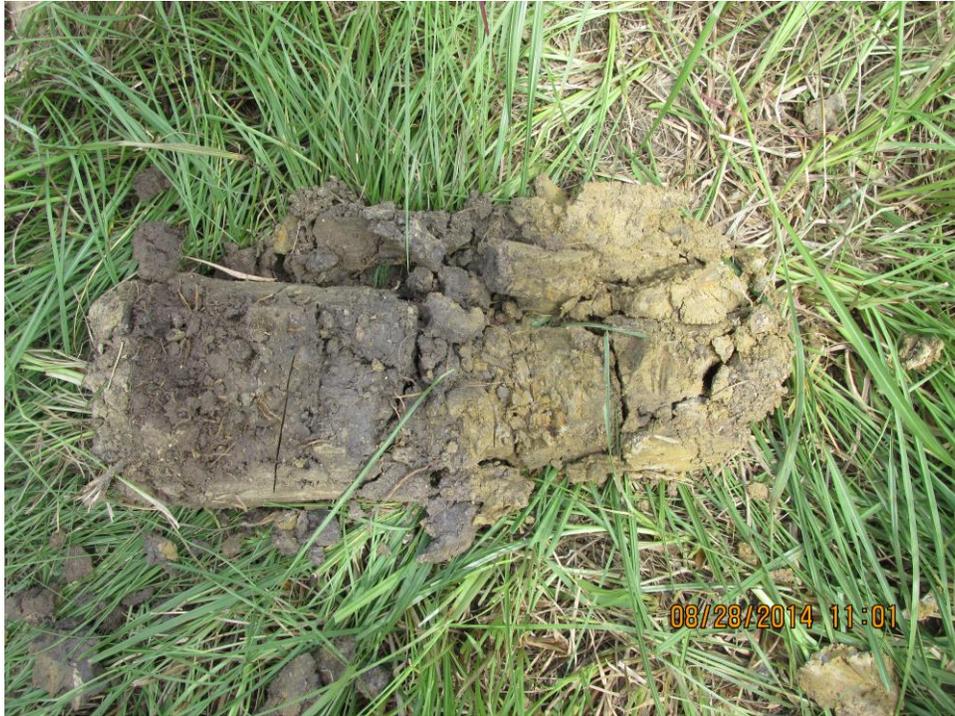
The soils within this sample plot are mapped as Thibaut clay. This series is not listed on the National or the Louisiana Hydric Soils lists. Field observations of the soil profile did not identify any hydric soil indicators; therefore, these soils are considered non-hydric soils. There were no primary or secondary indicators of wetland hydrology recorded at this sample plot. The wetland hydrology criterion is not met at this plot. It is GEC's opinion that this sample plot is not within a wetland, based on the lack of hydrophytic vegetation, hydric soils, and wetland hydrology (see Data Form Plot - 1).

Depth (inches)	Matrix		Redox Features				Texture	Remarks
	Color (moist)	%	Color (moist)	%	Type <sup>1</sup>	Loc <sup>2</sup>		
0-3	10YR 3/2	99	10YR 5/6	1	C	M	Silty Clay	
3-6	10YR 3/1	100			N/A	N/A	Silty Clay	
6-18+	10YR 5/4	97	10YR 5/8	2	C	M	Clay	
			10YR 7/1	1	D	M	Clay

**Photograph 1. Soil Profile Observed at Plot 1**

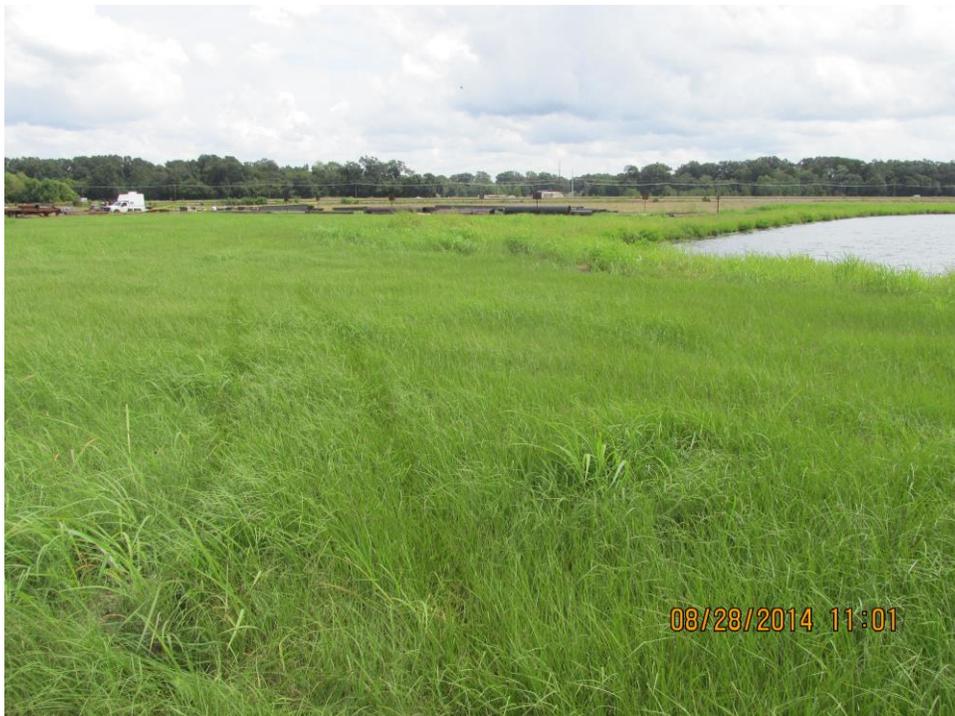
Sample Plot - 1: Sample Plot 1 is located in the parcel west of KCS Railroad within a maintained field in the northwest corner just west of the pond (Figure 3). The dominant herbaceous species observed within this sample plot are bahia grass (*Paspalum notatum*) and Johnson grass (*Sorghum halapense*). Other less dominant species included jungle rice (*Echinochloa colona*), and Virginia button-weed (*Diodia virginiana*). The hydrophytic vegetation criterion is not met within this sample plot.

**Photograph 2. Overview of Habitat Observed at Plot 1,  
Facing Northeast**

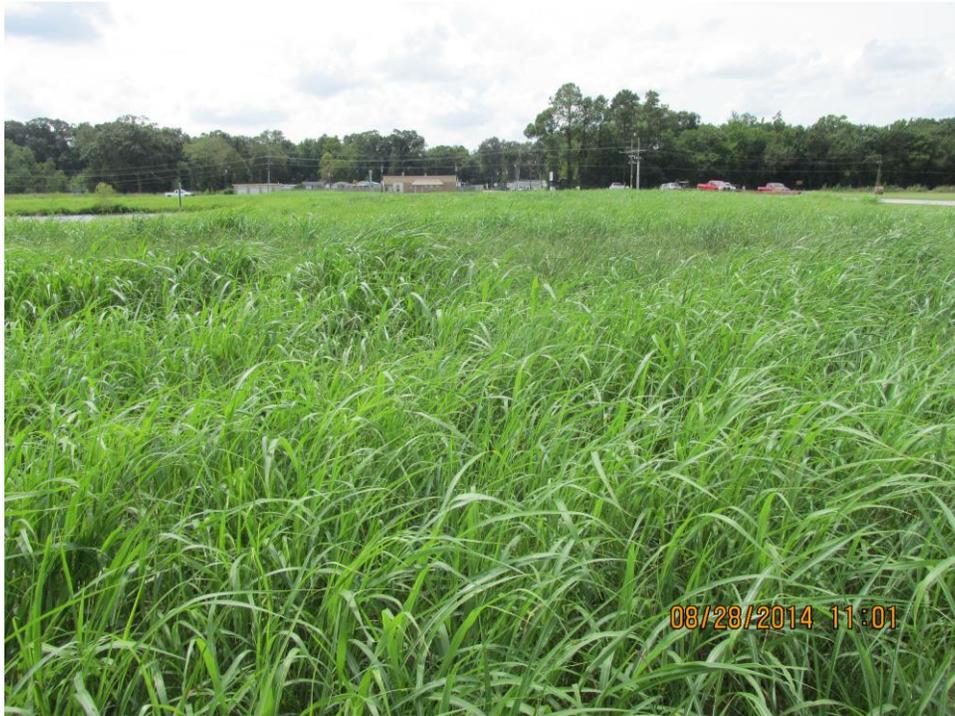
**Photograph 3. Overview of Habitat Observed at Plot 1, Facing South**

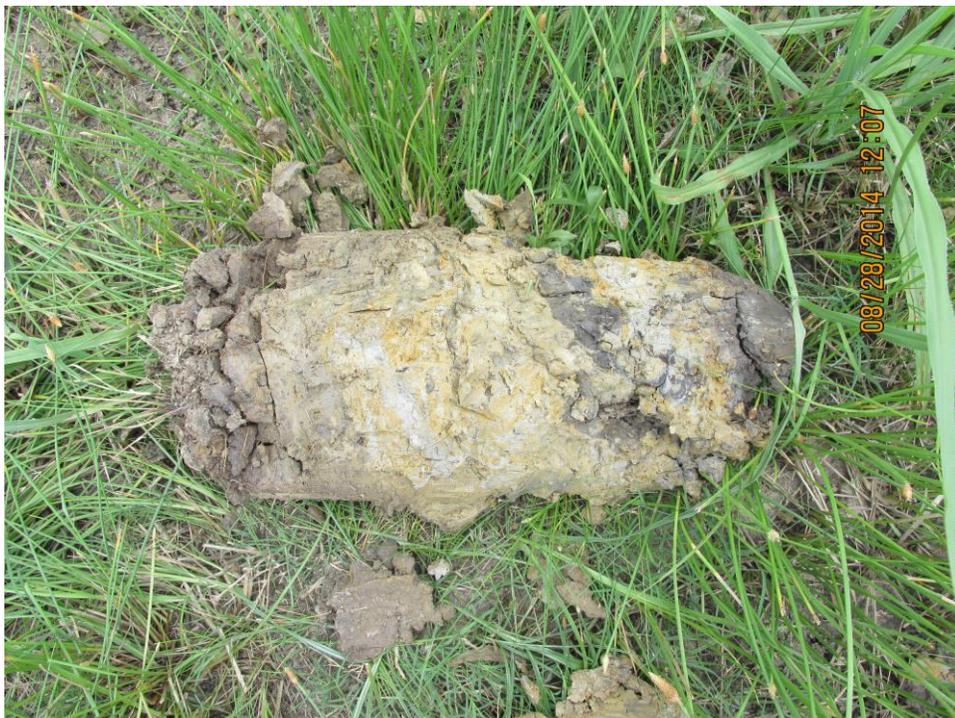
The soils within this sample plot are mapped as Galvez silt loam. This series is listed on the National and the Louisiana Hydric Soils lists. Field observations concluded that the hydric soils criterion is met within this plot based on the presence of hydric soil indicators for a depleted matrix. Primary indicators of hydrology recorded at this sample plot include water-stained leaves (B9) and oxidized rhizospheres on living roots (C3). Secondary indicators included surface soil cracks (B6), crayfish burrows (C8), and a positive FAC-Neutral test (D5). It is GEC's opinion that this sample plot is within a wetland, based on the presence of all three wetland parameters (see Data Form Plot - 2).

Depth (inches)	Matrix		Redox Features				Texture	Remarks
	Color (moist)	%	Color (moist)	%	Type <sup>1</sup>	Loc <sup>2</sup>		
0-2	10YR 4/2	98	10YR 5/6	2	C	M	Clay	
2-8	2.5Y 6/4	94	10YR 7/1	2	D	M	Clay	
			10YR 6/2	2	D	M	Clay	
			10YR 6/8	2	C	M	Clay	
8-17	10YR 6/2	95	10YR 5/8	3	C	M	Clay	
			10YR 6/8	2	C	M	Clay	
17-18+	10YR 2/1	100			N/A	N/A	Clay

**Photograph 4. Soil Profile Observed at Plot 2**

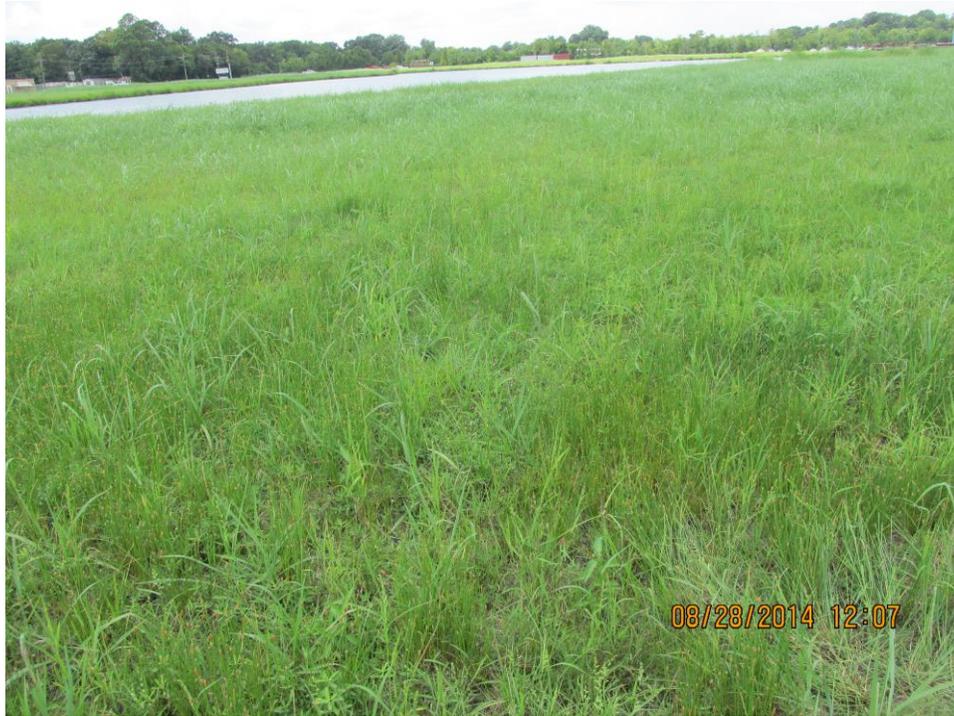
Sample Plot - 2: Sample Plot 2 is located in the western parcel just east of the pond within a herbaceous depression. Dominant herbaceous species within this depression include blunt spikerush (*Eleocharis obtusa*), Bermuda grass (*Cynodon dactylon*), Virginia button-weed, and jungle rice. There were also less abundant occurrences of alligator weed (*Alternanthera philoxeroides*) within the sample plot. The hydrophytic vegetation criterion is met within this sample plot.

**Photograph 5. Overview of Habitat Observed at Plot 2,  
Facing West**

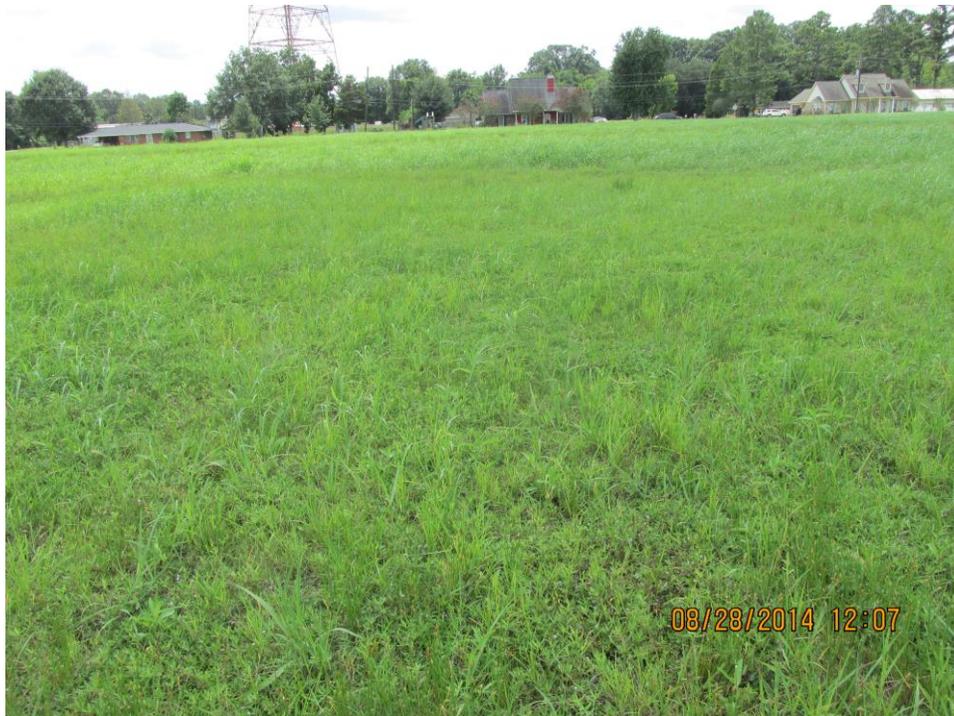
**Photograph 6. Overview of Habitat Observed at Plot 2,  
Facing Southeast**

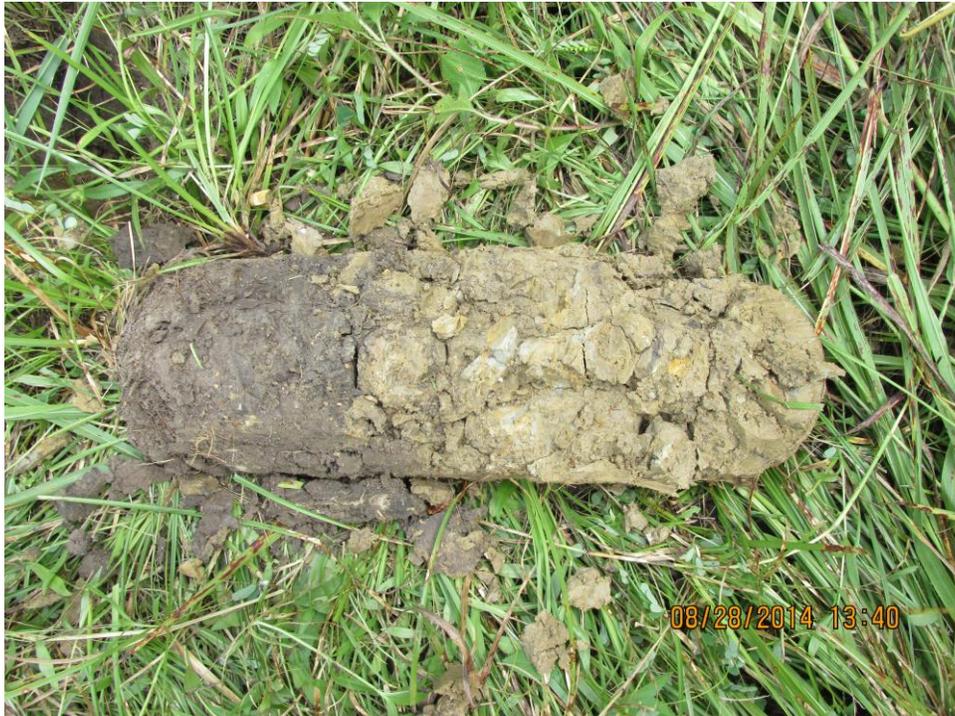
The soils within this sample plot are mapped as Galvez silty clay loam. This series is listed on the National and the Louisiana Hydric Soils lists. Field observations of the soil profile did not identify any hydric soil indicators; therefore the hydric soils criterion is not met within this sample plot. There were no primary or secondary hydrology indicators recorded within this sample plot. It is GEC's opinion that this sample plot is not within a wetland, based on the lack of indicators for hydrophytic vegetation, hydric soils and wetland hydrology within the plot (see Data Form Plot - 3).

Depth (inches)	Matrix		Redox Features				Texture	Remarks
	Color (moist)	%	Color (moist)	%	Type <sup>1</sup>	Loc <sup>2</sup>		
0-5	10YR 2/1	99	7.5YR 4/6	1	C	PL	Silty Clay	
5-18+	10YR 5/4	97	10YR 6/8	2	C	M	Clay	
			10YR 7/1	1	D	M	Clay

**Photograph 7. Soil Profile Observed at Plot 3**

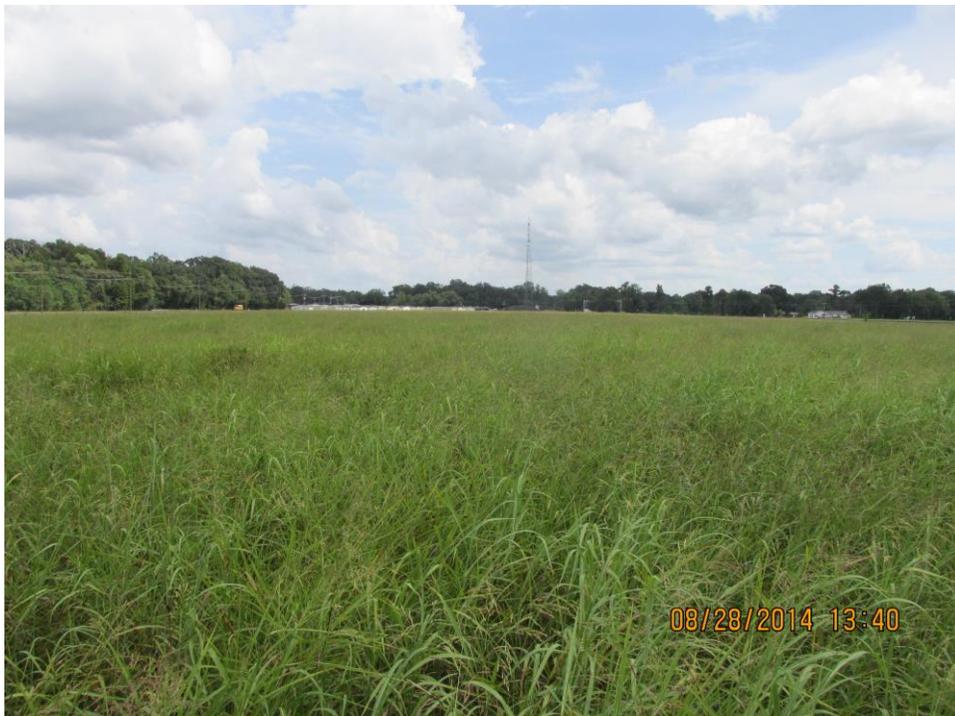
Sample Plot - 3: Sample Plot 3 is located in the center portion of the parcel adjacent to US Highway 61. This parcel is an overgrown field dominated by Johnson grass, vasey grass (*Paspalum urvillei*), and Bermuda grass. Other less abundant species observed include bush

aster (*Aster dumosus*), Virginia button-weed, rusty sedge (*Cyperus odoratus*), and saltmarsh loosestrife (*Lythrum lineare*). The hydrophytic vegetation criterion is not met within this sample plot.

**Photograph 8. Overview of Habitat Observed at Plot 3,  
Facing South**

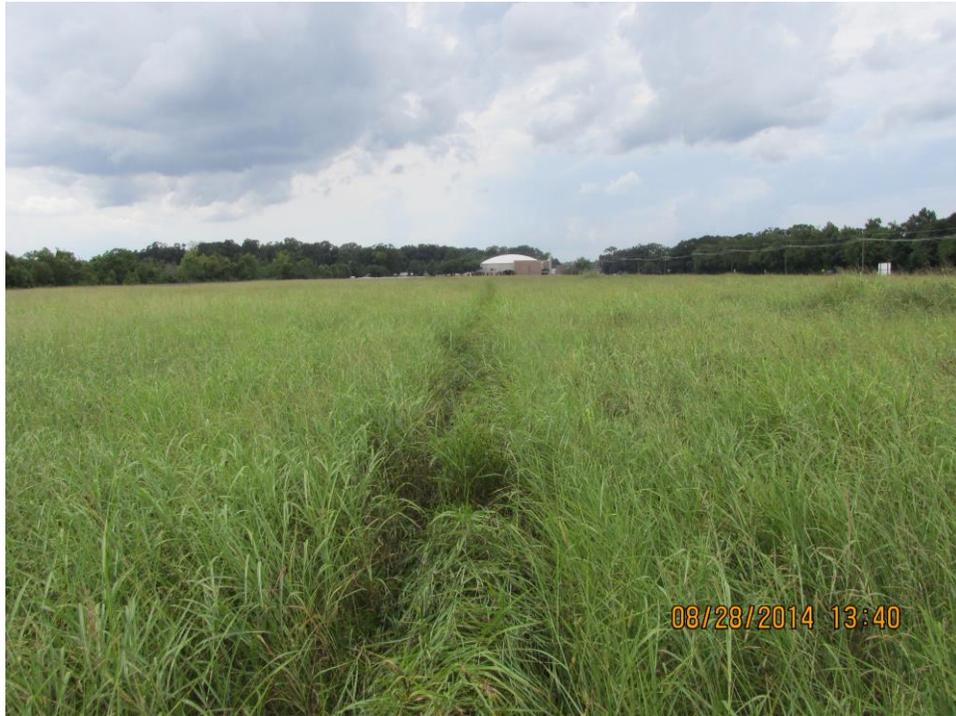
**Photograph 9. Overview of Habitat Observed at Plot 3,  
Facing North**
