Exhibit W. Foti - Highway 3120 N Wetlands Delineation Report

Re: Wetland Data Report
Foti Highway 3120 N Project
Ascension Parish, Louisiana
Providence Project No. 1204-001

On behalf of Baton Rouge Area Chamber (BRAC), Providence Engineering and Environmental Group LLC (Providence) is submitting this wetland data report for the Foti Highway 3120 N project (hereinafter referred to as Site) in Ascension Parish, Louisiana.

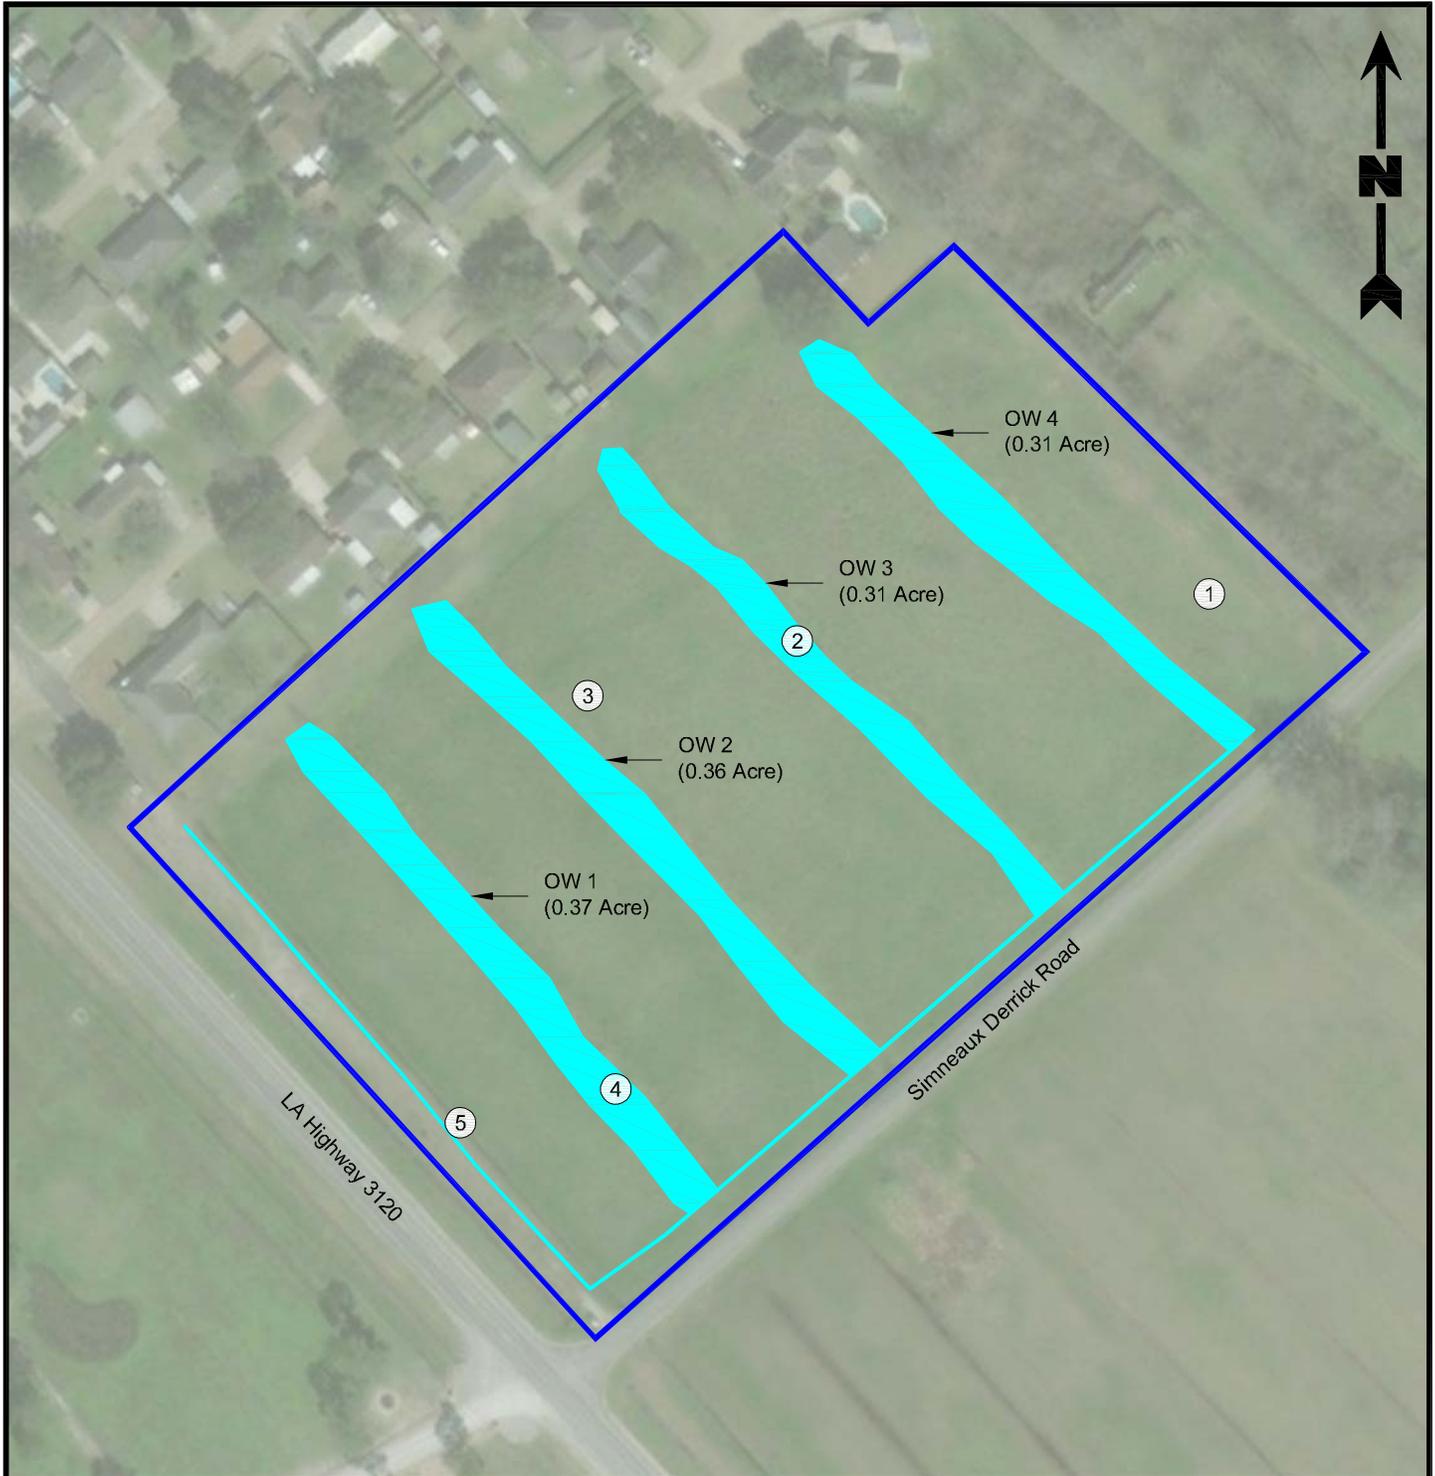
Aerial Photograph

It appears that approximately 1,152.49 linear feet (1.35 acres) of potential Other Waters of the U.S. from historical ephemeral drains may be present on the Site.

- Limits of Delineation (9.79 Acres)
- Potential Other Waters of The U.S. (1,152.49 Linear Feet; 1.35 Acres)
- ③ Sample Location

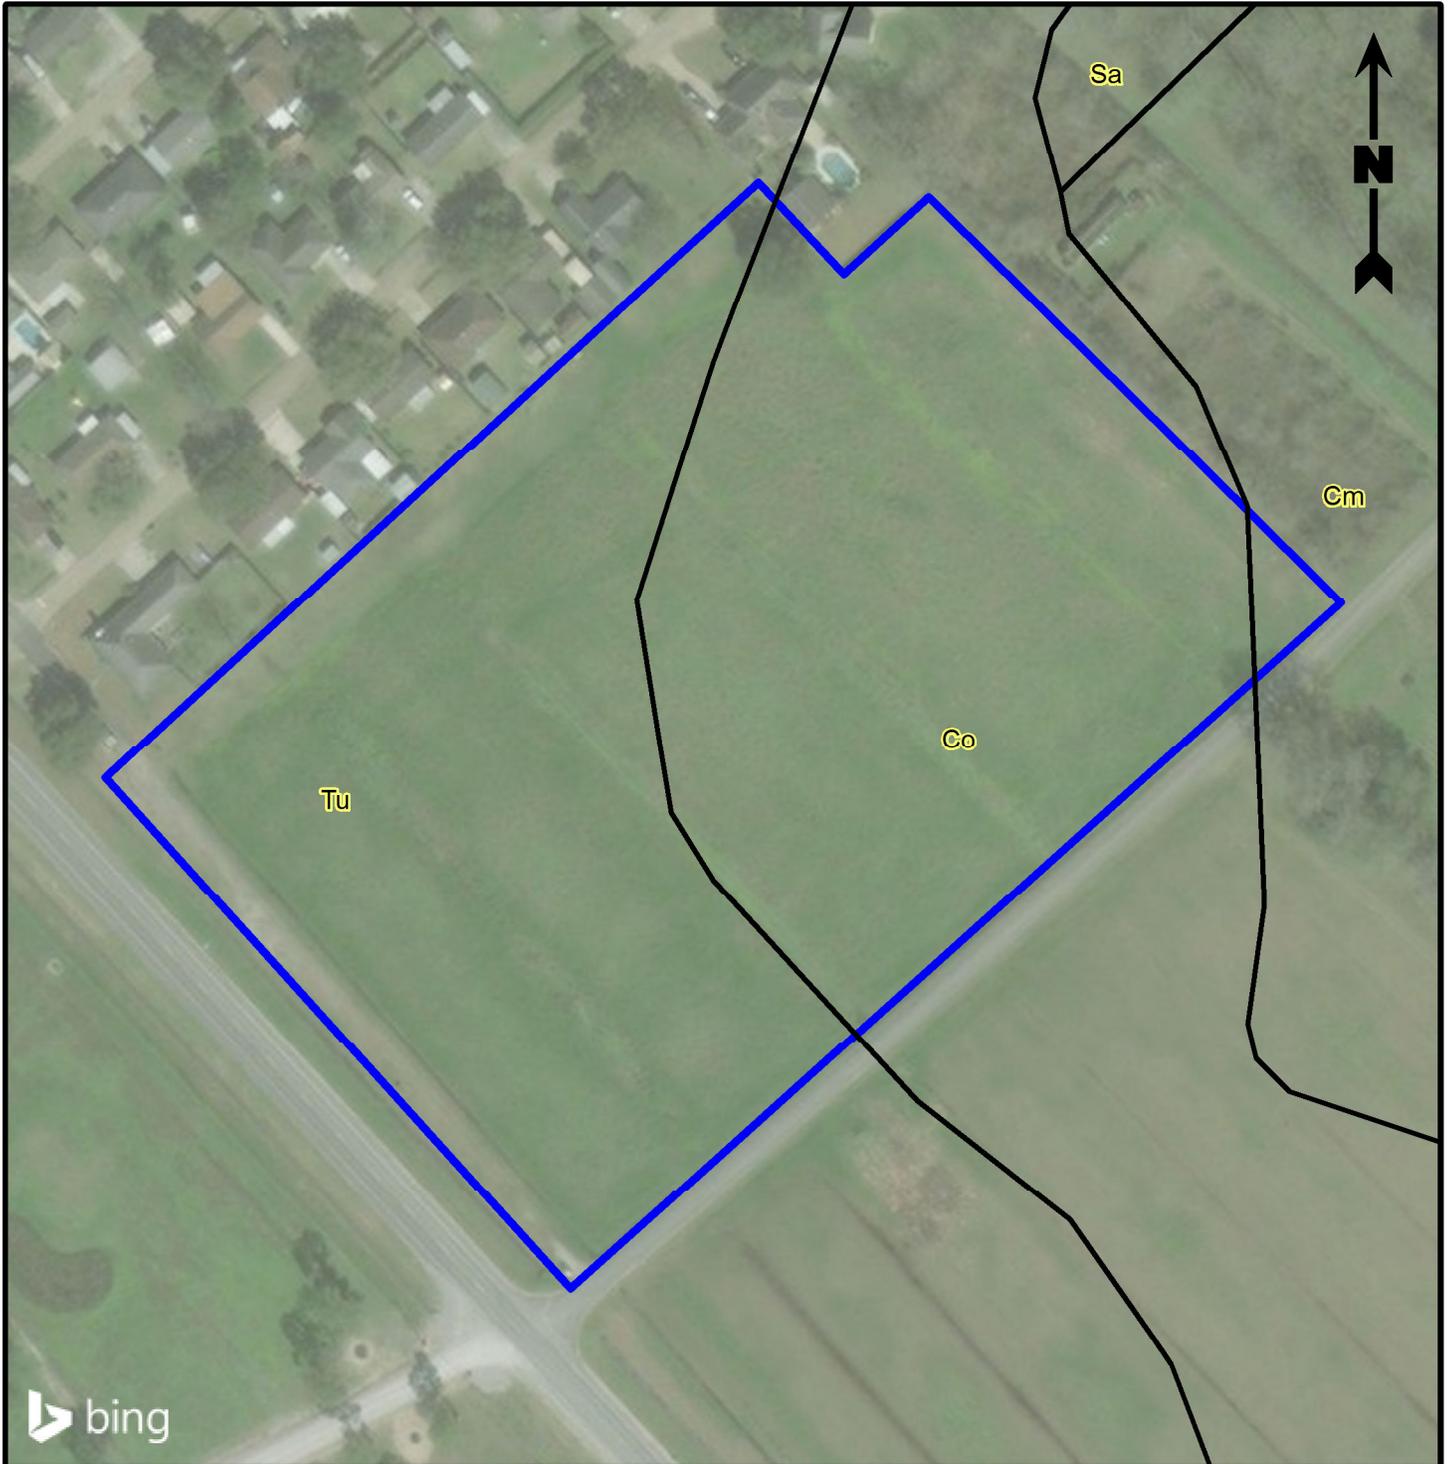
Soils Map

The NRCS Web Soil Survey was used to determine mapped soil series. The revised official series descriptions were used to confirm profile matrix, redox features, and texture of soils underlying the Site. The Web Soil Survey shows that the Site may be underlain by three soil map units (NRCS Web Soil Survey 2016). **Table 1** shows the soil map unit's individual soil components, component percentage, and hydric status in Ascension Parish (NRCS Survey Area Data, Version 11, September 23, 2016).

- Limits of Delineation (9.79 Acres)
- Soils Data:
 - Cm - Commerce silt loam
 - Co - Commerce silty clay loam
 - Tu - Thibaut clay, 0 to 1 percent slopes

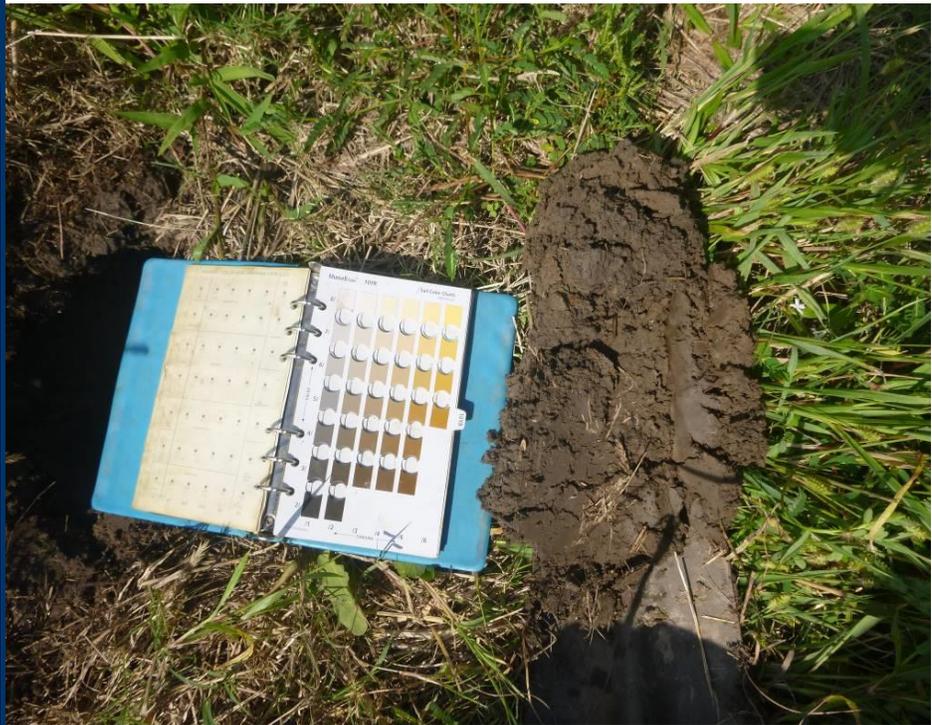
Photograph #1A

View of soil profile at Sample Location 1.

SOIL							
Depth Inches	Matrix		Redox Features			Location	Texture
0-16	Color	%	Color	%	Type		
	10YR 3/3	95	10YR 5/8	5	C	M	silty clay

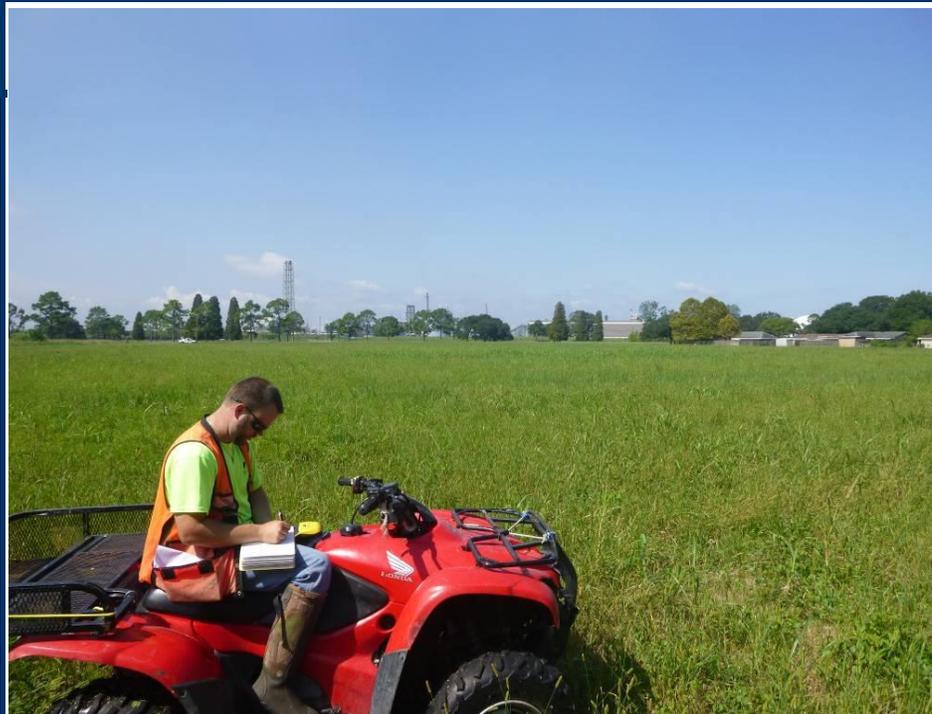
Photograph #1B

View of habitat and typical landscape features at Sample Location 1.

SUMMARY OF FINDINGS	
Hydrophytic Vegetation Present?	No
Hydric Soil Present?	No
Wetland Hydrology Present?	No
Is the Sampled Area within a Wetland?	
No	
Remarks:

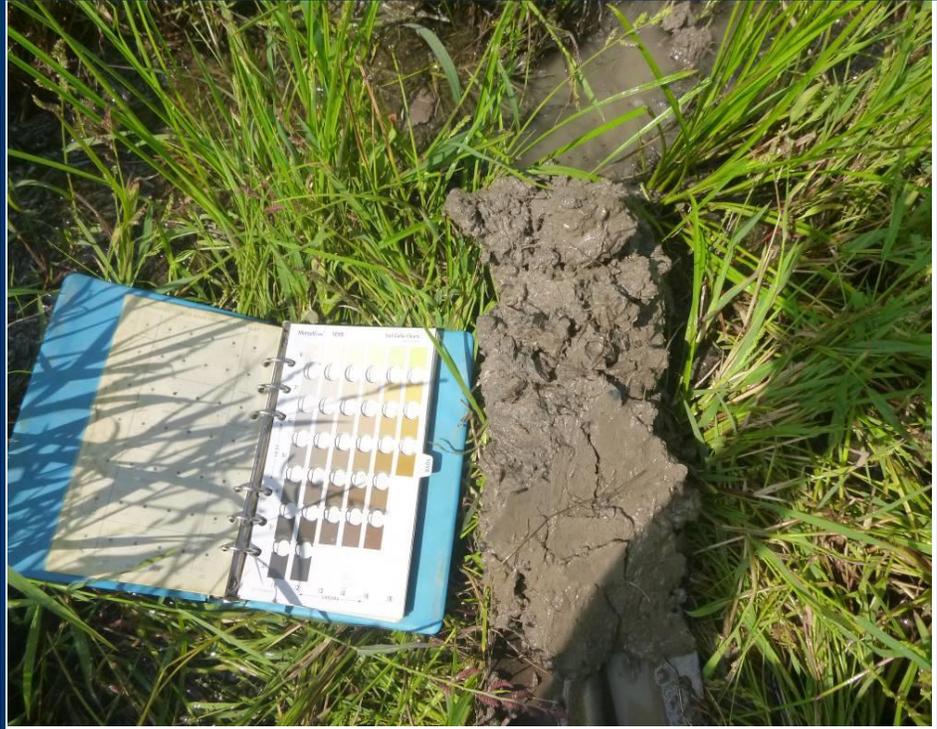
Photograph #2A

View of soil profile at Sample Location 2.

SOIL							
Depth Inches	Matrix		Redox Features			Texture	
	Color	%	Color	%	Type	Location	
0-4	10YR 3/2	100					silty clay
4-16	10YR 4/2	95	10YR 3/6	5	C	M	silty clay

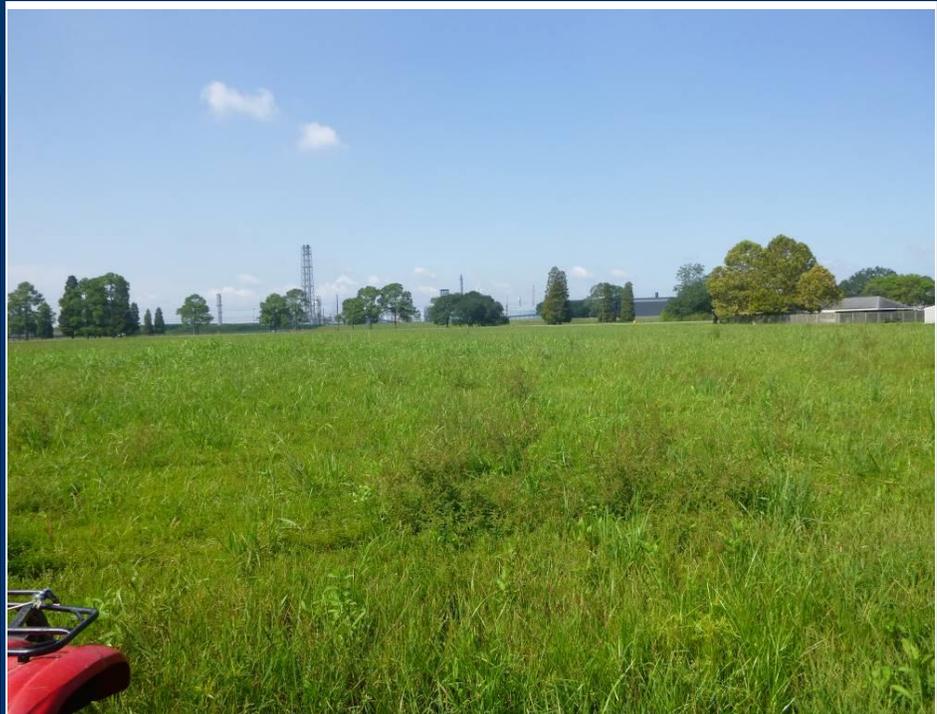
Photograph #2B

View of habitat and typical landscape features at Sample Location 2.

SUMMARY OF FINDINGS	
Hydrophytic Vegetation Present?	Yes
Hydric Soil Present?	Yes
Wetland Hydrology Present?	Yes
Is the Sampled Area within a Wetland? Yes	
Remarks:

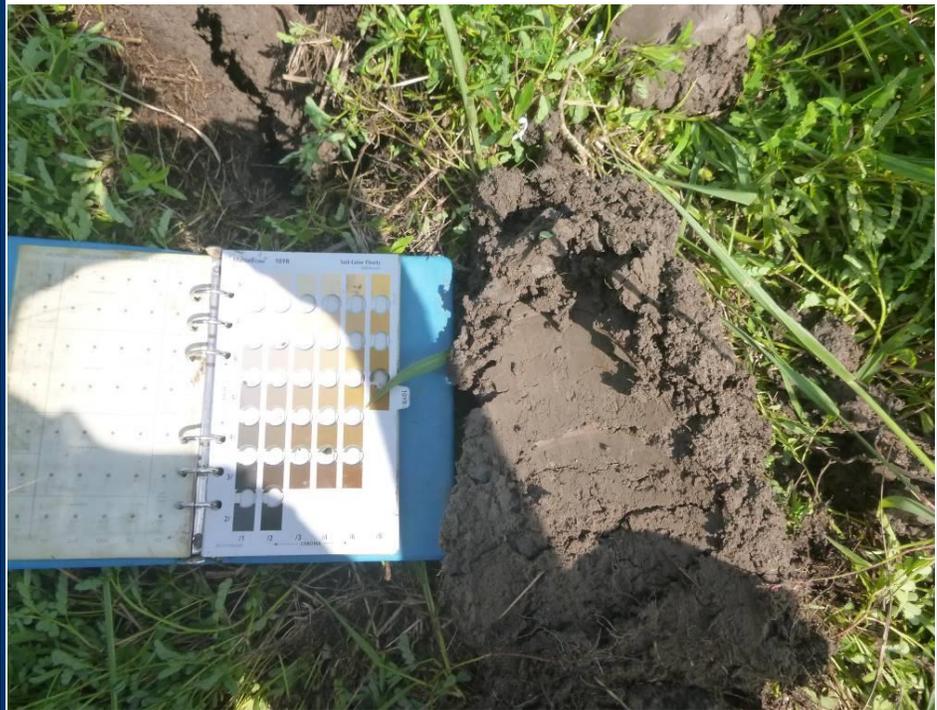
Photograph #3A

View of soil profile at Sample Location 3.

SOIL							
Depth Inches	Matrix		Redox Features			Location	Texture
	Color	%	Color	%	Type		
0-16	10YR 4/3	95	10YR 3/6	5	C	M	clay

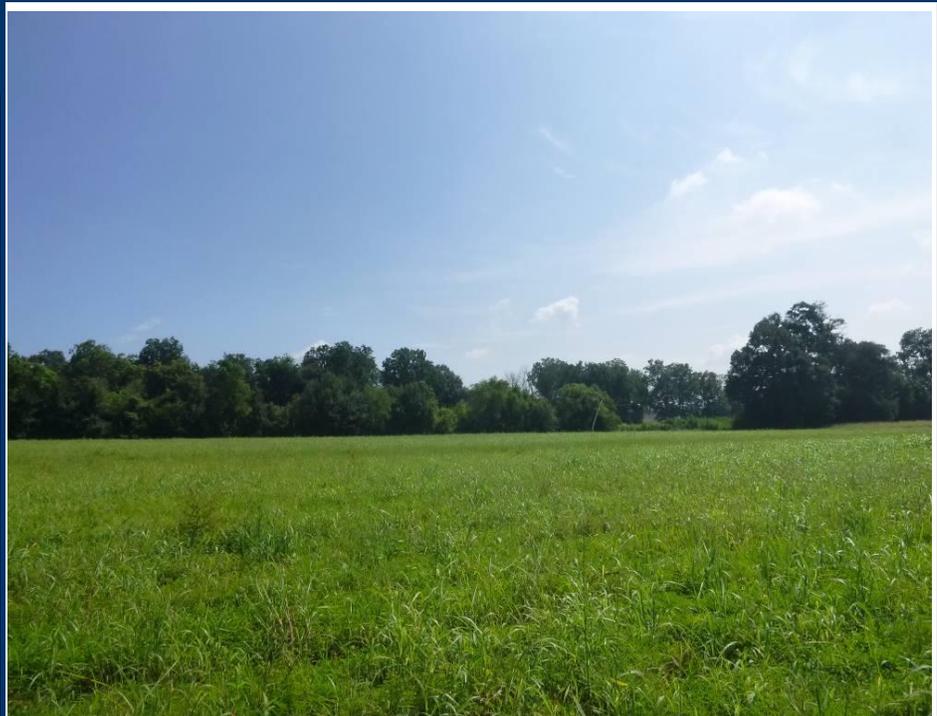
Photograph #3B

View of habitat and typical landscape features at Sample Location 3.

SUMMARY OF FINDINGS	
Hydrophytic Vegetation Present?	Yes
Hydric Soil Present?	No
Wetland Hydrology Present?	No
Is the Sampled Area within a Wetland?	
No	
Remarks:

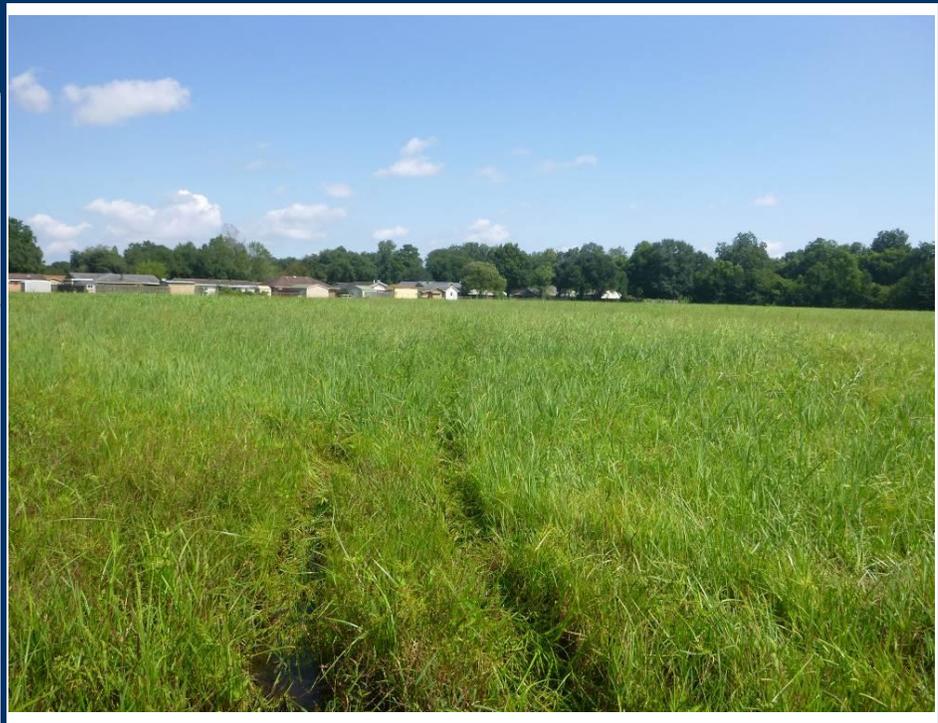
Photograph #4B

Comments:
View of habitat and typical landscape features at Sample Location 4.

SUMMARY OF FINDINGS	
Hydrophytic Vegetation Present?	Yes
Hydric Soil Present?	Yes
Wetland Hydrology Present?	Yes
Is the Sampled Area within a Wetland?	
Yes	
Remarks:

Field Observations:				
Surface Water Present?	Yes	Depth (inches):	6	Wetland Hydrology Present? <u>Yes</u>
Water table Present?	None	Depth (inches):	N/A	
Saturation Present?	None	Depth (inches):	N/A	
Remarks:

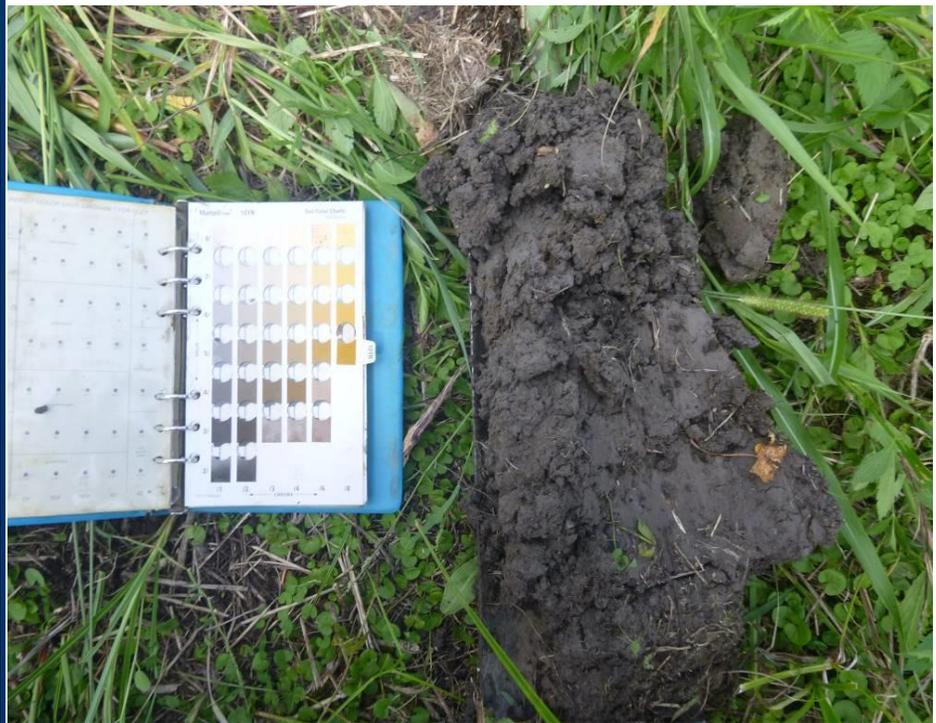
Photograph #5A

View of soil profile at Sample Location 5.

Depth Inches	Matrix		Redox Features				Texture
	Color	%	Color	%	Type	Location	
0-4	10YR 3/2	100					clay
4-16	10YR 4/2	90	10YR 3/6	10	C	M	clay

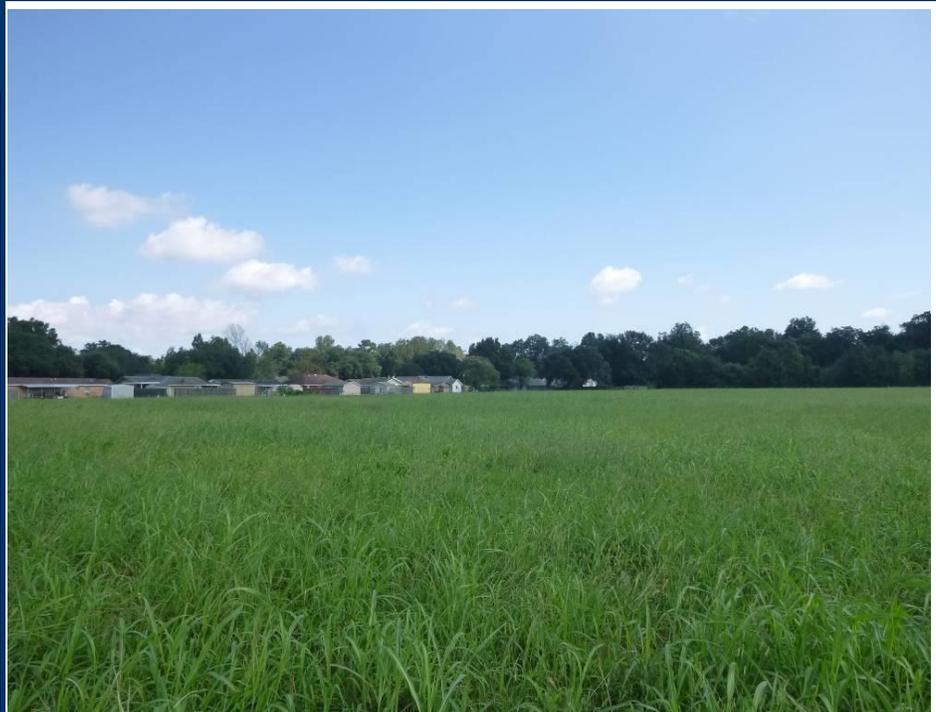
Photograph #5B

View of habitat and typical landscape features at Sample Location 5.

Hydrophytic Vegetation Present?	Yes	Is the Sampled Area within a Wetland?	No
Hydric Soil Present?	Yes		
Wetland Hydrology Present?	No		
Remarks:
