**RE: Preliminary Jurisdictional Determination
Schexnayder 1000-Acre Wetland Delineation
Ascension Parish, Donaldsonville, Louisiana**

**WETLAND DELINEATION REPORT
PROJECT ID. 213084.20.002
1,000-ACRE SCHEXNAYDER SITE
ASCENSION PARISH, DONALDSONVILLE,
LOUISIANA**

GEC Project Number: 0013.2122014.006

WETLAND DELINEATION REPORT 1,000-ACRE SCHEXNAYDER SITE ASCENSION PARISH, DONALDSONVILLE, LOUISIANA

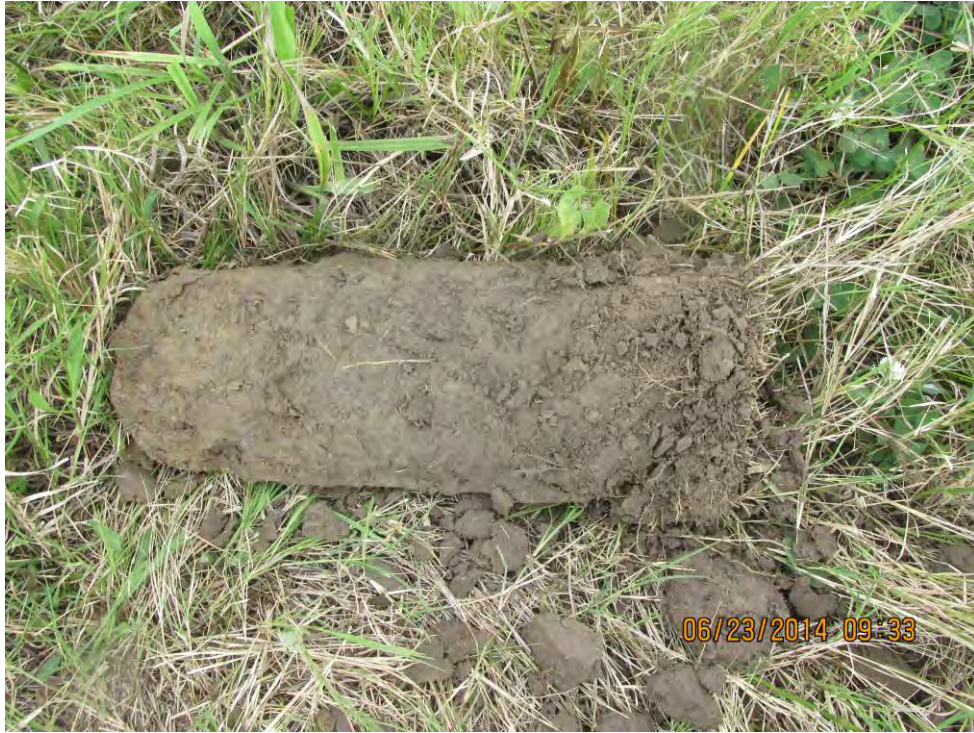
The soils within this sample plot are mapped as Convent silt loam. This series is listed on the National and the Louisiana Hydric Soils lists. Field investigations determined that the soils exhibited hydric soil indicators for a depleted matrix. Primary and secondary indicators of wetland hydrology were lacking from this sample plot. The wetland hydrology criterion is not met at this plot. It is GEC's opinion that this sample plot is not within a wetland, based on the lack of hydrophytic vegetation and wetland hydrology (see Data Form Plot - 1).

Depth (inches)	Matrix		Redox Features				Texture	Remarks
	Color (moist)	%	Color (moist)	%	Type ¹	Loc ²		
0-2	10YR 3/3	100			N/A	N/A	Silty Clay	
2-10	10YR 4/2	99	10YR 3/6	1	C	M	Silty Clay	
10-18+	10YR 4/2	97	10YR 4/6	2	C	M	Clay	
			10yr 5/1	1	D	M	Clay

Photograph 1. Soil Profile Observed at Plot 1

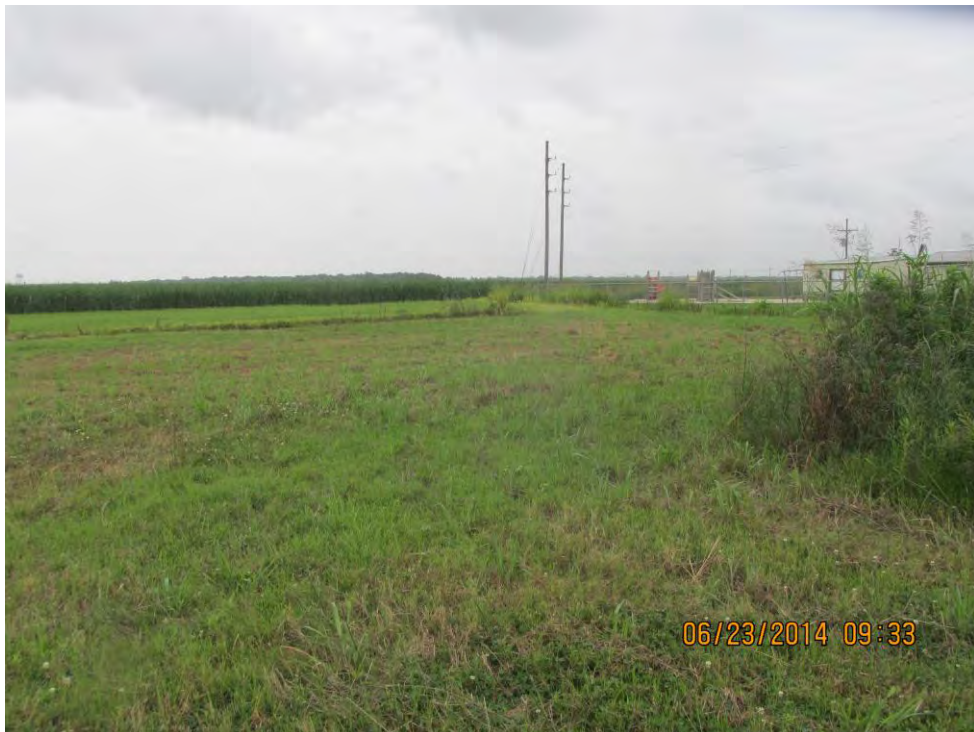
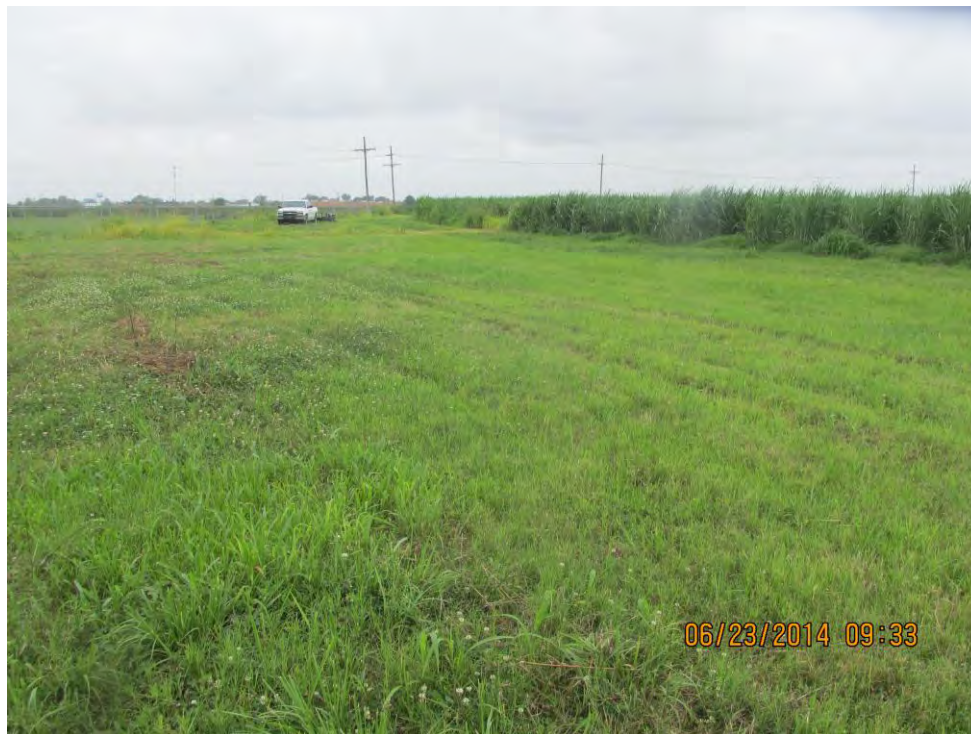
Sample Plot - 1: Sample Plot 1 is located within the northern portion of the property in a maintained field situated adjacent to the agriculture fields (Figure 3). The dominant herbaceous species observed within this sample plot is Common Bermuda grass (*Cynodon dactylon*). Other herbaceous vegetation recorded within the plot included white clover (*Trifolium repens*), Johnson grass (*Sorghum halepense*), Brazilian vervain (*Verbena brasiliensis*), and common morning-glory (*Ipomoea purpurea*), but with less abundance. The hydrophytic vegetation criterion is not met within this sample plot.

**Photograph 2. Overview of Habitat Observed at Plot 1,
Facing East**

**Photograph 3. Overview of Habitat Observed at Plot 1,
Facing Northwest**

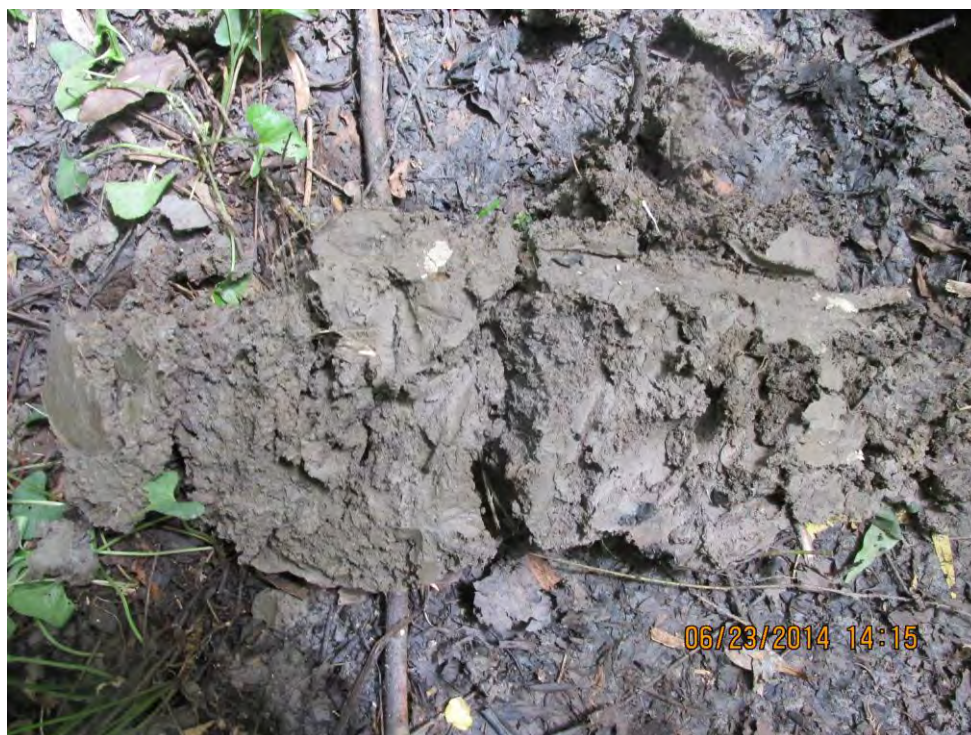
The soils within this sample plot are mapped as Sharkey clay. This series is listed on the National and the Louisiana Hydric Soils lists. Field observations concluded that the hydric soils criterion is met within this plot based on the presence of hydric soil indicators for a depleted matrix. Primary indicators of hydrology recorded at this sample plot include water marks (B1) and water-stained leaves (B9). The only secondary indicator recorded was a positive

Depth (inches)	Matrix		Redox Features				Texture	Remarks
	Color (moist)	%	Color (moist)	%	Type ¹	Loc ²		
0-8	10YR 4/1	96	10YR 3/6	4	C	M	Clay	
8-18+	10YR 4/1	90	10YR 4/6	5	C	M	Clay	
			10YR 5/1	5	D	M	Clay

Photograph 4. Soil Profile Observed at Plot 2

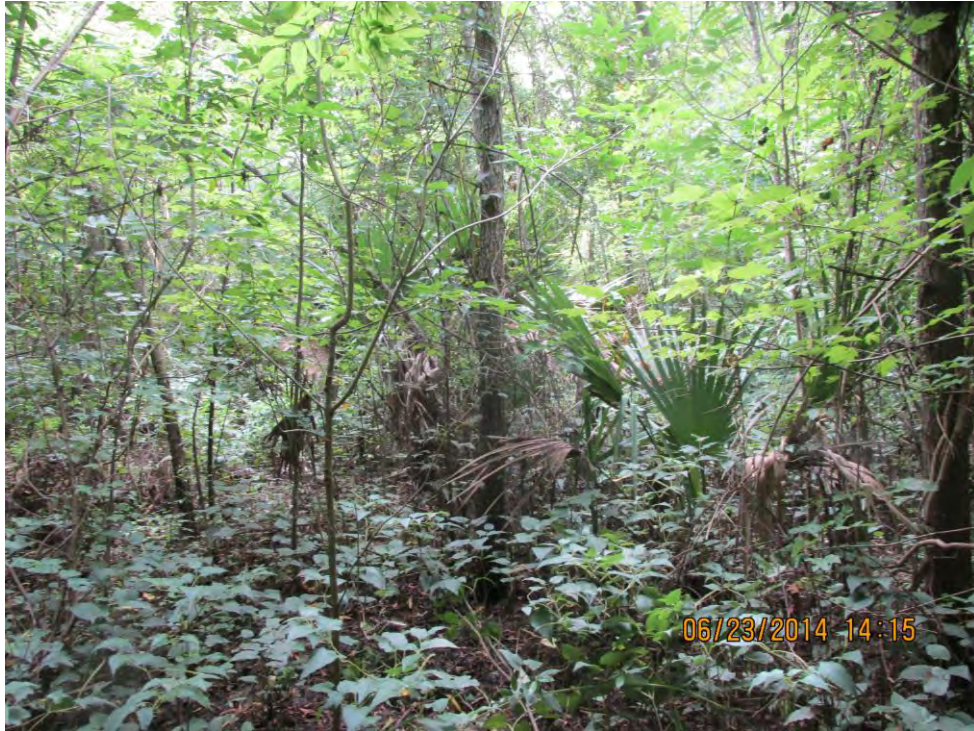
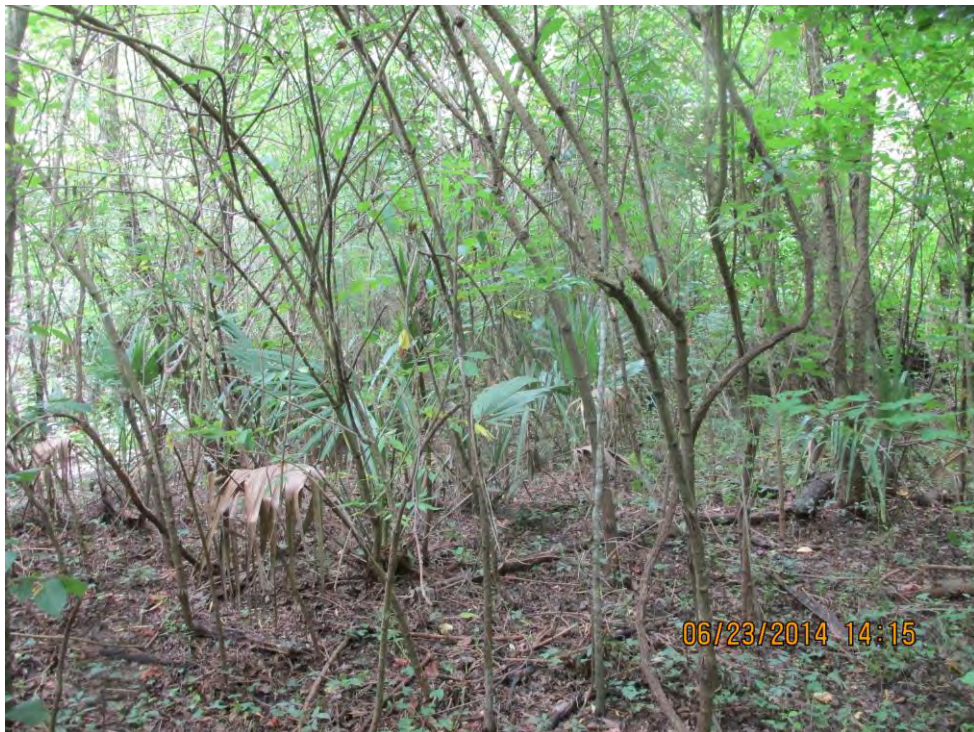
Sample Plot - 2: Sample Plot 2 is located in the very southern portion of the property within a hardwood forest. This habitat consists of black willow (*Salix nigra*) and sugarberry (*Celtis laevigata*) as the dominant tree species with some scattered American elms (*Ulmus americana*). The sapling/shrub stratum is dominated by black will and American elder (*Sambucus canadensis*) with less abundant occurrences of box elder (*Acer negundo*), Drummond red maple (*Acer rubrum* var. *drummondii*), laurel oak (*Quercus laurifolia*), dwarf palmetto (*Sabal minor*), **and American elm. Dominant herbaceous species include lizard's tail (*Saururus cernuus*), and bayou violet (*Viola langloisi*).** The woody vine stratum consists of dominants such as poison ivy (*Toxicodendron radicans*), Virginia creeper (*Parthenocissus quinquefolia*), and trumpet creeper (*Campsis radicans*). Scattered occurrences of Louisiana blackberry (*Rubus louisianus*) were also observed and recorded within this sample plot. The hydrophytic vegetation criterion is met within this sample plot.

**Photograph 5. Overview of Habitat Observed at Plot 2,
Facing West**

**Photograph 6. Overview of Habitat Observed at Plot 2,
Facing North**

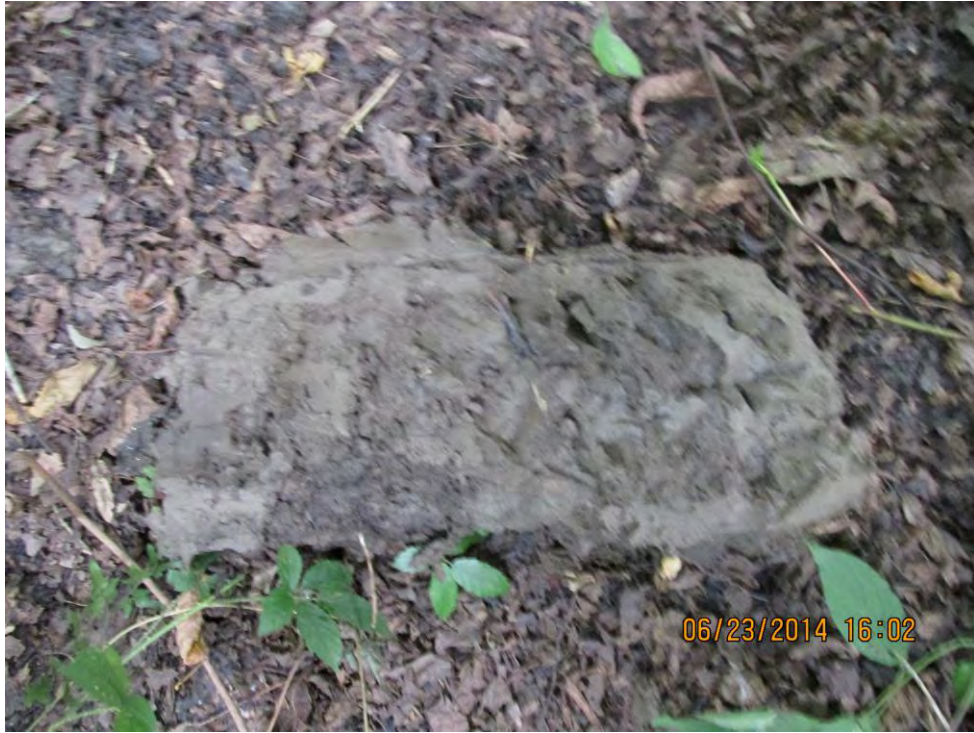
The soils within this sample plot are mapped as Sharkey clay. This series is listed on the National and the Louisiana Hydric Soils lists. Field observations concluded that the hydric soils criterion is met within this plot based on the presence of hydric soil indicators for a depleted matrix. Primary hydrology indicators included water-stained leaves only. However, crayfish burrows (C8), Saturation visible on aerial photography (C9), geomorphic position (D2), and a positive FAC-Neutral test (D5) were all secondary indicators of hydrology recorded at the sample plot. It is GEC's opinion that this sample plot is within a wetland, based on the presence of hydrophytic vegetation, hydric soils and wetland hydrology within the plot (see Data Form Plot - 3).

Depth (inches)	Matrix		Redox Features				Texture	Remarks
	Color (moist)	%	Color (moist)	%	Type ¹	Loc ²		
0-4	10YR 3/1	100			N/A	N/A	Clay	
4-10	10YR 4/1	100			N/A	N/A	Clay	
10-18+	10YR 4/1	95	10YR 4/6	5	C	M	Clay

Photograph 7. Soil Profile Observed at Plot 3

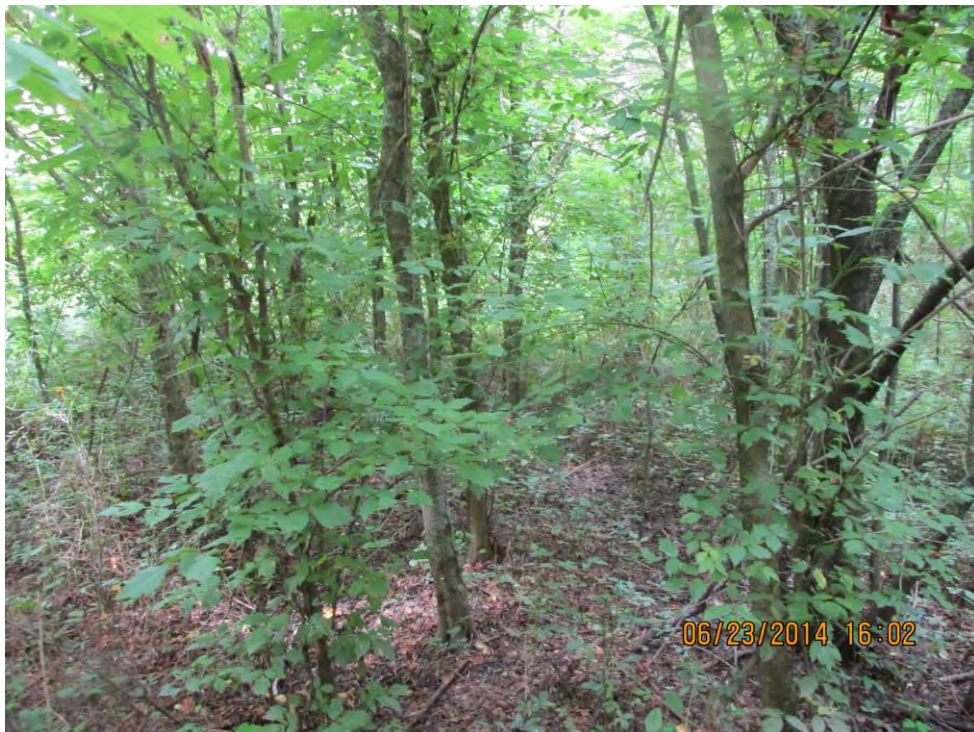
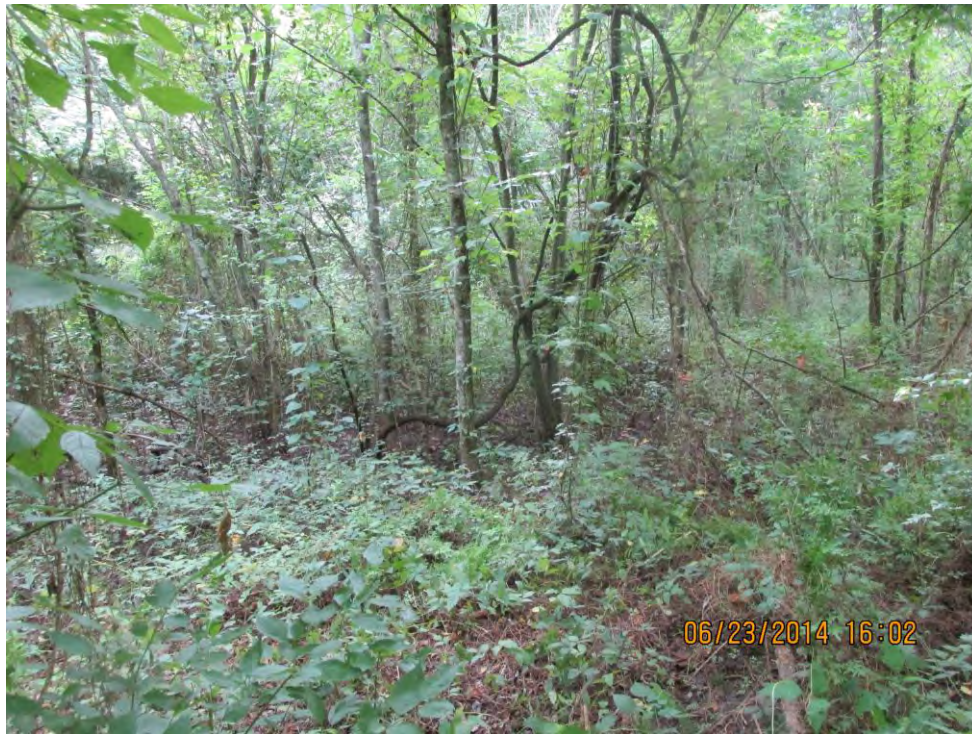
Sample Plot - 3: Sample Plot 3 is also located within the southern portion of the property in a young (8-10 year old) forested habitat. This habitat is dominated by box elder in the sapling/shrub stratum with less abundant occurrences of stiff dogwood (*Cornus foemina*), American elm, sugarberry, and American elder. The herbaceous stratum consists of poison ivy and Japanese climbing fern (*Lygodium japonicaum*) as the dominants with scattered occurrences of small-spike false nettle (*Boehmeria cylindrica*) and Carolina coral-beads (*Cocculus carolinus*). The dominant woody vines are trumpet creeper, poison ivy, and Virginia creeper. The hydrophytic vegetation criterion is met within this sample plot.

**Photograph 8. Overview of Habitat Observed at Plot 3,
Facing North**

**Photograph 9. Overview of Habitat Observed at Plot 3,
Facing South**

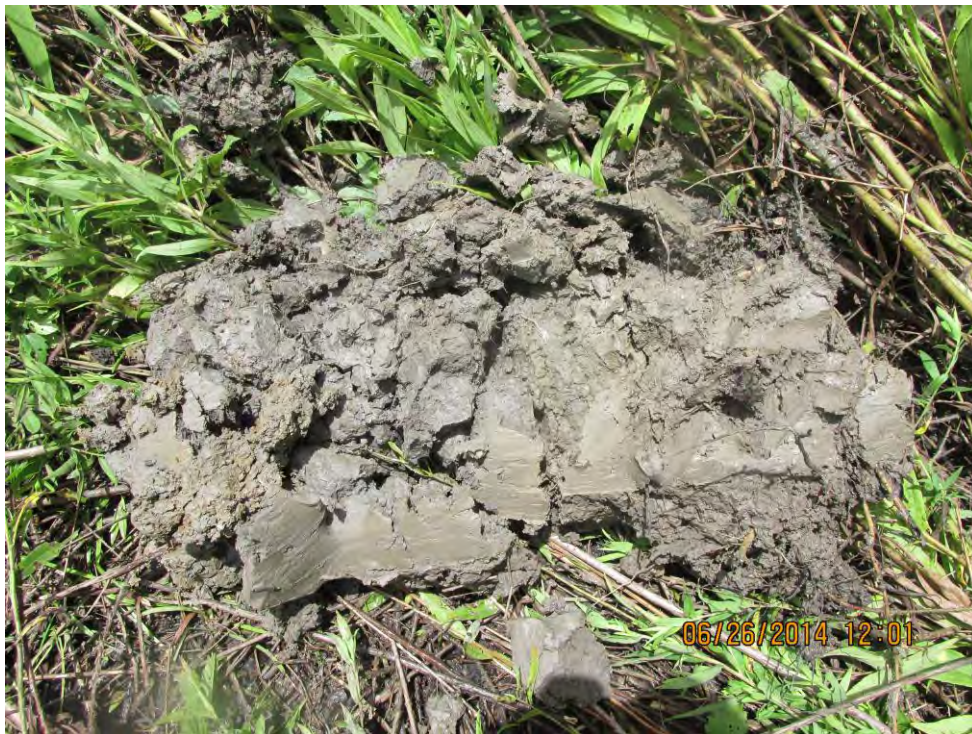
The soils within this sample plot are mapped as Sharkey clay. This series is listed on the National and the Louisiana Hydric Soils lists. Field observations concluded that the hydric soils criterion is met within this plot based on the presence of hydric soil indicators for a depleted matrix. Primary hydrology indicators include surface water (A1), high water table (A2), saturation (A3), and water-stained leaves (B9). The surface water was approximately one inch in depth, which was possibly attributed to a thunderstorm the previous afternoon. The water table was at 12 inches and the saturation was within the top two inches of the surface. In addition, crayfish burrow (C8), geomorphic position (D2), and a positive FAC-Neutral test were observed and recorded as secondary hydrology indicators within the plot. The wetland hydrology criterion is met at this plot. It is GEC's opinion that this sample plot is within a wetland, based on the presence of hydrophytic vegetation, hydric soils and wetland hydrology indicators within the plot (see Data Form Plot - 4).

Depth (inches)	Matrix		Redox Features				Texture	Remarks
	Color (moist)	%	Color (moist)	%	Type ¹	Loc ²		
0-3	10YR 4/1	100			N/A	N/A	Clay	
3-6	10YR 4/1	96	10YR 3/3	4	C	M	Clay	
6-18+	10YR 4/1	95	7.5YR 4/6	5	C	M	Clay

Photograph 10. Soil Profile Observed at Plot 4

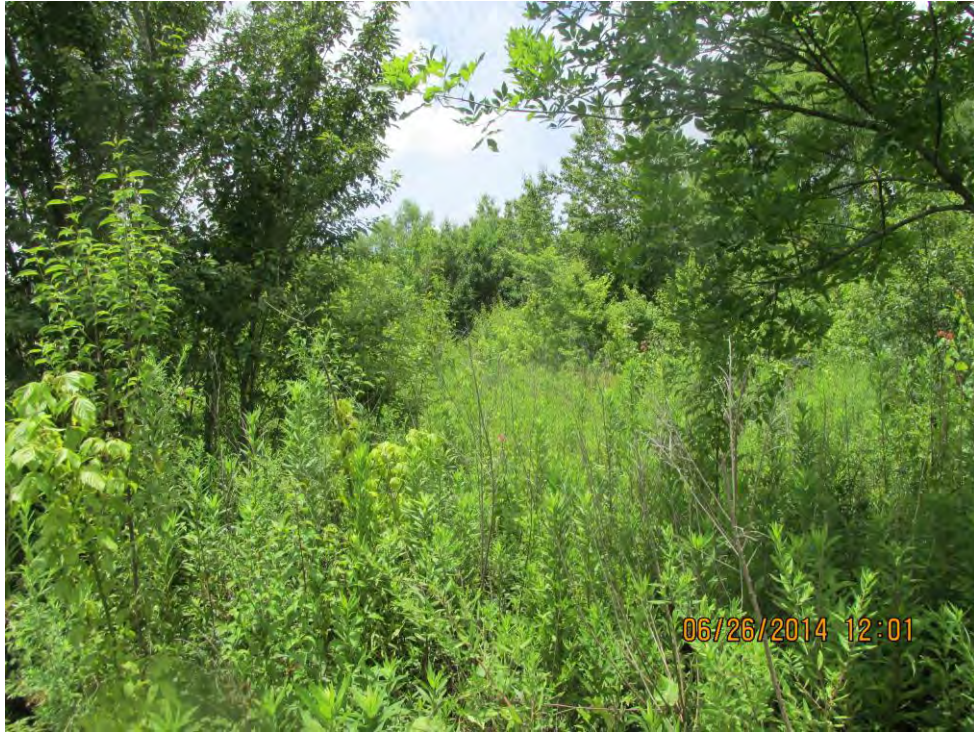
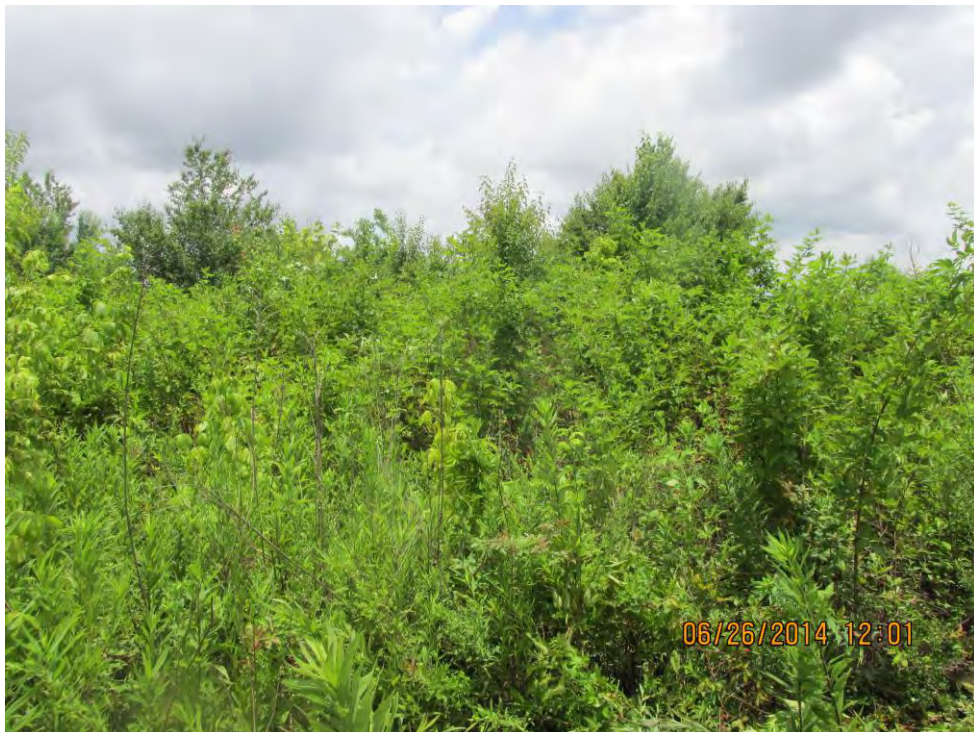
Sample Plot - 4: Sample Plot 4 is located within a abandon agriculture field which contains scattered sapling species. The dominant sapling/shrub species include stiff dogwood and box-elder. Other less abundant sapling/shrub species include green ash (*Fraxinus pennsylvanica*), Drummond red maple, and American elm. Dominant herbaceous vegetation within this habitat includes Canada goldenrod and calico aster (*Symphyotrichum lateriflorum*). Saltmarsh loosestrife (*Lythrum lineare*) was also recorded within the plot but less abundant. Southern dewberry (*Rubus trivialis*) and peppervine (*Ampelopsis arborea*) are the dominant woody vine species at the plot with scattered occurrences of serrate-leaf blackberry (*Rubus agutus*). The hydrophytic vegetation criterion is met within this sample plot.

**Photograph 11. Overview of Habitat Observed at Plot 4,
Facing Southwest**

**Photograph 12. Overview of Habitat Observed at Plot 4,
Facing North**

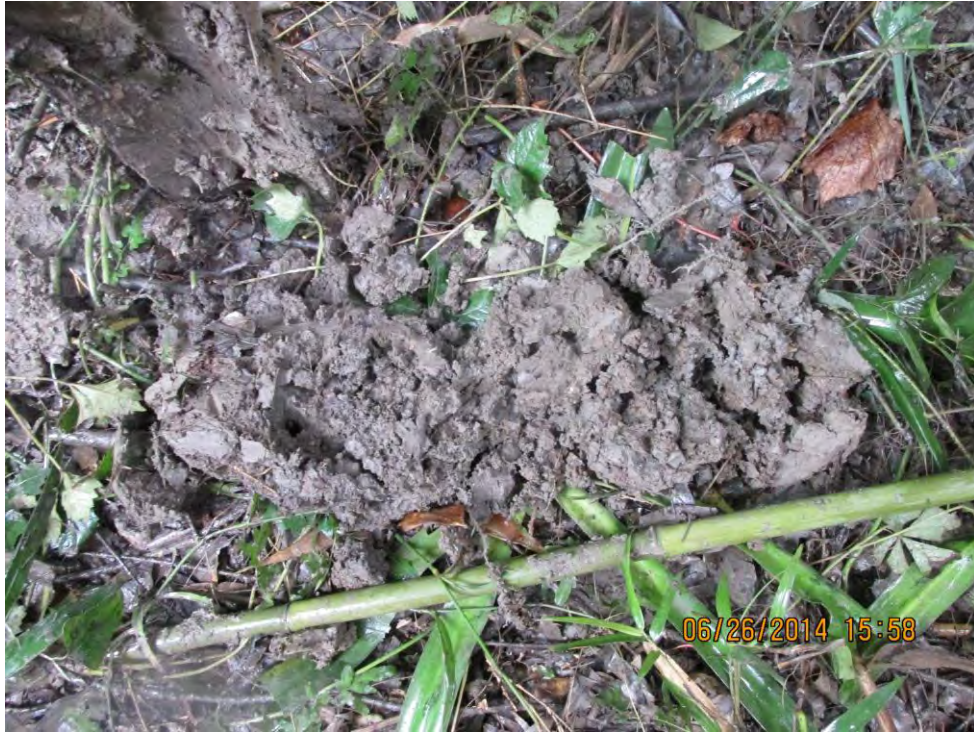
The soils within this sample plot are mapped as Sharkey clay. This series is listed on the National and the Louisiana Hydric Soils lists. Field observations concluded that the hydric soils criterion is met within this plot based on the presence of hydric soil indicators for a depleted matrix. Primary wetland hydrology indicators include surface water (A1), high water table (A2), saturation (A3), water marks (B1), drift deposits (B3), and water-stained leaves (B9). Secondary wetland hydrology indicators observed and recorded were crayfish burrows (C8), geomorphic position (D2), and a positive FAC-Neutral test (D9). The wetland hydrology criterion is met at this plot. It is GEC's opinion that this sample plot is within a wetland, based on the presence of hydrophytic vegetation, hydric soils and wetland hydrology within the plot (see Data Form Plot - 5).

Depth (inches)	Matrix		Redox Features				Texture	Remarks
	Color (moist)	%	Color (moist)	%	Type ¹	Loc ²		
0-3	10YR 3/2	98	10YR 5/8	2	C	M	Clay	
3-7	10YR 4/1	100			N/A	N/A	Clay	
7-18+	10YR 4/1	95	10YR 5/8	2	C	M	Clay	
			10YR 4/6	3	C	M	Clay

Photograph 13. Soil Profile Observed at Plot 5

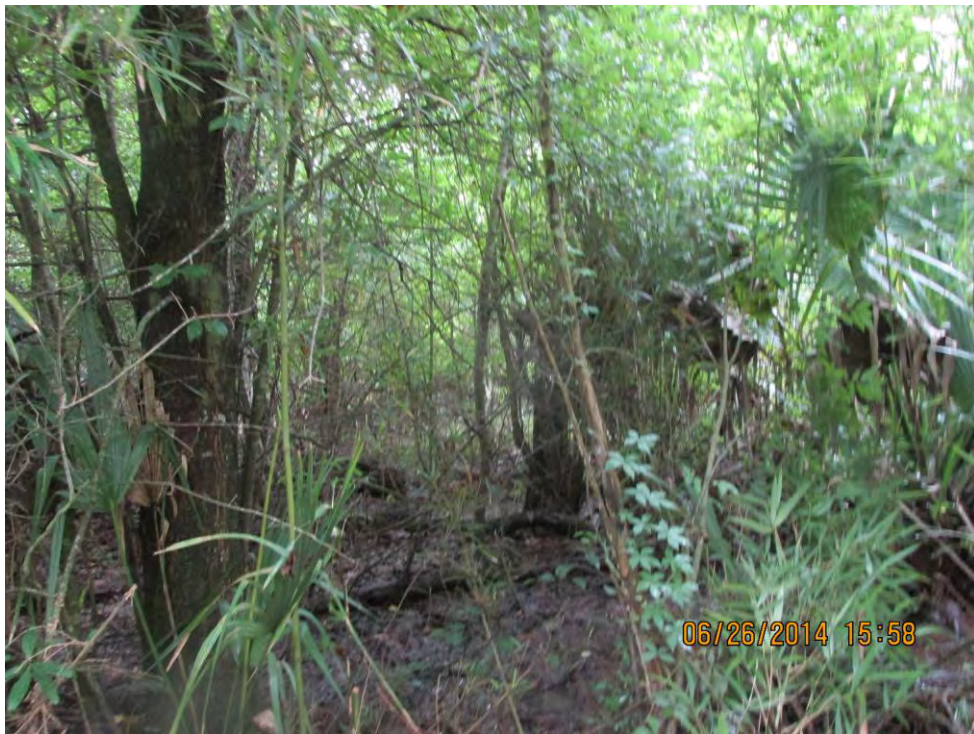
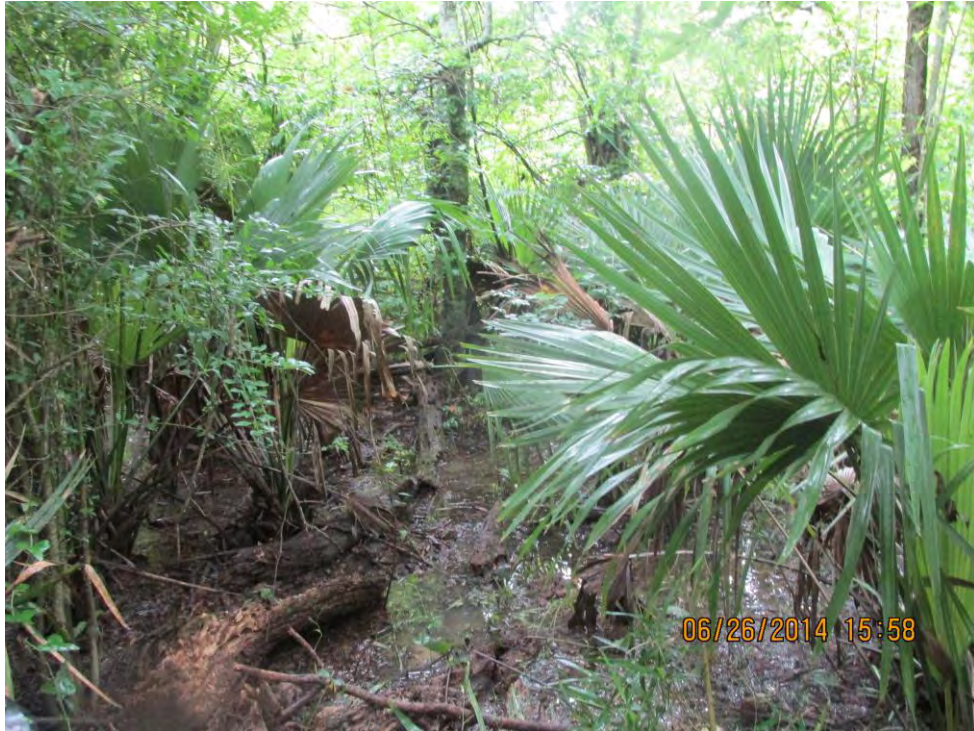
Sample Plot - 5: Sample Plot 5 is located in the far southeast tract of the property along the east side of LA Highway 70 within a forested habitat (Figure 3). This habitat is dominated by sugarberry, laurel oak, box elder, and Drummond red maple. Dominant species within the

**Photograph 14. Overview of Habitat Observed at Plot 5,
Facing South**

**Photograph 15. Overview of Habitat Observed at Plot 5,
Facing West**

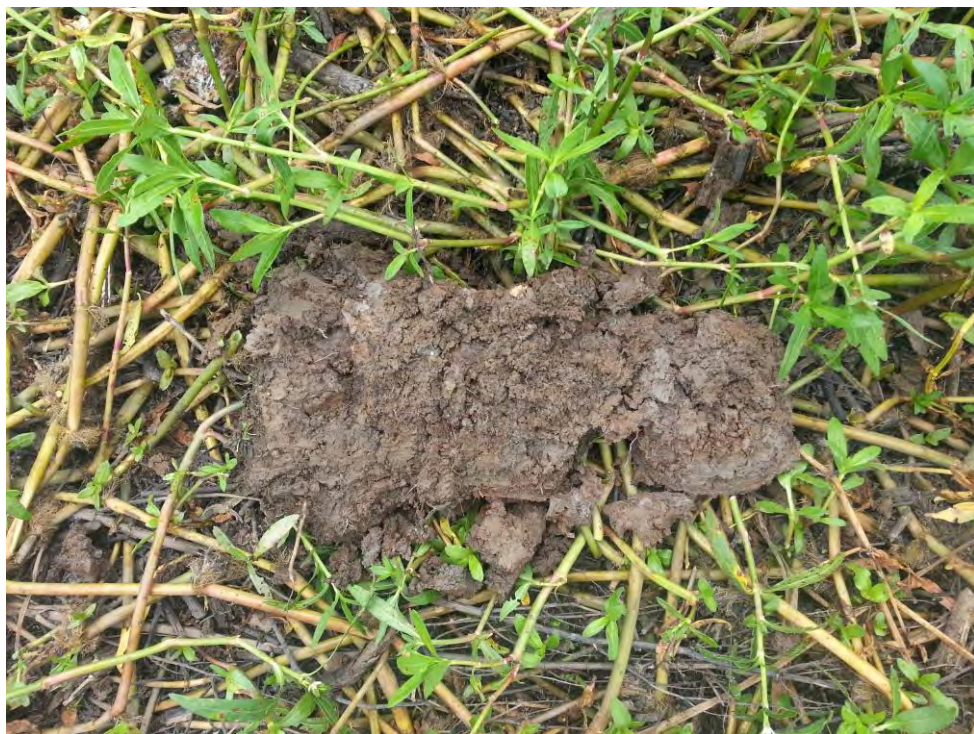
The soil series mapped at this plot is the Convent soils, frequently flooded. This series is listed on the National and the Louisiana Hydric Soils lists. Field observations concluded that the hydric soils criterion is met within this plot based on the presence of hydric soil indicators for a depleted matrix. Primary wetland hydrology indicators include water marks (B1), sediment deposits (B2), drift deposits (B3), inundation visible on aerial imagery (B7), water-stained leaves (B9) and oxidized rhizospheres on living roots (C3). The secondary wetland hydrology indicators observed and recorded were a positive FAC-Neutral test (D5) and geomorphic position (D2). The wetland hydrology criterion is met at this plot. It is GEC's opinion that this sample plot is within a wetland, based on the presence of hydrophytic vegetation, hydric soils and wetland hydrology within the plot (see Data Form Plot - 6).

Depth (inches)	Matrix		Redox Features				Texture	Remarks
	Color (moist)	%	Color (moist)	%	Type ¹	Loc ²		
0-10	10YR 4/2	90	10YR 3/4	10	C	M	Clay	
10-18+	10YR 4/2	85	10YR 3/4	10	C	M	Clay	
			5YR 4/6	5	C	M	Clay

Photograph 16. Soil Profile Observed at Plot 6

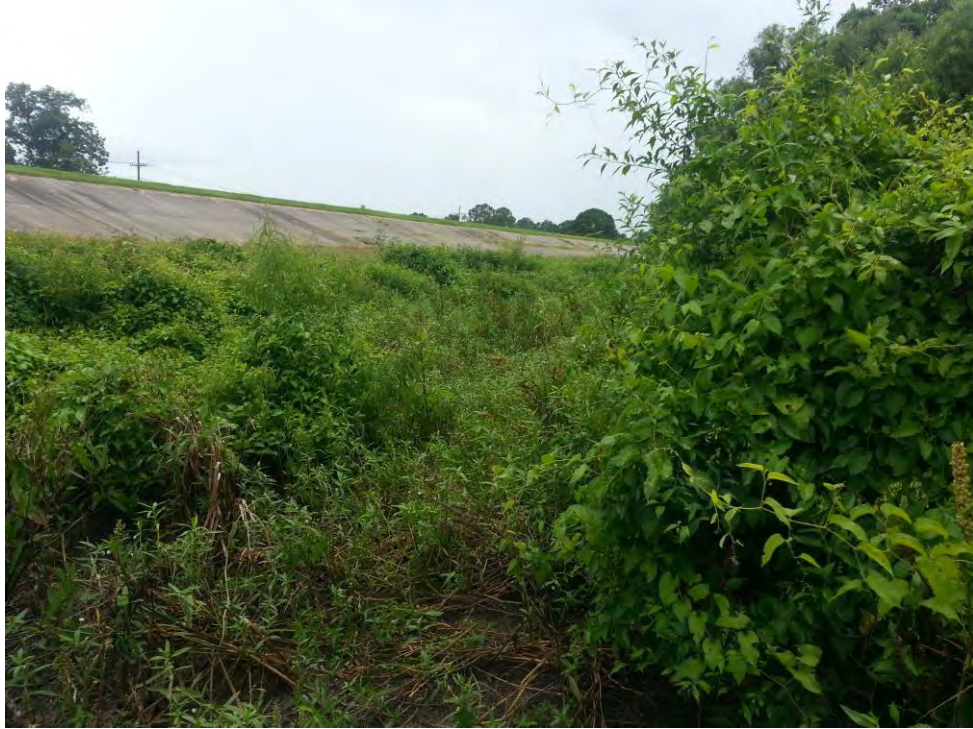
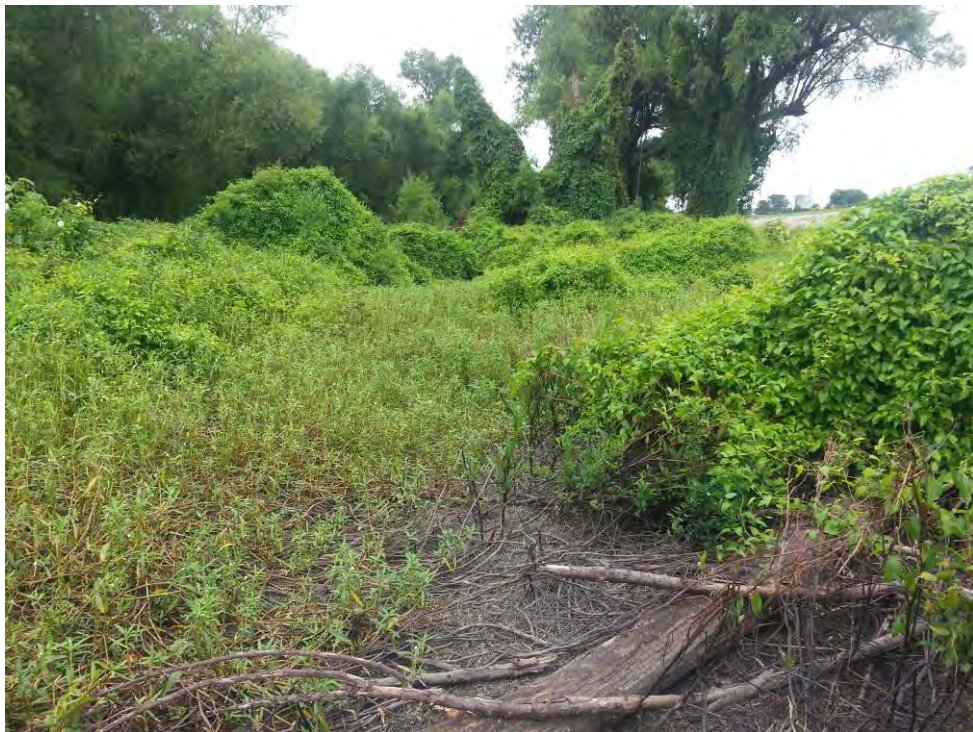
Sample Plot - 6: Sample Plot 6 is located within the batture land between the protective levee and the Mississippi River. The plot was located within an herbaceous habitat along the toe of the levee. This habitat has scattered occurrences of black willow and eastern swamp privet (*Foresteria acuminata*) as the dominant sapling/shrub species. The herbaceous stratum was dominated by alligator weed (*Alternanthera philoxeroides*) with scattered patches of swamp dock (*Rumex verticillatus*). The dominant woody vine is redvine (*Brunnichia cirrhosa*). Adjacent to the river the batture land was forested with black willow, eastern cottonwood (*Populus deltoides*), sugarberry, American sycamore (*Platanus occidentalis*), and pecan hickory (*Carya illinoensis*). The hydrophytic vegetation criterion is met within this sample plot.

**Photograph 17. Overview of Habitat Observed at Plot 6,
Facing West**

**Photograph 18. Overview of Habitat Observed at Plot 6,
Facing East**

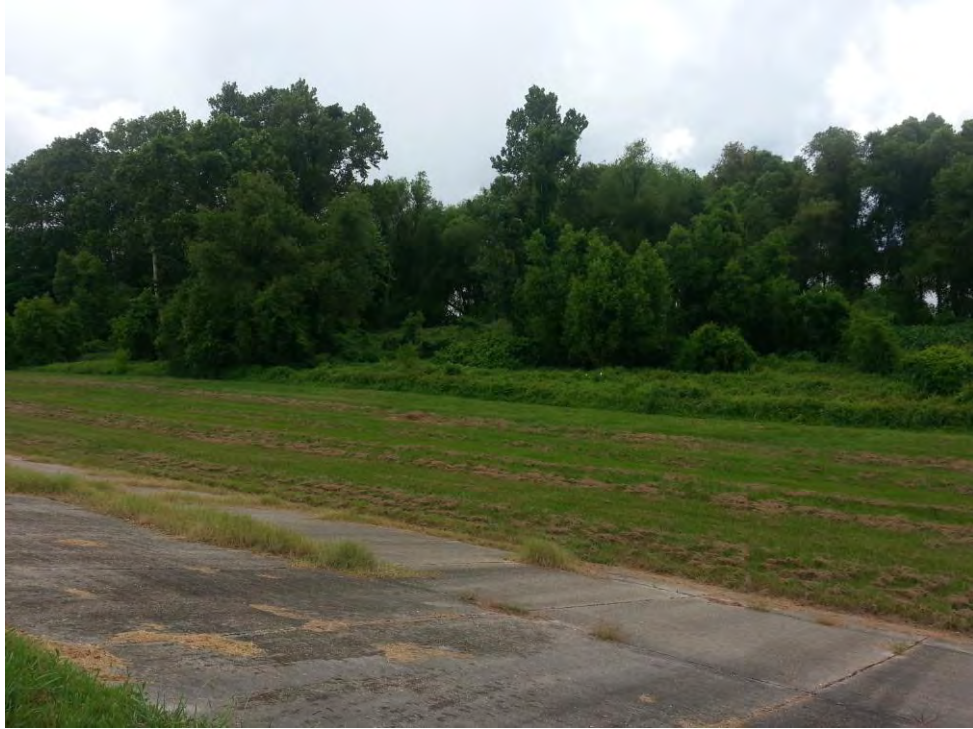
Photograph 19. Overview of Habitat Observed in Batture, Facing West

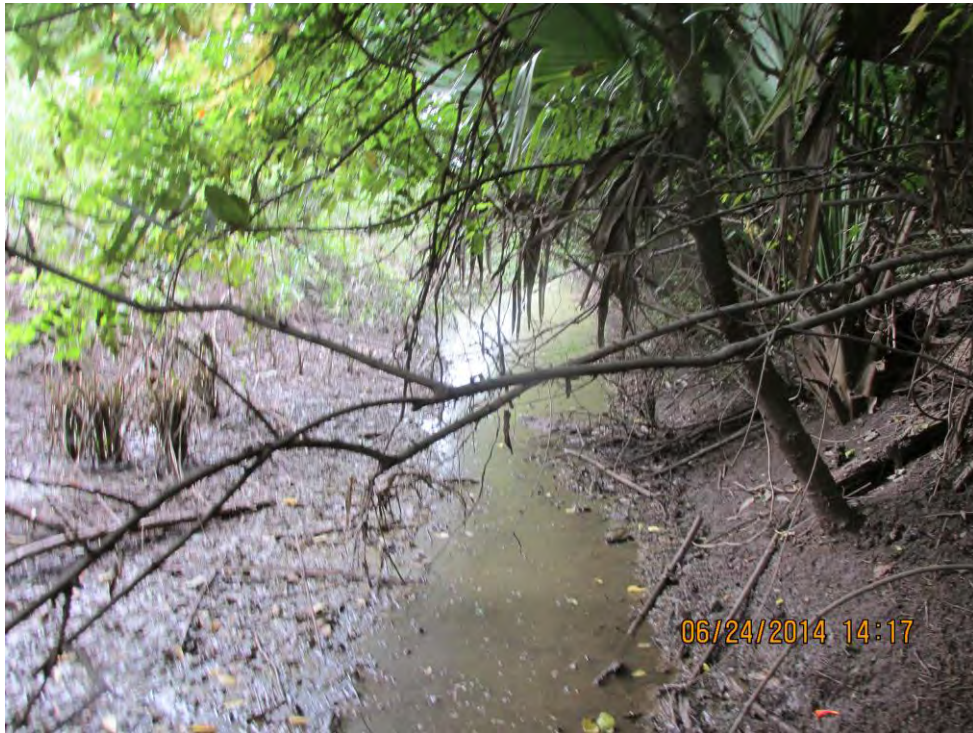
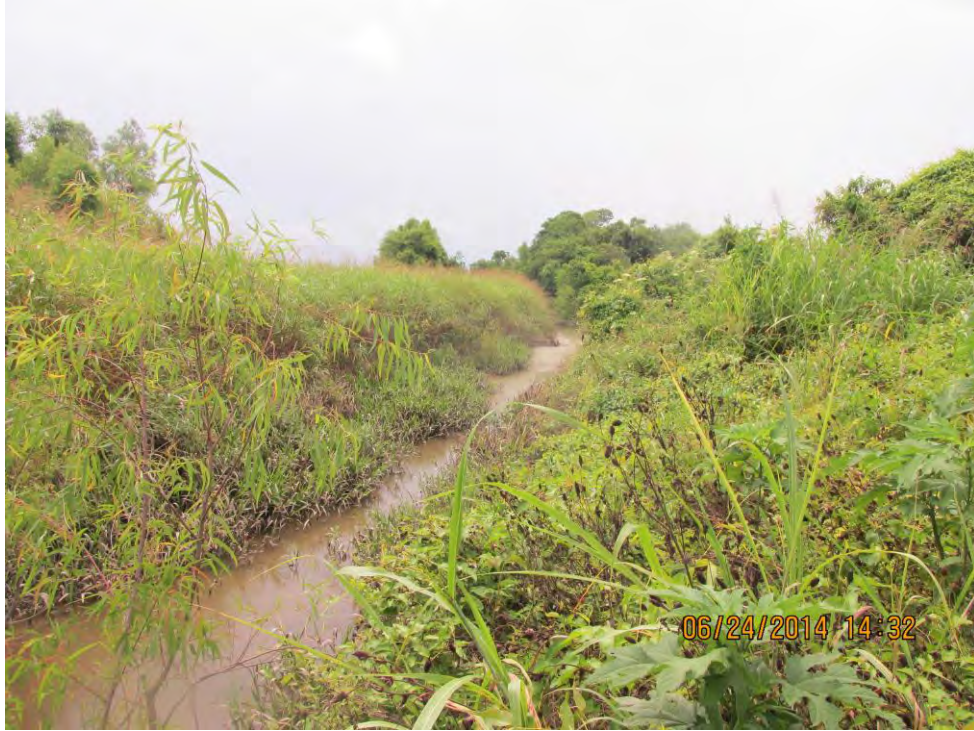
Photograph 20. Large Drainage Canal Along the Southern Boundary of the Property, Facing Upstream from Midpoint of Boundary

Photograph 21. Large Drainage Canal Along the Southern Boundary of Property at West End, Facing Northwest (upstream)

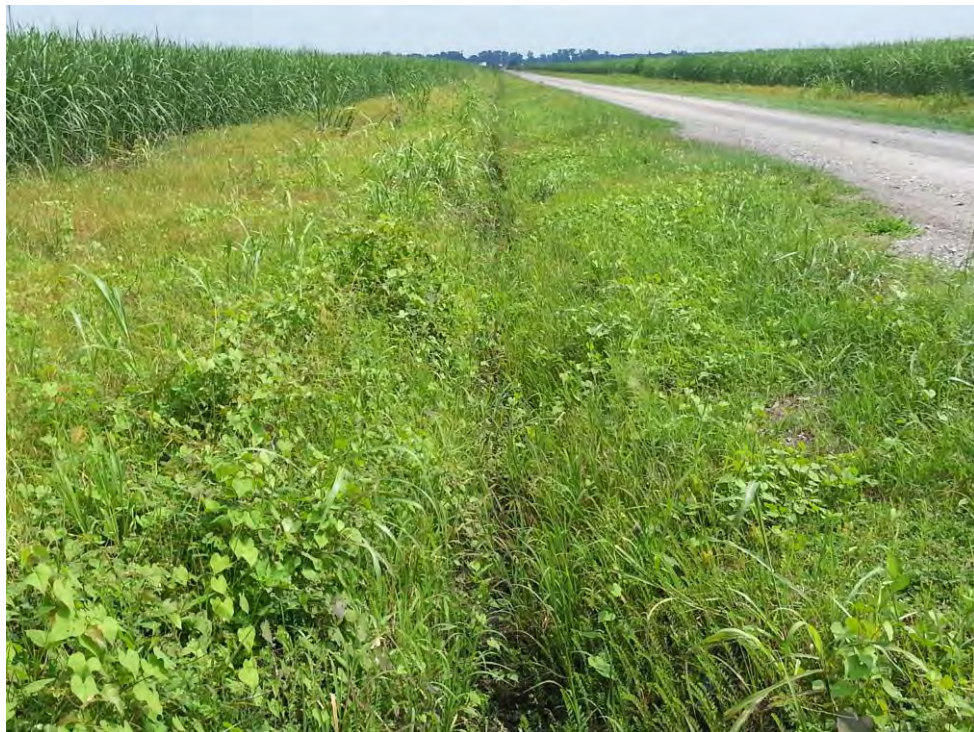
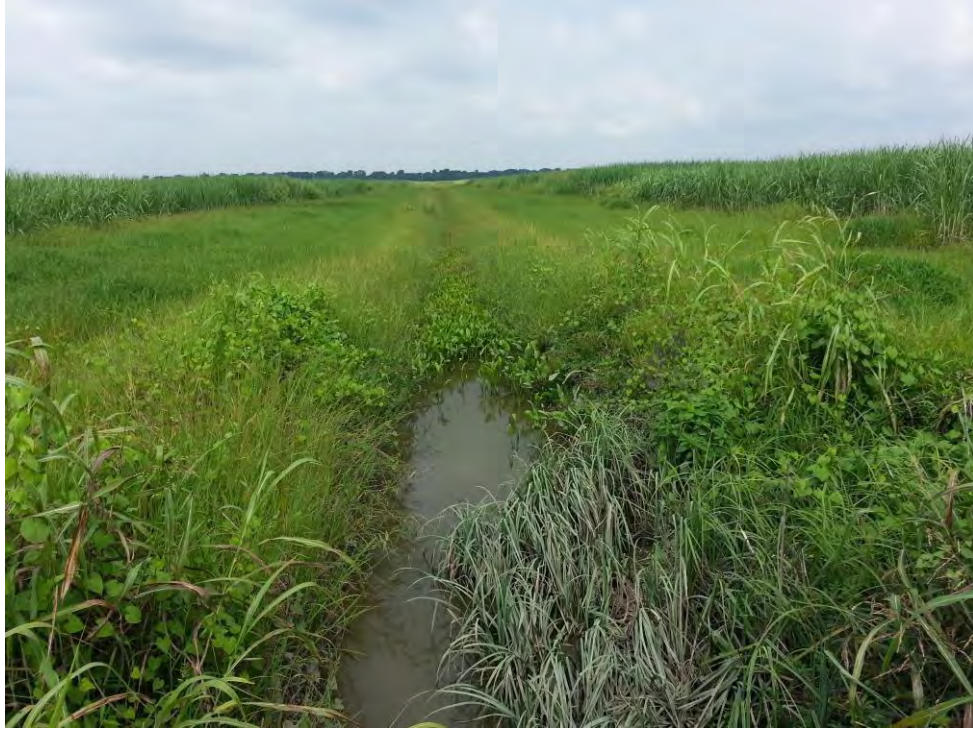
fields were mapped as non-wetland habitat for this delineation. Numerous agriculture drainage ditches traverse the property and have been mapped as other waters, which encompass 3.11 acres.

Photograph 22. Typical Agriculture Drainage Ditch within the Agriculture Fields North of LA Highway 3089

Photograph 23. Typical Agriculture Drainage Ditch within the Agriculture Fields South of LA Highway 3089
