**Exhibit CC. NRG Industrial Park
Jurisdictional Determination & Wetlands
Delineation Report**

WETLAND DELINEATION MAP
NRG Industrial Park Wetland Delineation
Pointe Coupee Parish

**WETLAND DELINEATION REPORT
NRG NEW ROADS HOLDINGS LLC
635 – ACRE TRACT
POINTE COUPEE PARISH,
VENTRESS, LOUISIANA**

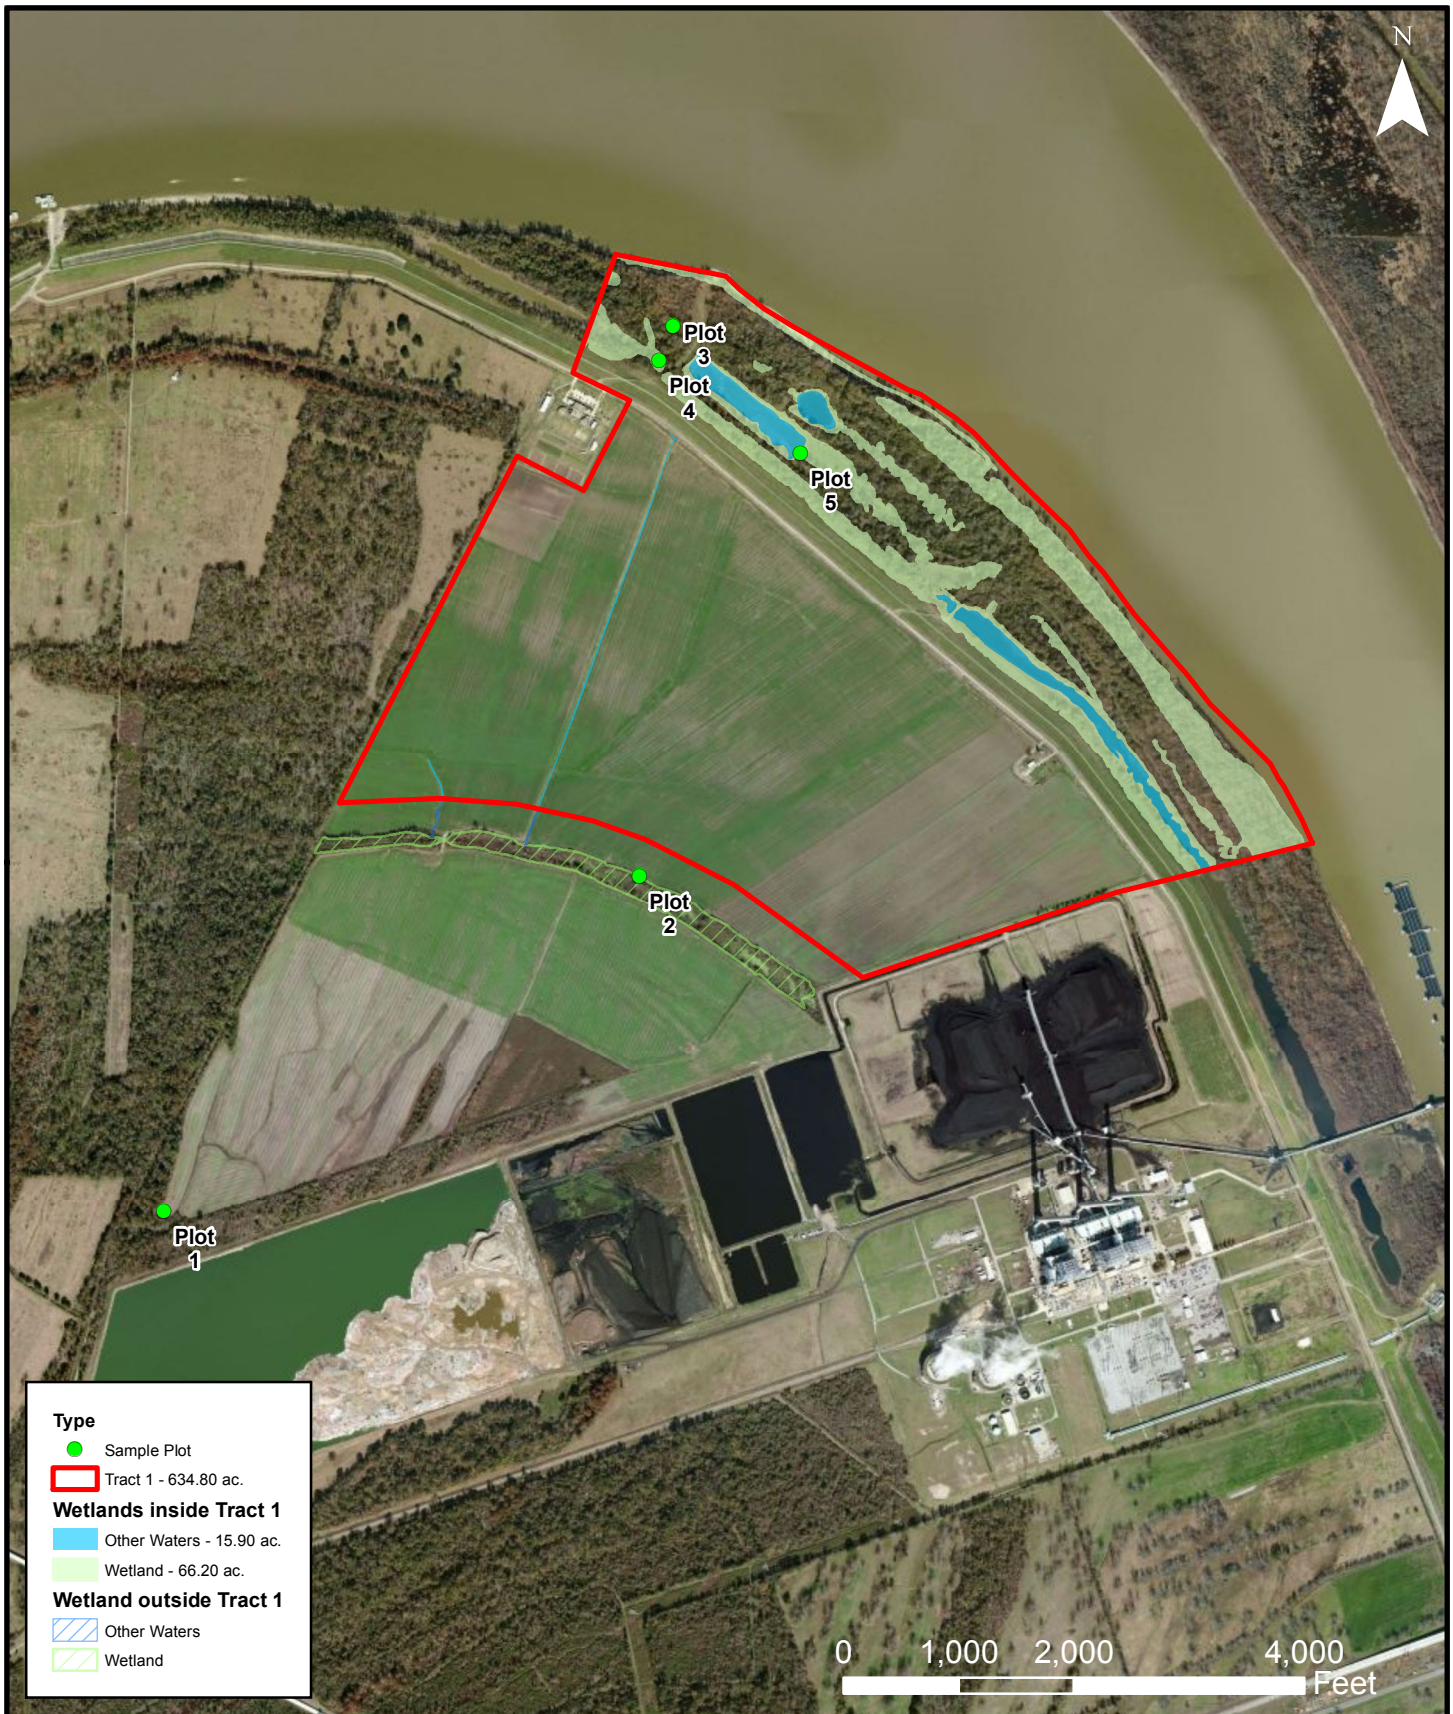
Figure: 3

WETLAND DELINEATION MAP

Routine Wetland Delineation Data Forms (Appendix A), as approved by Headquarters, U.S. Army Corps of Engineers (USACE) 10/08, were completed for various vegetative communities encountered within the project area. These data forms contain sufficient information regarding the presence or absence of hydric soils, hydrophytic vegetation, and wetland hydrology, to support the demarcation of a wetland boundary. The location of each sample plot along with mapped wetlands and other waters are shown in Figure 3.

Sample Plot - 4: Sample Plot four is located in a mature BLH (Figure 3) on the edge of a swale on the batture side of the levee. The tree stratum is dominated by black willow (*Salix nigra*), and ash leaf maple while the sapling/shrub stratum is dominated by sugarberry. Butterweed (*Packera glabella*), and coastal plain aster dominate the herbaceous stratum while pepper vine, frost grape, and eastern poison ivy dominates the woody vine stratum. The hydrophytic vegetation criterion is met within this sample plot.

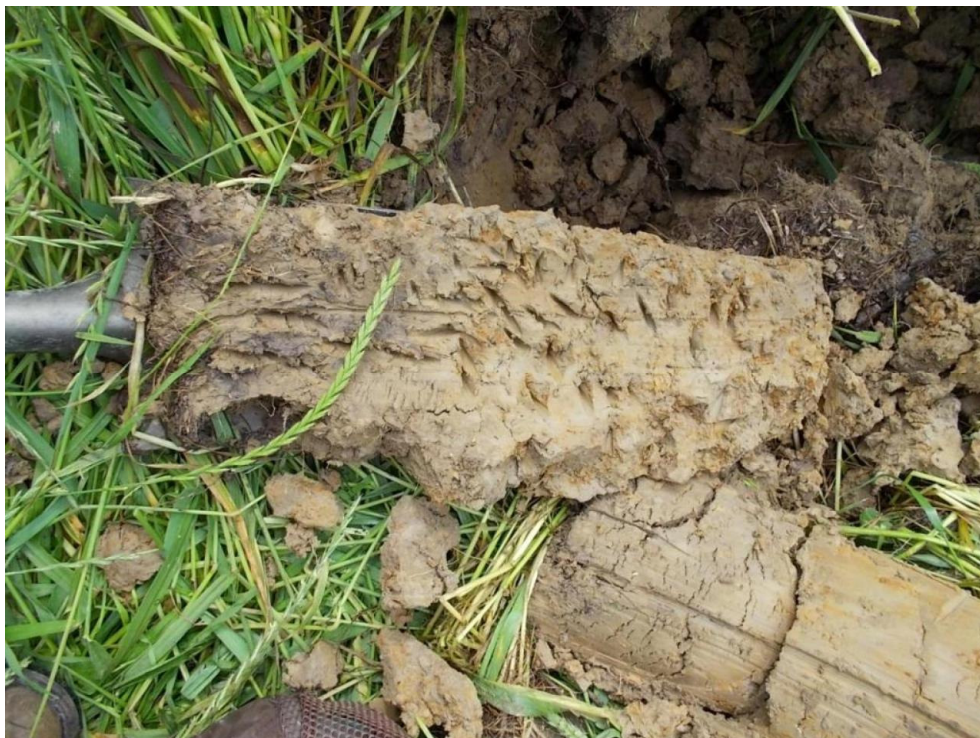
Photograph 1. Soil Profile Observed at Plot 1

The soil series mapped at this plot is the Commerce silt loam. This series is listed on the National Hydric Soils list as well as the Louisiana Hydric Soils list. The soil profile observed did not closely resemble the typical pedon described by the NRCS. Field investigation identified the soil profile as non-hydric in nature. The hydric soils criterion is not met at this plot. Primary indicators of hydrology as well as secondary indicators of hydrology were lacking within this plot. It is GEC's opinion that this sample plot is not within a wetland, based on the lack of hydric vegetation, hydric soils, and wetland hydrology within the plot (see Data Form Plot - 1).

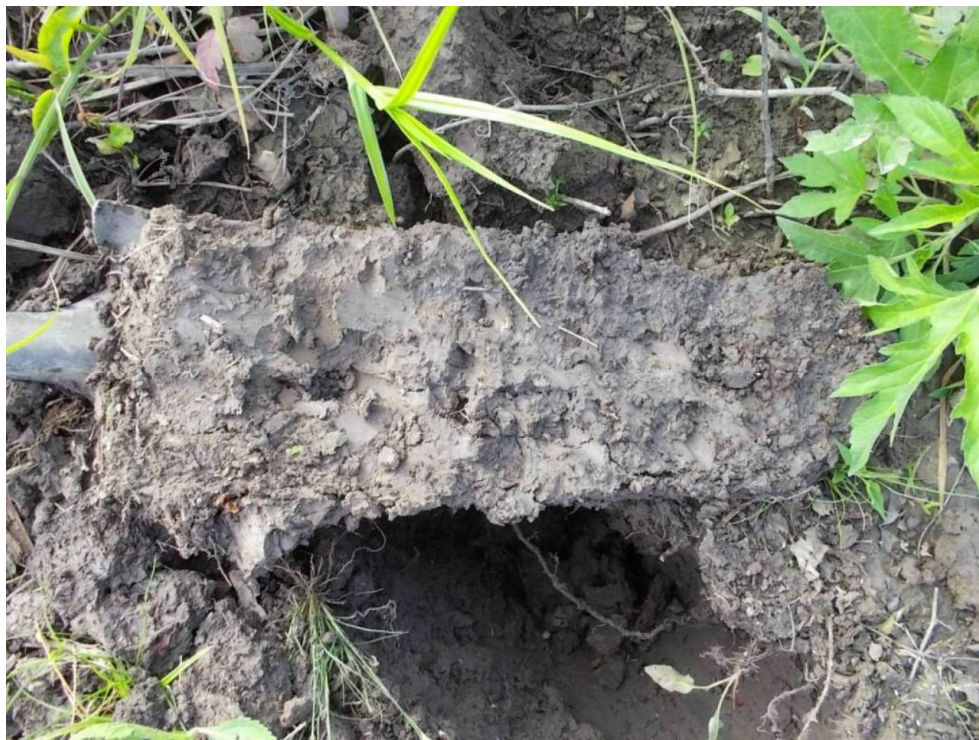
Photograph 5. Soil Profile Observed at Plot 2

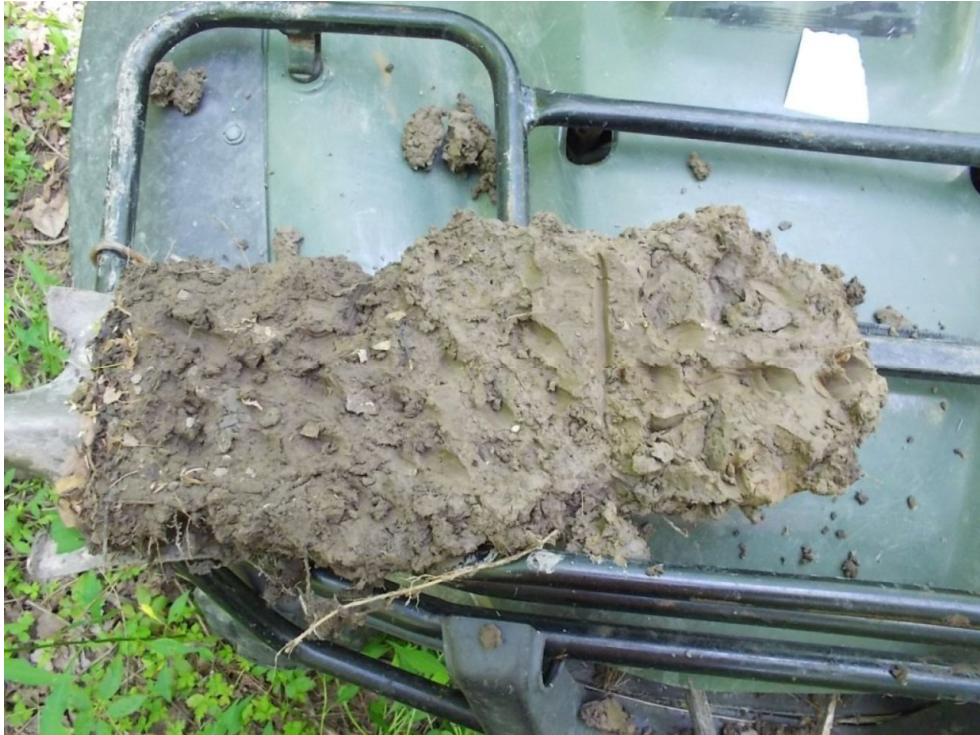
Photograph 9. Soil Profile Observed at Plot 3

The soil series mapped at this plot is the Robinsonville and Commerce soil. Both of these series are listed on the National and Louisiana Hydric Soils lists. Field investigations concluded that the hydric soils criterion is met within this plot. Primary indicators of wetland hydrology are lacking within this plot while secondary indicators include a positive FAC neutral test. The hydrology criterion is not met at this plot. It is GEC's opinion that this sample plot is not within a wetland, based on the lack of wetland hydrology indicators found within the plot (see Data Form Plot - 3).

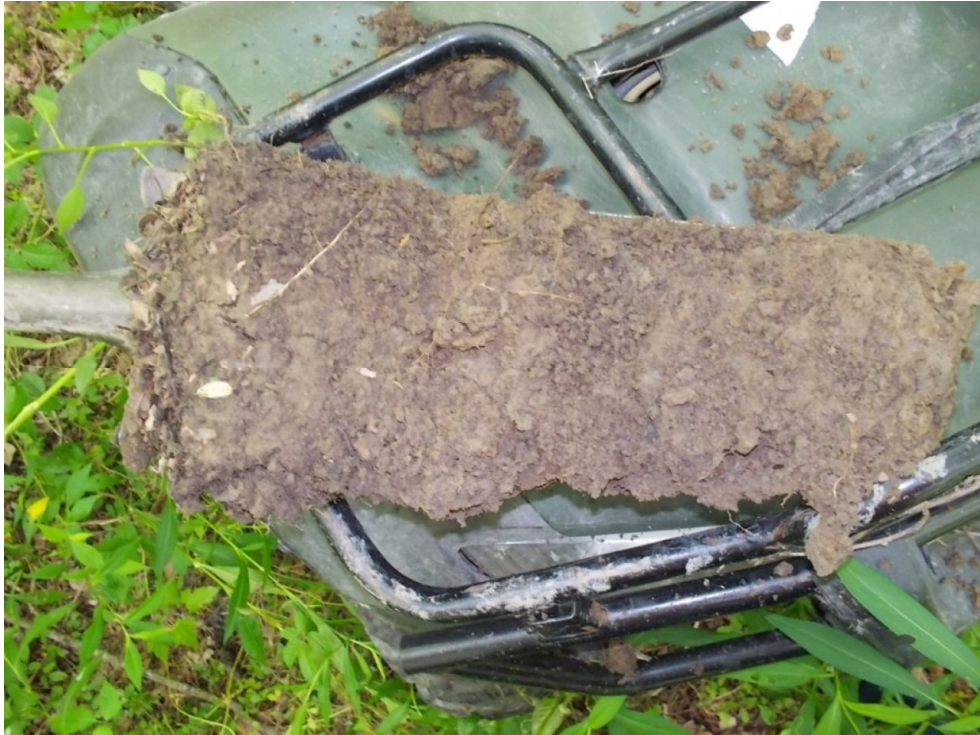
Photograph 13. Soil Profile Observed at Plot 4

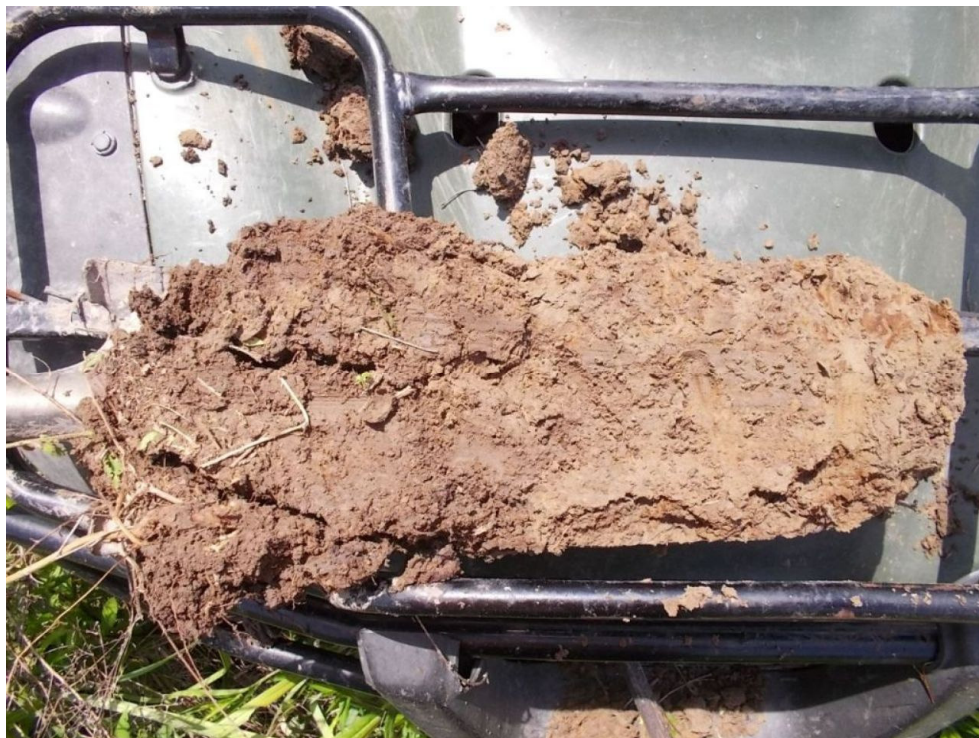
Photograph 17. Soil Profile Observed at Plot 5
