Exhibit BB. Grace Farms East P.
Jurisdictional Determination &
Wetlands Delineation Report

PRELIMINARY
JURISDICTIONAL DETERMINATION

456.5-ACRE GRACE FARMS EAST IBERVILLE PARISH, LOUISIANA

WETLAND DELINEATION REPORT

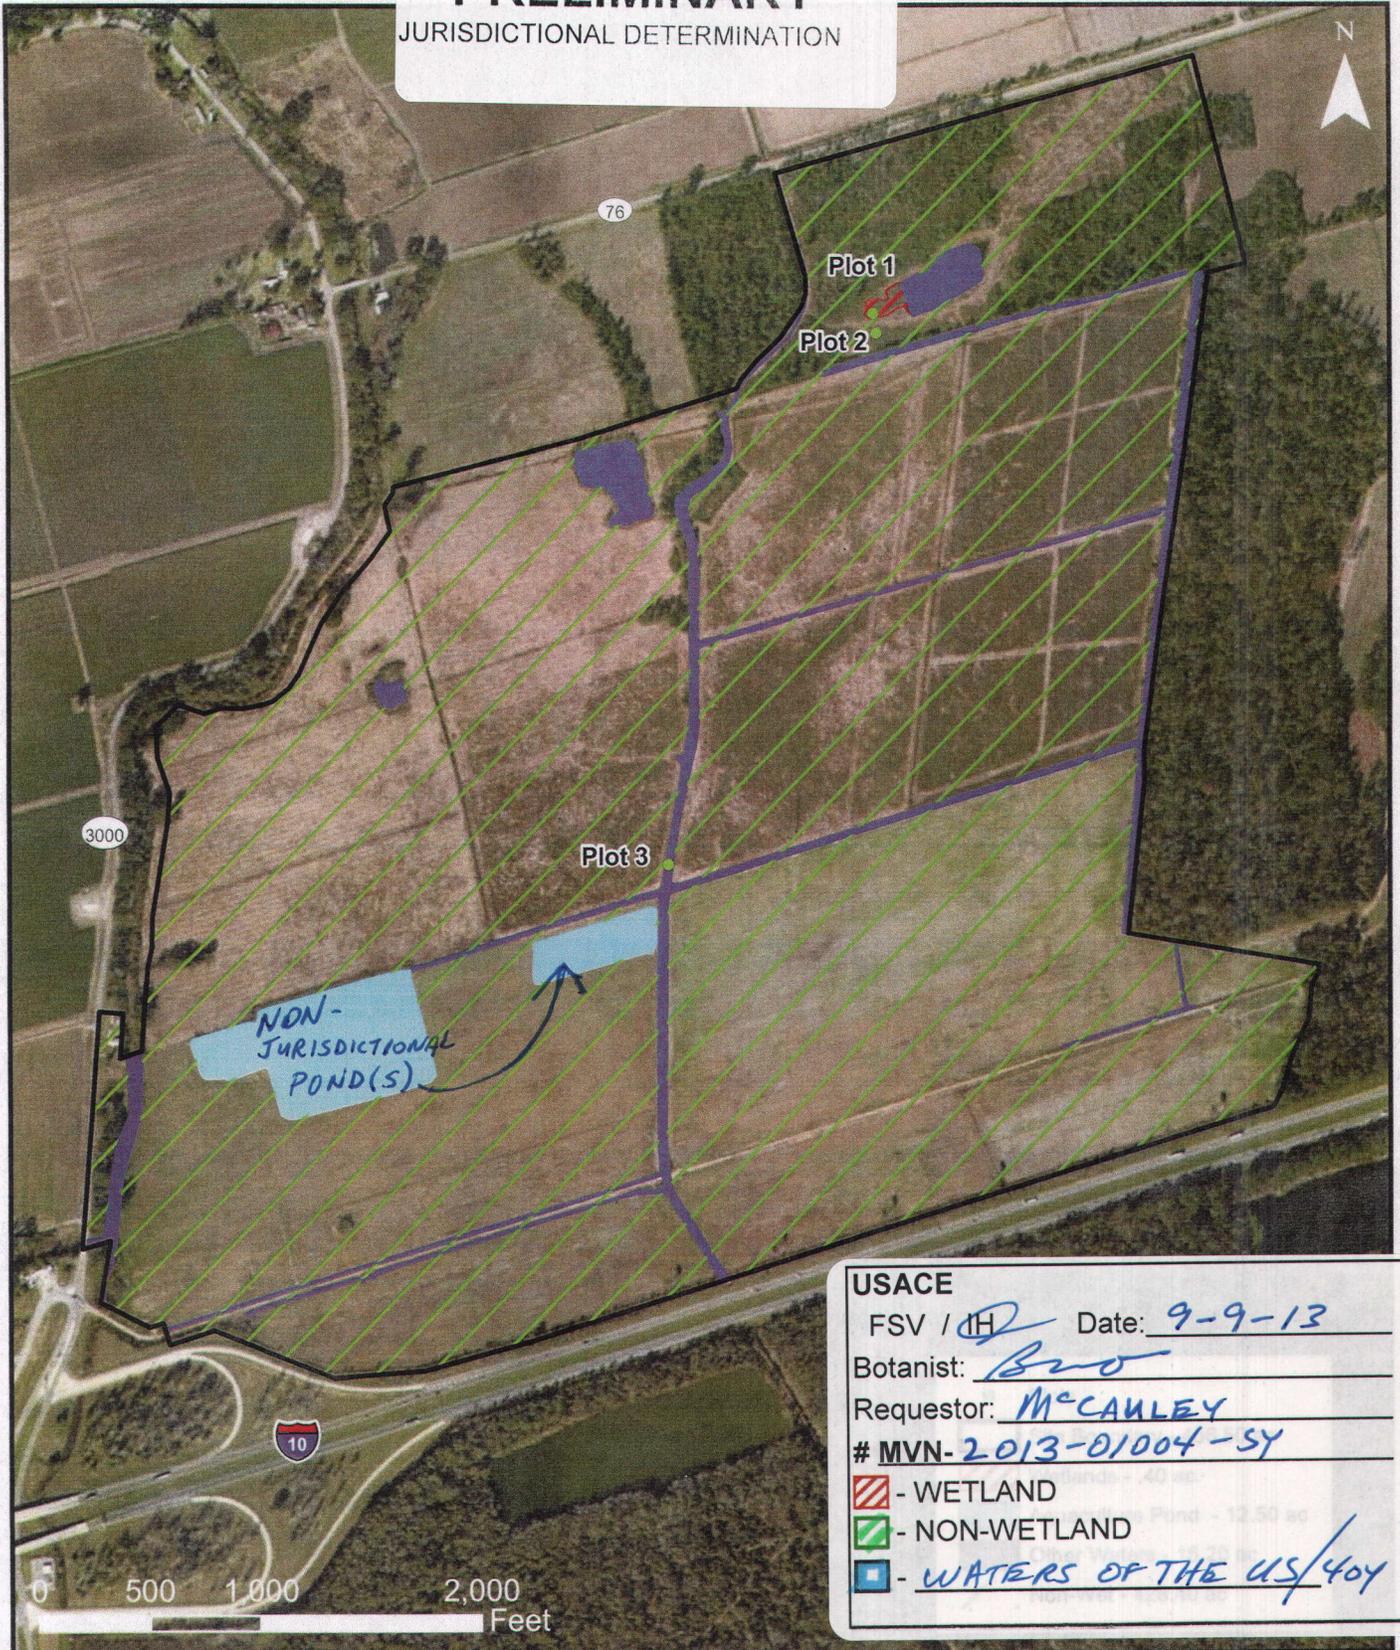
GEC	
Figure: 3	
Date: March 2013	
Scale: 1:10,000	
Source: GEC/Bing	
Map ID: 132122013001-3060

USACE
 FSV / TH Date: 9-9-13
 Botanist: Bzo
 Requestor: MCCAWLEY
 # MVN-2013-01004-SY
 [Red Hatched Box] - WETLAND
 [Green Box] - NON-WETLAND
 [Blue Box] - WATERS OF THE US/404

WETLAND MAP

Based on review of recent maps, aerial photography, soils data, and the information provided with your request, we have determined that part of the property is wetland and may be subject to Corps' jurisdiction. The approximate limits of the wetland are designated in red on the map. A Department of the Army (DA) permit under Section 404 of the Clean Water Act will be required prior to the deposition or redistribution of dredged or fill material into wetlands that are waters of the United States.

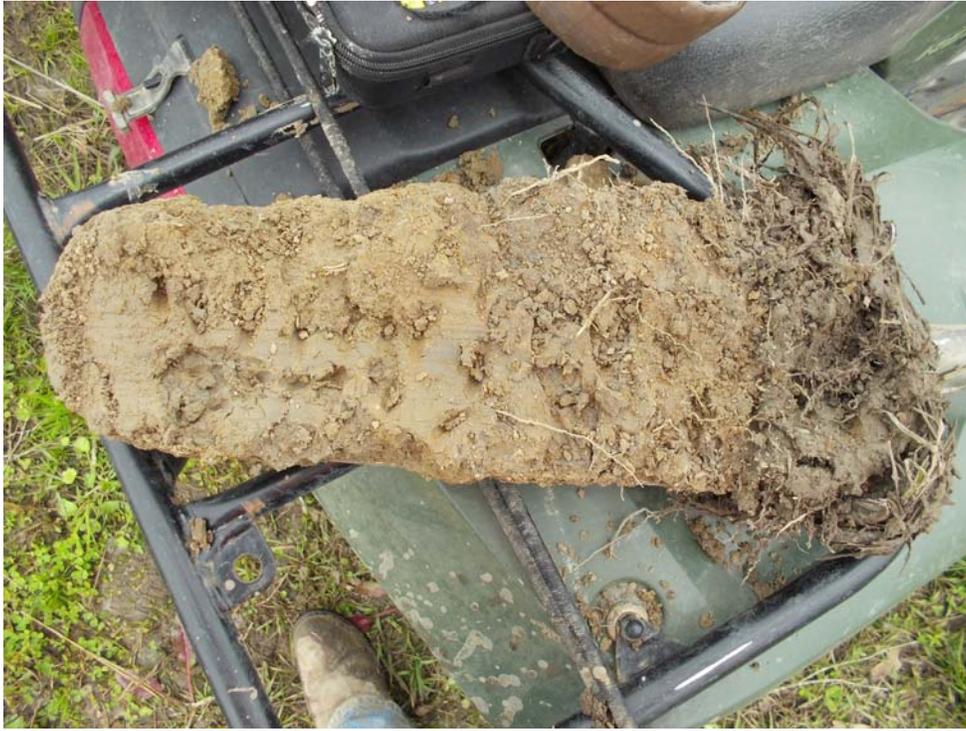
Photograph 1. Soil Profile Observed at Plot 1

The soil series mapped by the NRCS at Plot 1 as Commerce Silt Loam; field investigations confirm this soil type. The primary wetland hydrology indicator was saturation. It is GEC's opinion that this feature does meet the criteria for a wetland based on all three parameters being met. Photographs 1 and 2 depict the soil profile and an overview of the plot location.

Depth (inches)	Matrix		Redox Features				Texture	Remarks
	Color (moist)	%	Color (moist)	%	Type ¹	Loc ²		
0-3	Gley 1 3/10Y	100					ZC	
3-7	10 YR 4/1	90	7.5 YR 5/6	10	C	PL	ZC	
7-18	10 YR 5/1	95	7.5 YR 5/6	5	C	M	ZC

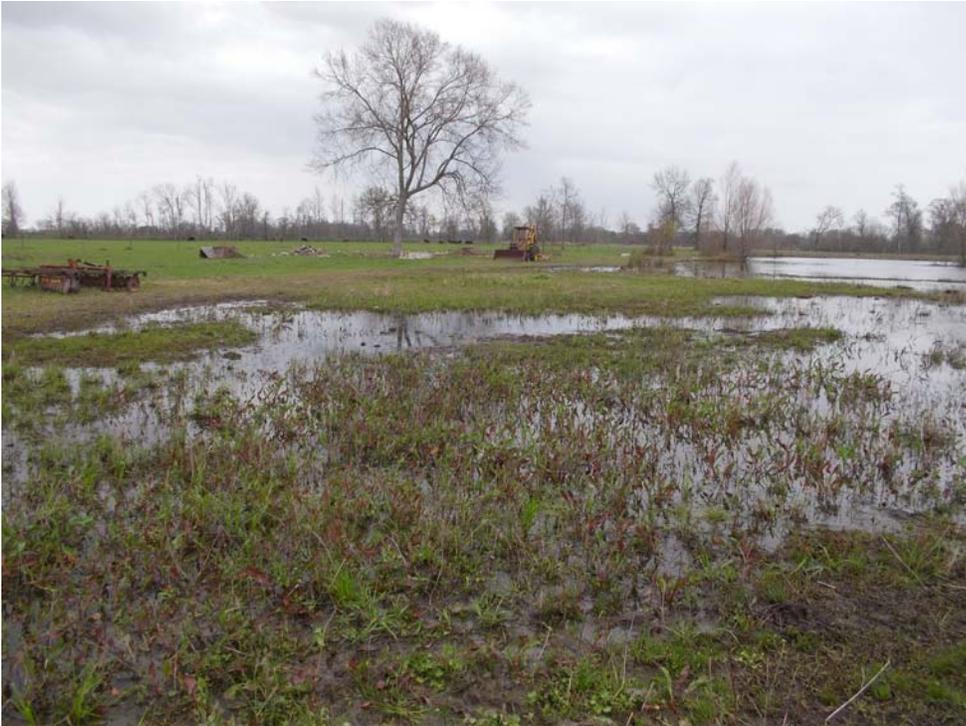
Photograph 2. Overview of Plot 1

Sample Plot 1 consists of an edge habitat of a agricultural pond. This plot is located at 30.4156 N and 91.4955 W. The location of this plot is presented in Figure 4.

The herbaceous stratum was dominated by curly dock (*Rumex crispus*) and Pennsylvania smartweed (*Polygonum pensylvanicum*). The hydrophytic vegetation criteria were met at this site.

Remarks:
 Plot taken on the upstream edge of an agricultural pond.

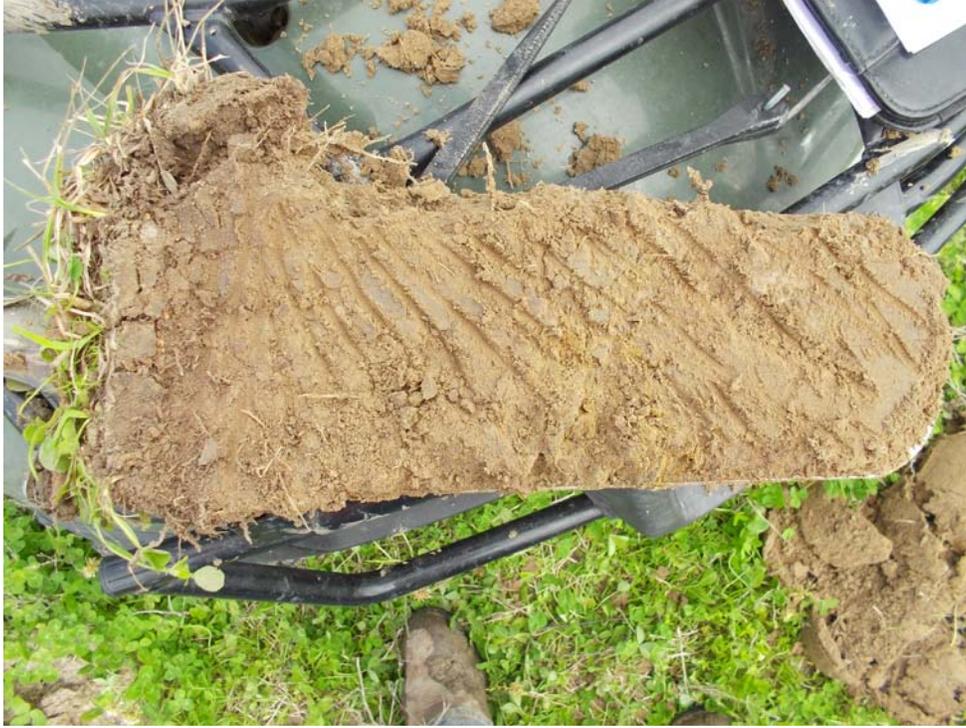
Photograph 3. Soil Profile Observed at Plot 2

The soil series mapped by the NRCS at Plot 2 as Commerce Silt Loam; field investigations confirm this soil type. No wetland hydrology indicator was noted. It is GEC's opinion that this feature does not meet the criteria for a wetland based on all three parameters not being met. Photographs 3 and 4 depict the soil profile and an overview of the plot location.

Depth (inches)	Matrix		Redox Features				Texture	Remarks
	Color (moist)	%	Color (moist)	%	Type ¹	Loc ²		
0-7	10 YR 4/3	98	10 YR 5/1	1	D	M	ZC	
			10 YR 5/6	1	C	PL	ZC	
7-18	10 YR 4/1	75	7.5 YR 4/6	25	C	M	ZC

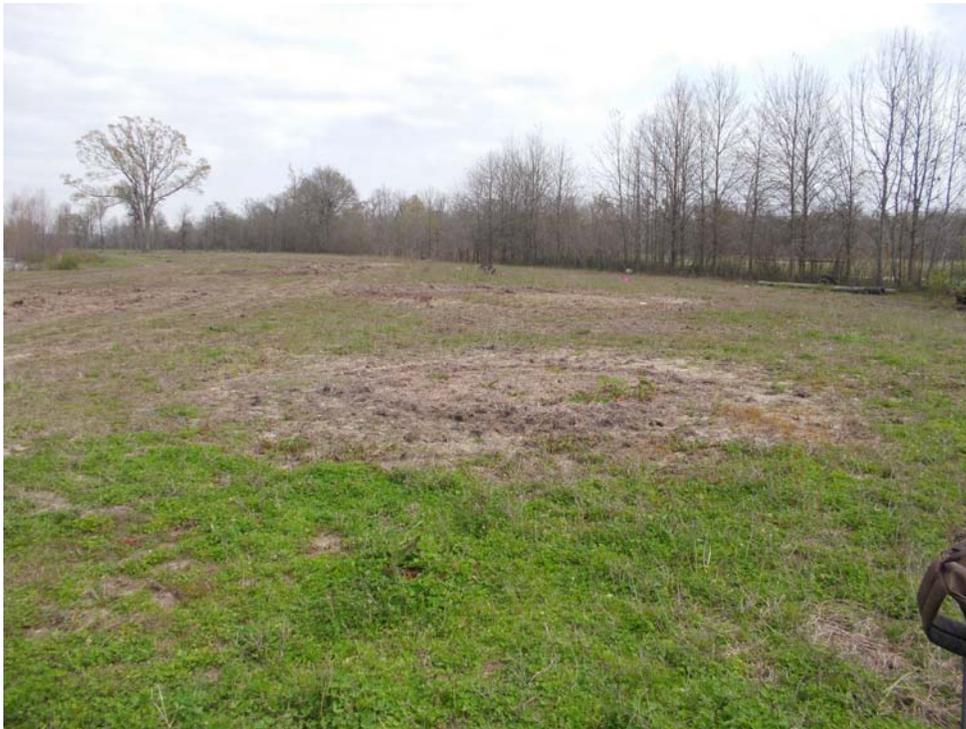
Photograph 4. Overview of Plot 2

Sample Plot 2 consists of an agricultural field currently used for pasture. This plot is located at 30.4154 N and 91.4955 W. The location of this plot is presented in Figure 4.

The herbaceous stratum was dominated by white clover (*Trifolium repens*) and bahiagrass (*Paspalum notatum*). The hydrophytic vegetation criteria were not met at this site.

Remarks:
 Plot taken in a field used for cattle grazing

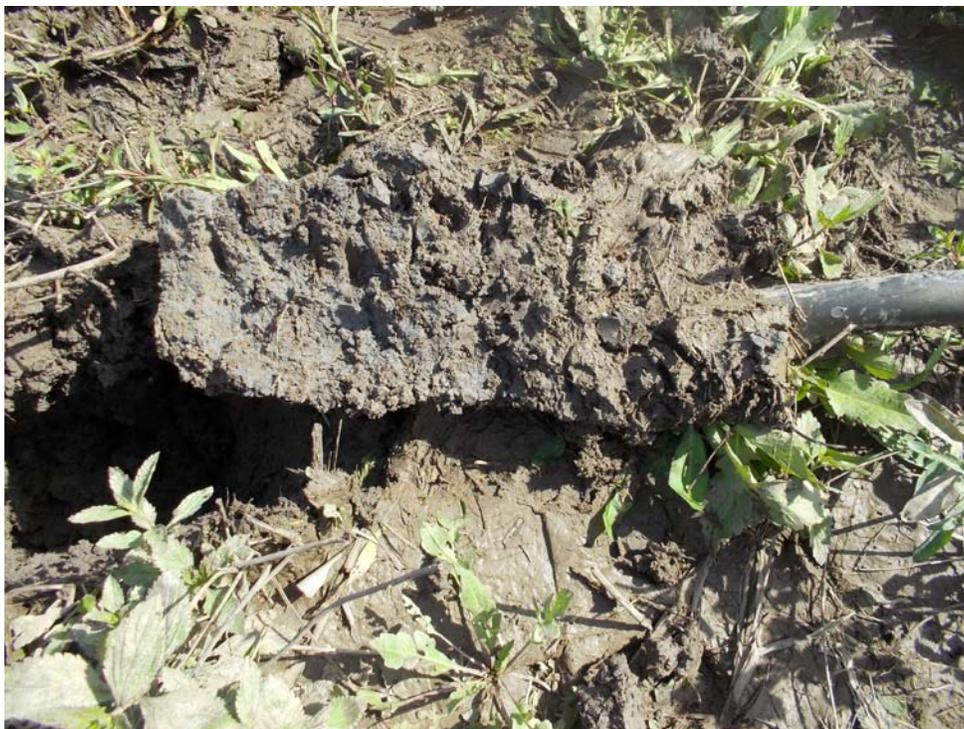
Photograph 5. Soil Profile Observed at Plot 3

The soil series mapped by the NRCS at Plot 3 as Commerce Silty Clay Loam field investigations confirm this soil type. The primary wetland hydrology indicator was surface water and saturation. It is GEC's opinion that this feature does meet the criteria for a wetland based on all three parameters being met. Photographs 5 and 6 depict a soil profile and an overview of the plot location.

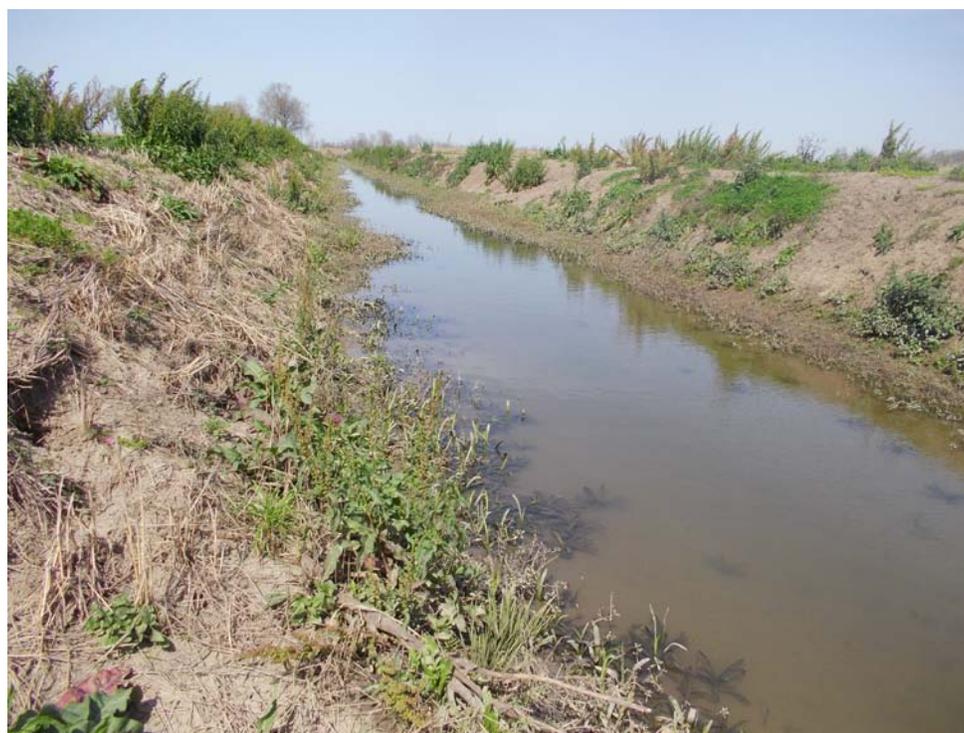
Photograph 6. Overview of Plot 3

The herbaceous stratum was dominated by duck potato (*Sagittaria platyphylla*) and alligator weed (*Alternanthera philoxeroides*). The hydrophytic vegetation criteria was met at this site.
