Ruston Industrial Park Wetlands Delineation Report

Wetland Delineation and Determination

Ruston Industrial Park Site ± 150.00 ac.

Lincoln Parish, Louisiana

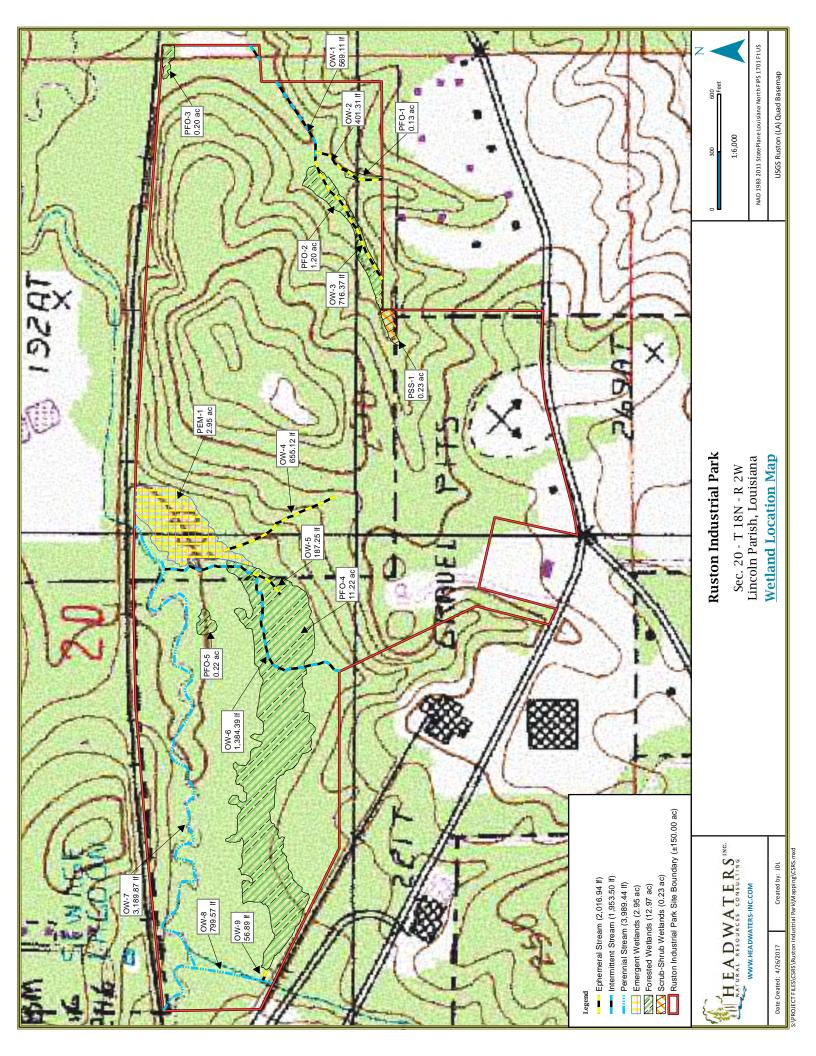
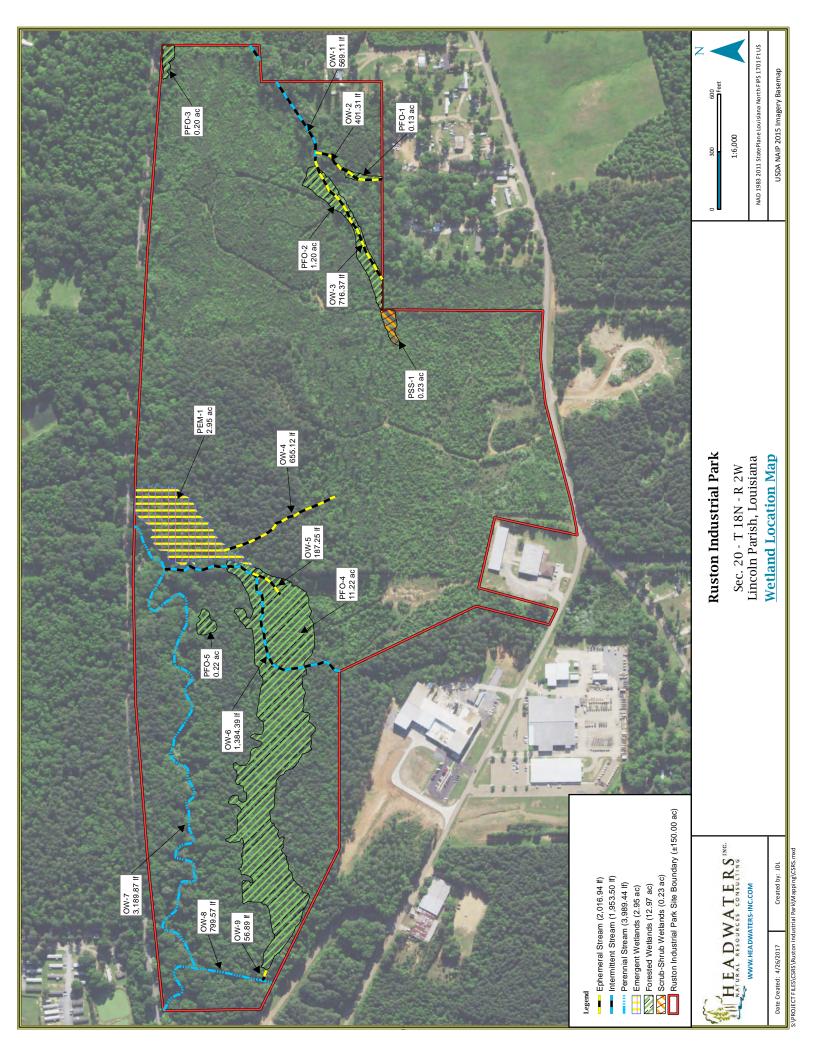
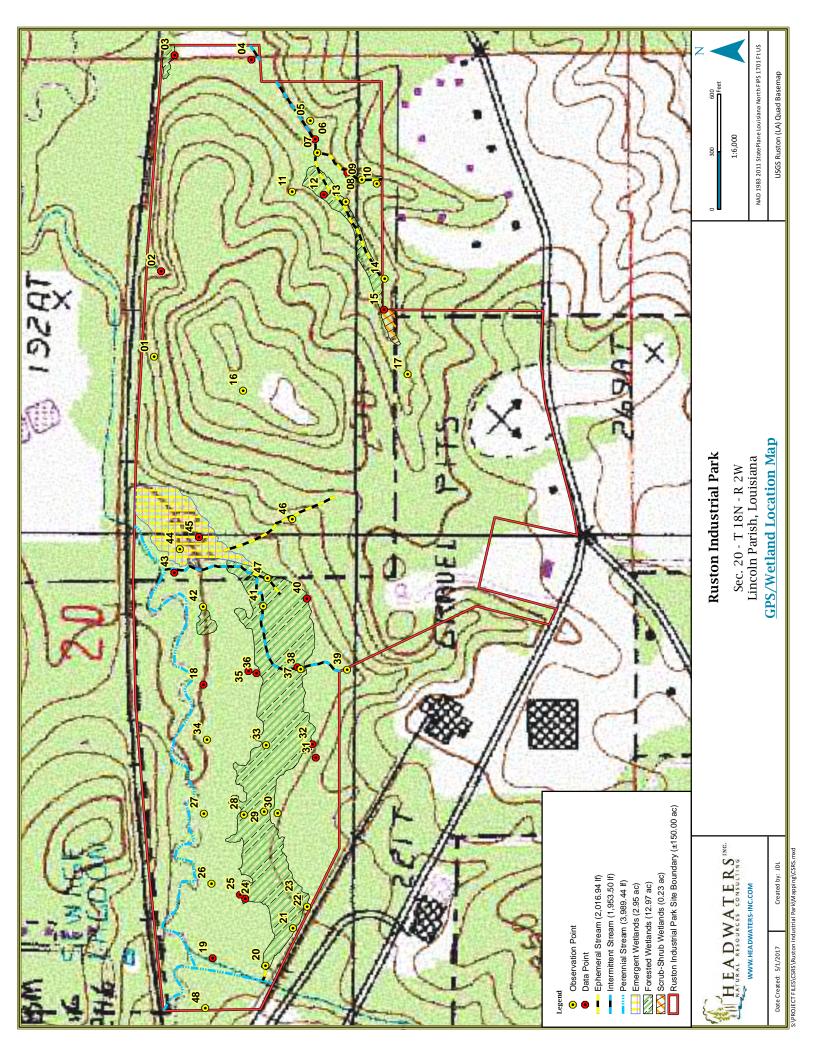
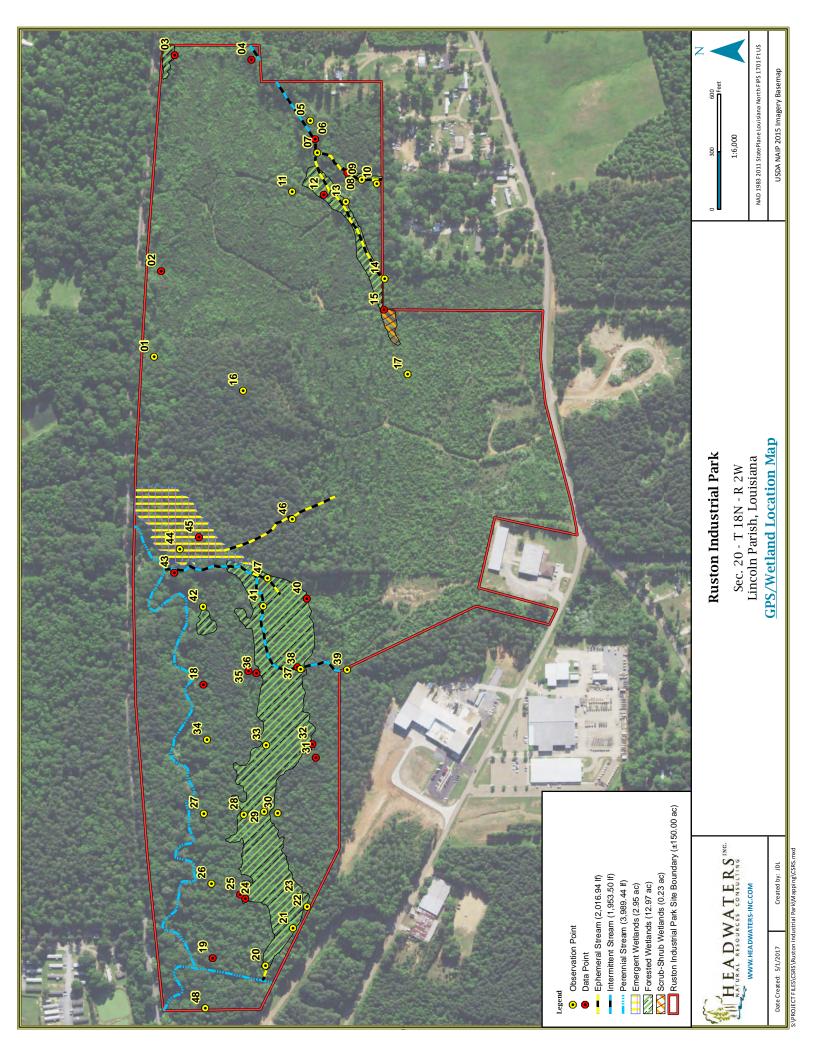
## - Site Map Depicting Wetland Areas, GPS Waypoints, and Wetland Delineation Data Point Locations

ranging from a 4/4, 4/6 (dark yellowish brown) to a 5/6, 5/8 (yellowish brown) on the 10YR chart to 5/6 (strong brown) on the 7.5YR chart. Redox concentrations and depleted matrix were observed within the soil profile within the top 12 inches. These forested wetland habitats (PFO-1, PFO-2, PFO-3, PFO-4, & PFO-5) are depicted on the wetland location exhibits included within Appendix II.

Palustrine Scrub - Shrub Wetland (PSS) - The field reconnaissance determined that a portion of the site was comprised of a scrub – shrub wetland habitat. PSS-1 was observed within the eastern portion of the site along the west side of an existing logging road. The logging road has impeded that natural flows in this area causing this are to become inundated. Scrub – shrub vegetative components were observed within and along fringe of the impounded area. Hydrology indicators within PSS-1 included inundation, saturation, drainage patterns, water-stained leaves, crawfish burrows, sediment & drift deposits, and oxidized rhizospheres along living roots. Vegetative components observed within this wetland habitat included black willow (Salix nigra), water oak (Quercus nigra), loblolly pine (Pinus taeda), willow oak (Quercus phellos), Chinese tallowtree (Triadica sebifera), buttonbush (Cephalanthus occidentialis), lamp rush (Juncus effusus), marsh flat sedge (Cyperus pseudovegetus), bushy blue stem (Andropogon virginicus), wool grass (Scirpus spp.)., Polygonum spp., and red vine (Brunnichia cirrhosa) among others. The soils observed within PSS-1 were similar in nature to those described above that were observed in the forested wetland habitat. This scrub - shrub wetland habitat (PSS-1) is depicted on the wetland location exhibits included within Appendix II.

**Ephemeral Stream** - Segments of five (5) ephemeral streams (OW-2, OW-3, OW-4, OW-5, & OW-9) were identified transecting portions of the property. These tributaries provide the secondary source of storm water runoff from within the subject property. These drainage features may be characterized by shallow stream banks with the overall lack of significant vegetative components within the channel. Some of these drainages were observed within a forested wetland top-bank habitat, while others were observed as maintaining an upland (non-wetland) forested habitat. The presence of the ephemeral streams identified within the limits of the project site would be considered as "other waters of the United States." The locations and alignments of these ephemeral streams are depicted on the wetland location maps (Appendix II).

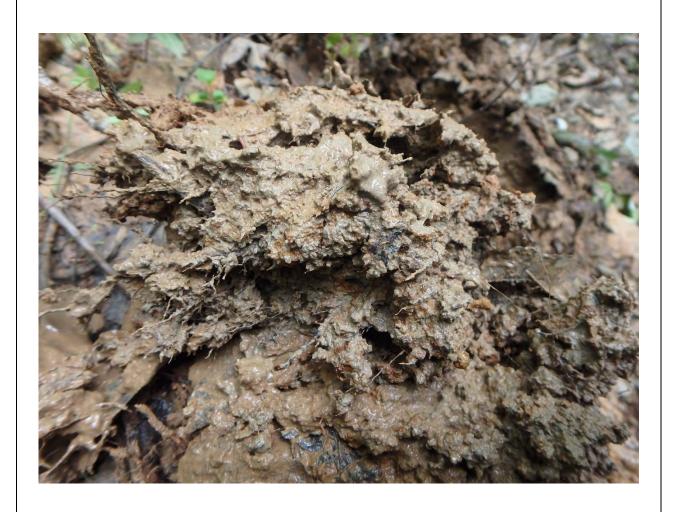
#### Hydric soil profile (PFO-2)

View depicting the hydric soil profile observed within the forested wetland habitat (PFO-2) within the southeast portion of the site. The soils at this waypoint were a 5/1 on the 10YR page of the Munsell Soil Color chart with a mottle color of 5/6 on the 7.5 page of approximately 20-25%. Redox concentrations were observed within the top 12" of the soil profile

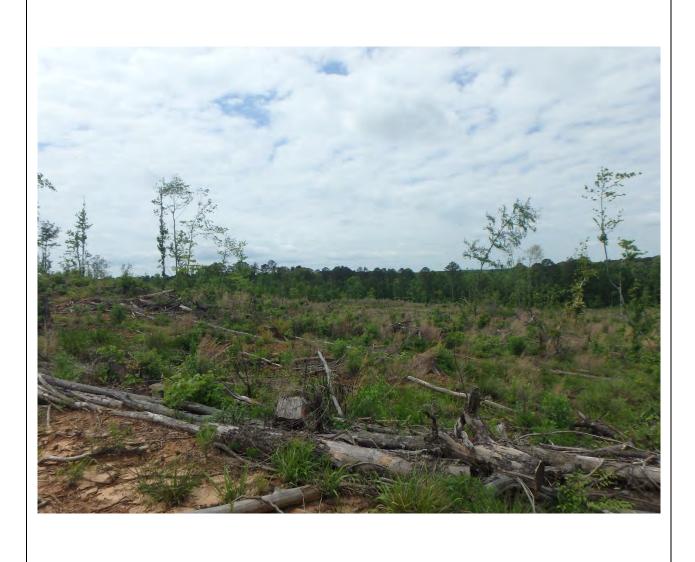
#### Upland (non-wetland) cut-over habitat

nerally west depicting the typical conditions observed or habitat in the central portion of the site.

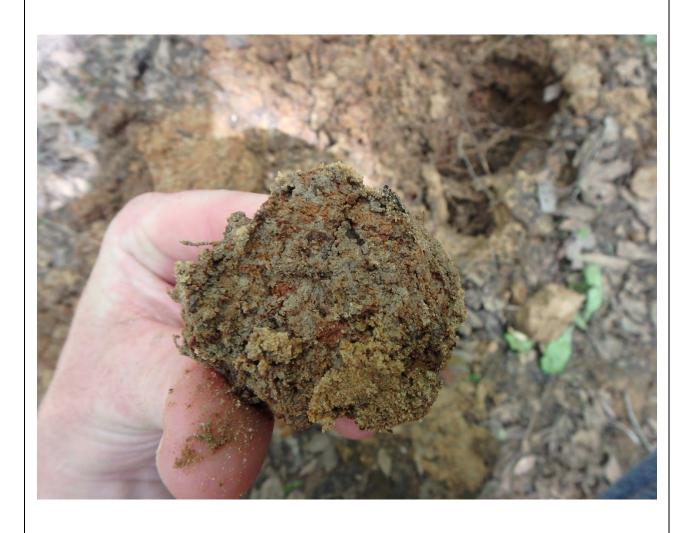
#### Hydric soil profile (PFO-4)

**Description** View depicting the hydric soil profile observed within the western end of the large forested wetland complex (PFO-4) in the western half of the subject property.

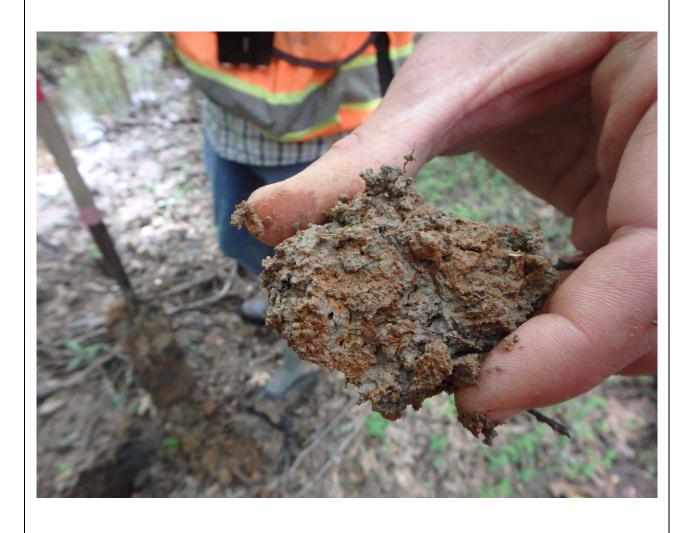
### Hydric soil profile (PFO-4)

**Description** View depicting the hydric soil profile observed within the western end of the large forested wetland complex (PFO-4) in the western half of the subject property. The soils at this waypoint were a 5/1 on the 10YR page of the Munsell Soil Color chart with a 5/8 mottle on the 7.5YR page.

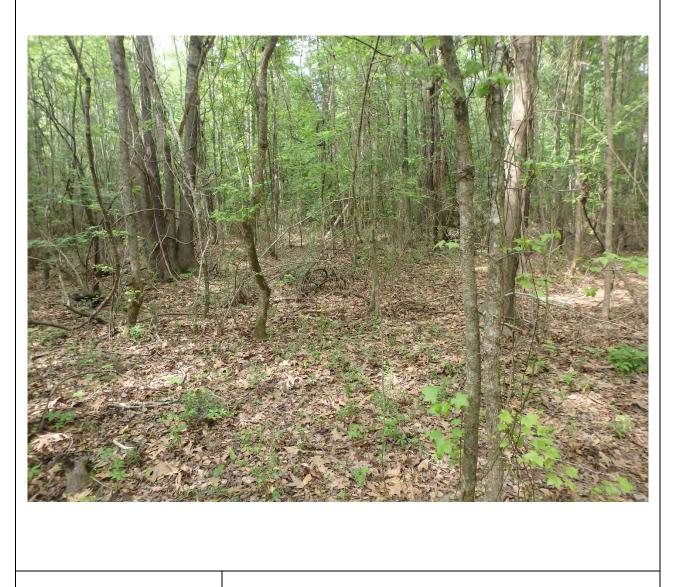
### Wetland (PFO-4) – Upland (non-wetland) habitat transition line

View looking north depicting the forested upland (non-wetland) habitat observed to the north of this transition line. The forested wetland habitat (PFO-4) is located to the south of this transition line.

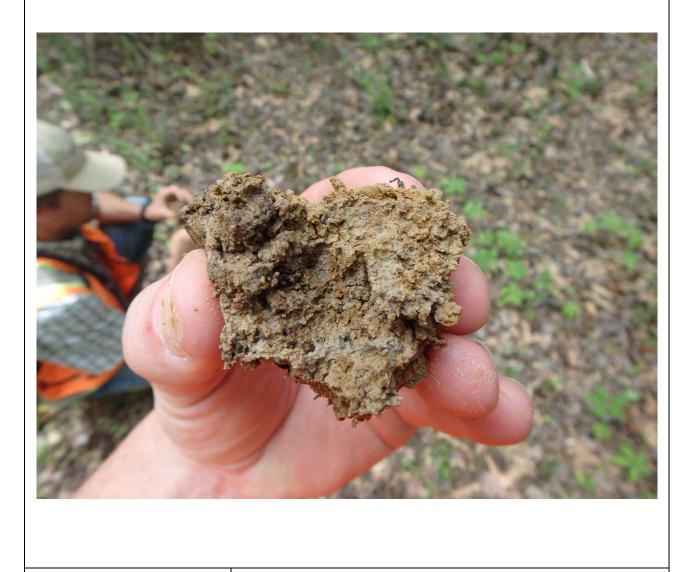
### Wetland (PFO-4) – Upland (non-wetland) habitat transition line

View depicting the transition soils profile observed along the habitat transition line. The soils at this waypoint were a 5/3 on the 10YR page of the Munsell Soil Color chart with a predominant mottle color of 5/6 on the 10YR page.

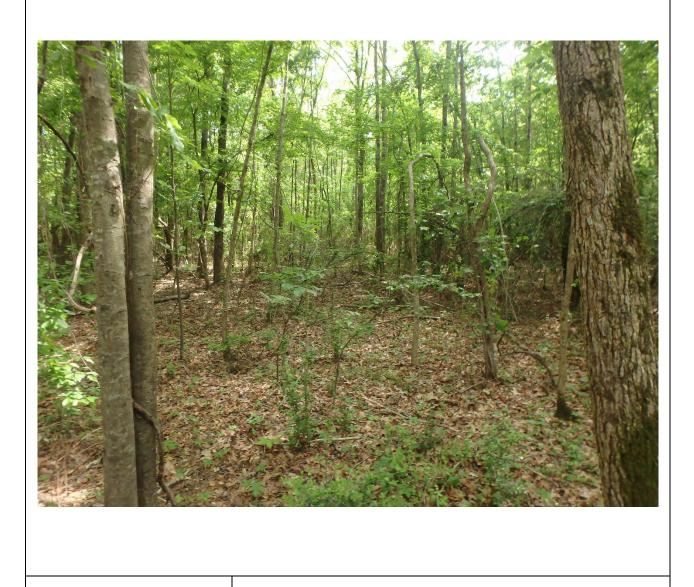
### Wetland (PFO-4) – Upland (non-wetland) habitat transition line

View looking north depicting the forested upland (non-wetland) habitat observed to the north of this transition line. The forested wetland habitat (PFO-4) is located to the south of this transition line.

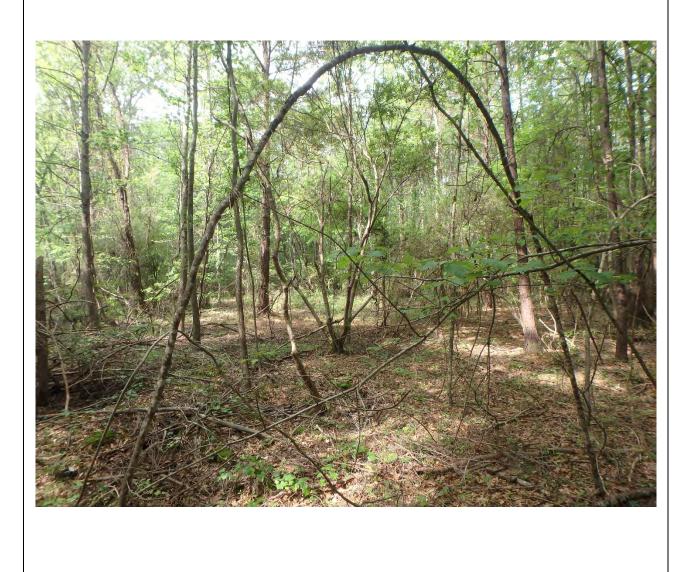
WAYPOINT NO. 32		
	Forested Wetland Habitat (PFO-4)	
<image/>		
Description	View to the northwest within the forested wetland complex (PFO-4) depicting the typical habitat conditions observed.

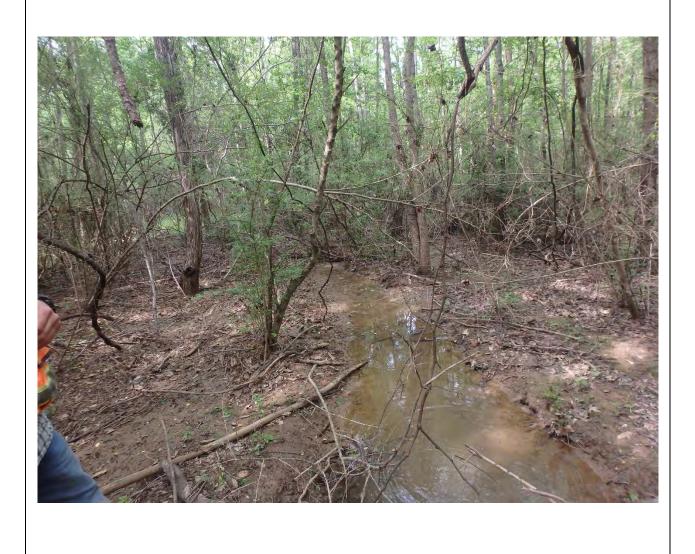
# Intermittent Stream (OW-6) and forested wetland habitat (PFO-4)

<b>-</b>	View looking down gradient of the intermittent stream (OW-6) as it meanders through the forested wetland complex (PFO-4).
Description

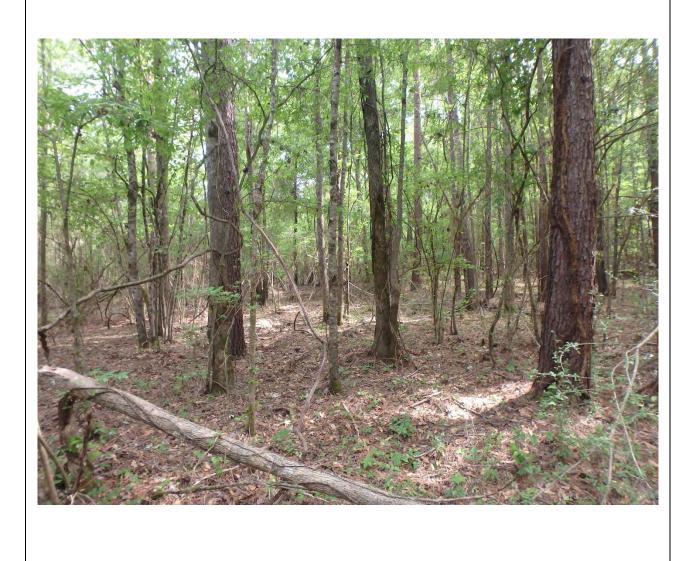
### Wetland (PFO-4) – Upland (non-wetland) habitat transition line

**Description**View looking south depicting the forested upland (non-wetland) habitat<br/>observed to the south of this transition waypoint. The forested wetland<br/>(PFO-4) is located north of this waypoint.

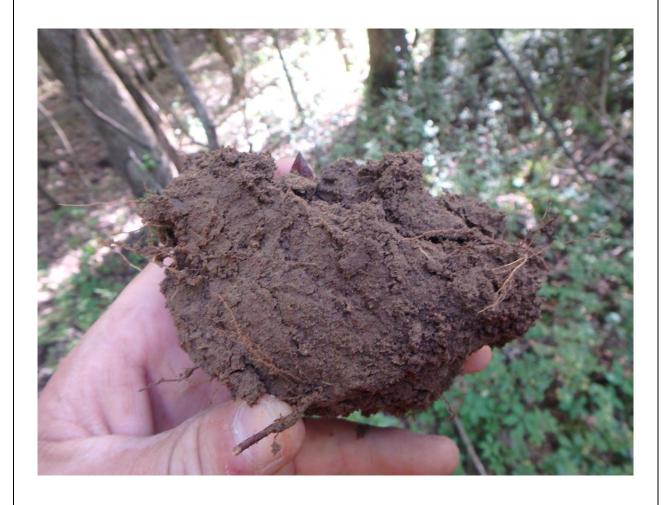
### Upland (non-hydric) soil profile

View depicting the upland (non-hydric) soil profile along the wetland – upland transition line form the micro-habitat forested wetland habitat (PFO-5) observed to the west of this waypoint. The soils at this waypoint ranged from a 4/4 - 4/6 on the 10YR page of the Munsell Soil Color chart.

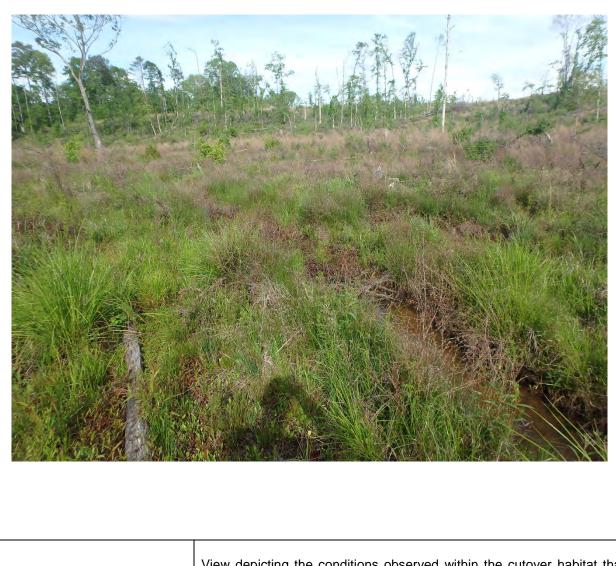
### Emergent Wetland Habitat (PEM-1)

View depicting the conditions observed within the cutover habitat that was identified as an emergent wetland habitat (PEM-1) in the northern portion of the site.
