Phase I Environmental Site Assessment

Harvey Couch Business Park

190 Harvey Couch Boulevard

Terracon Project No. BB187041

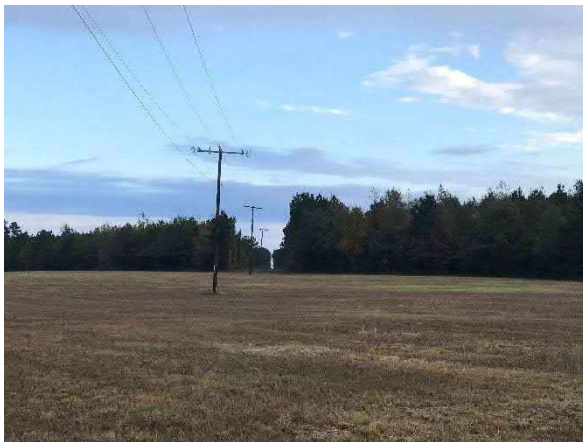
Photo #3 View of the northeast easement opening facing northeast.

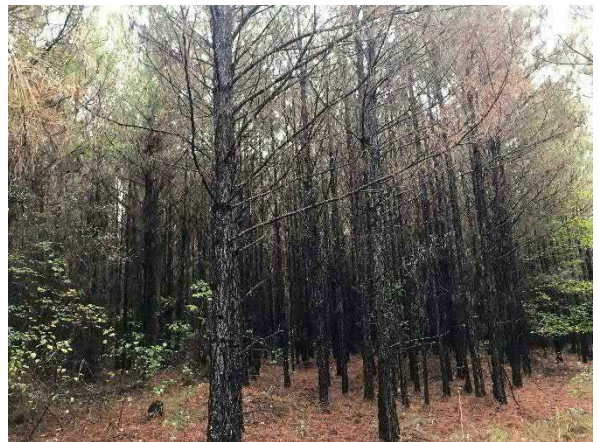
Photo #4 Representative view of the interior wooded portions of the site.

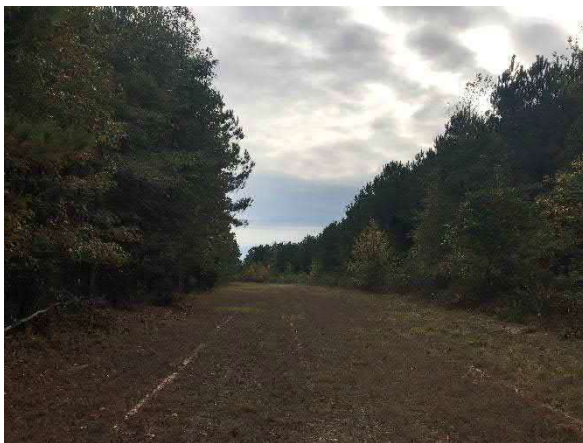
Photo #5 Representative view of interior cleared portions of the site.

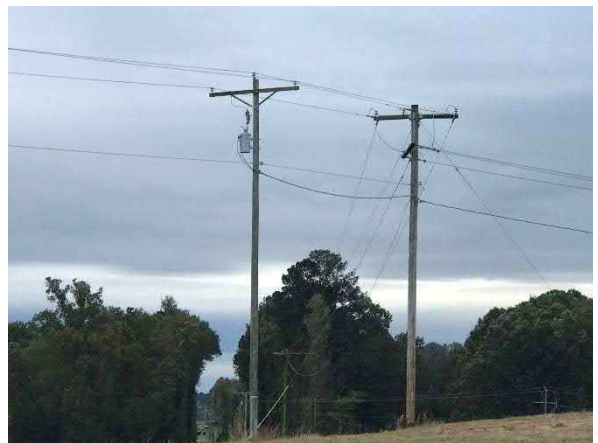
During site reconnaissance, Terracon observed one pole-mounted transformer near the southwest corner of the site. The transformer appeared to be associated with a powerline easement which runs diagonally through the northwest of the site. Information with regard to PCB content of the transformer fluids was not observed. Some transformers contain mineral oil which may contain PCBs. Entergy Arkansas maintains responsibility for the transformers, and if the transformers were “PCB contaminated”, Entergy Arkansas is not required to replace the transformer fluids until a release is identified. However, evidence of a current or past release was not observed in the vicinity of the electrical equipment during the site reconnaissance.

Photo #6 View of on-site pole-mounted transformer.

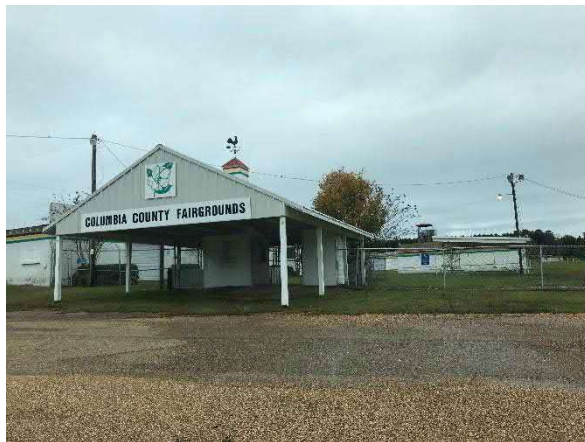
Photo #7 View of adjoining property to the east of the site.

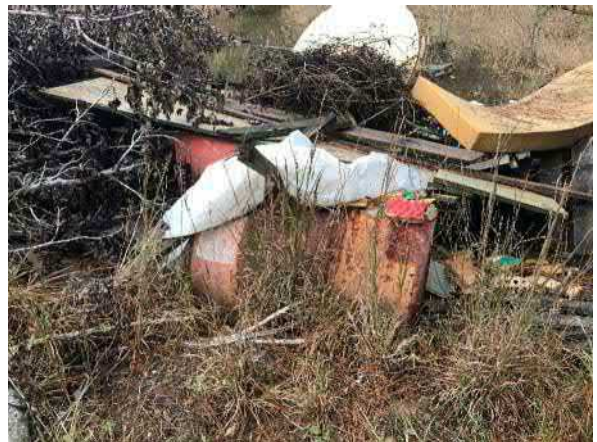
During site reconnaissance, trash and debris was on the eastern adjoining property. The debris covered approximately ten square feet. Based on visual observation (only of surface materials), the debris consisted of wooden building materials, pallets, two drums (without contents), and trash. Leakage, spills or other releases from these materials were not observed during the visual reconnaissance. The debris materials did not appear to be hazardous in nature and do not represent a REC in connection with the site.

Photo #8 View of dumping on the eastern adjoining property.
