# Henderson I-10 Site Phase I Cultural Resources Assessment Report

**PHASE I CULTURAL RESOURCES SURVEY  
OF 147 ACRES (59.5 HECTARES)  
NEAR BREAUX BRIDGE, ST. MARTIN PARISH, LOUISIANA**

**Draft Report**

**January 2026**

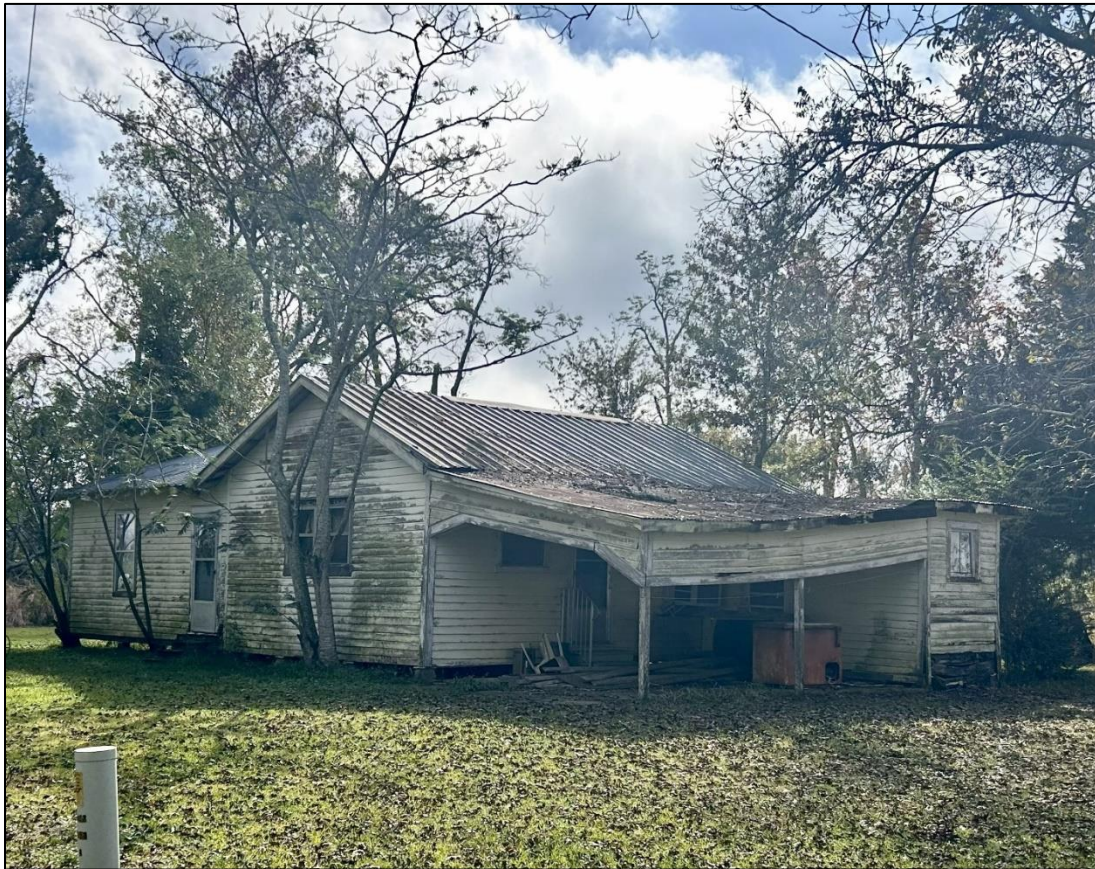
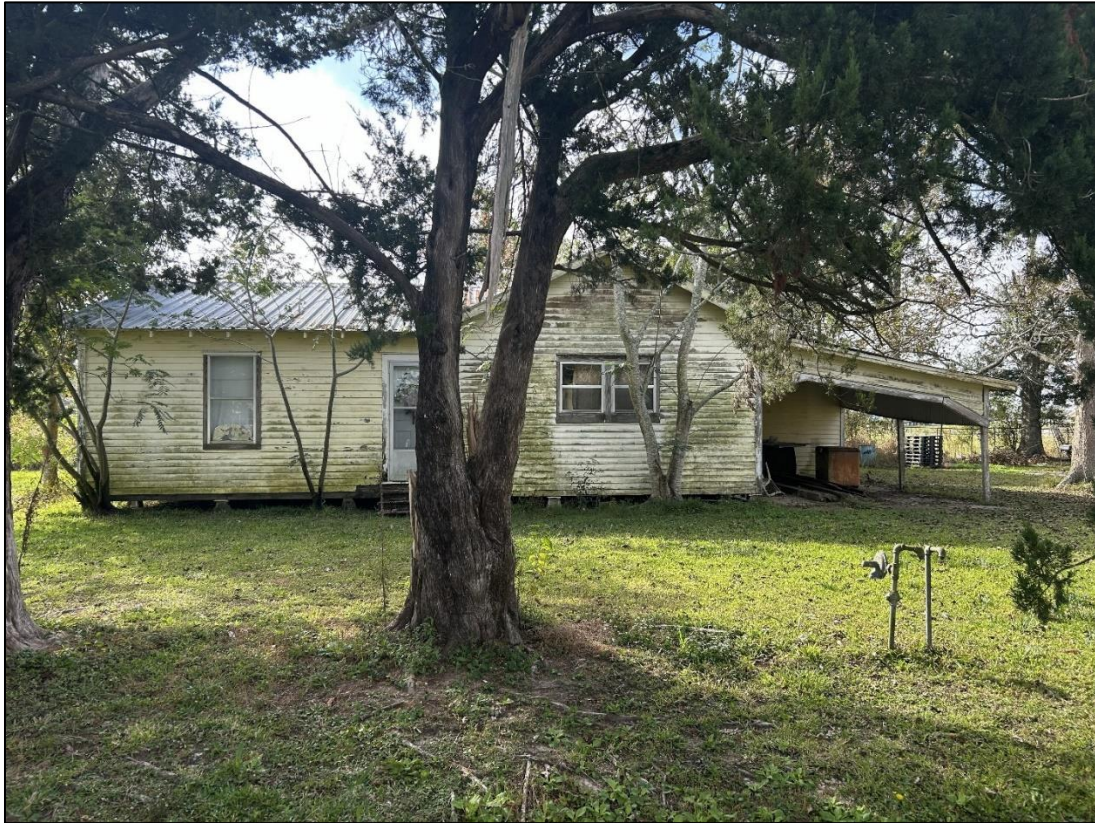
This one-story, wood frame dwelling with clapboard siding is elevated on brick piers. It has a corrugated metal, broken-pitch roof and aluminum frame double hung windows. The attached port cocher is sagging and in a state of imminent collapse. There is a rear addition with a gable roof and aluminum storm door. The structure is abandoned and is in poor condition. It was constructed in 1962 and would not qualify for the National Register due to lack of integrity.

Figure 50. House at 1026 Ameda Berard, facing SE. (Resource No. 50-00802)

Figure 51. House at 1026 Ameda Berard, looking south. (Resource No. 50-00802)

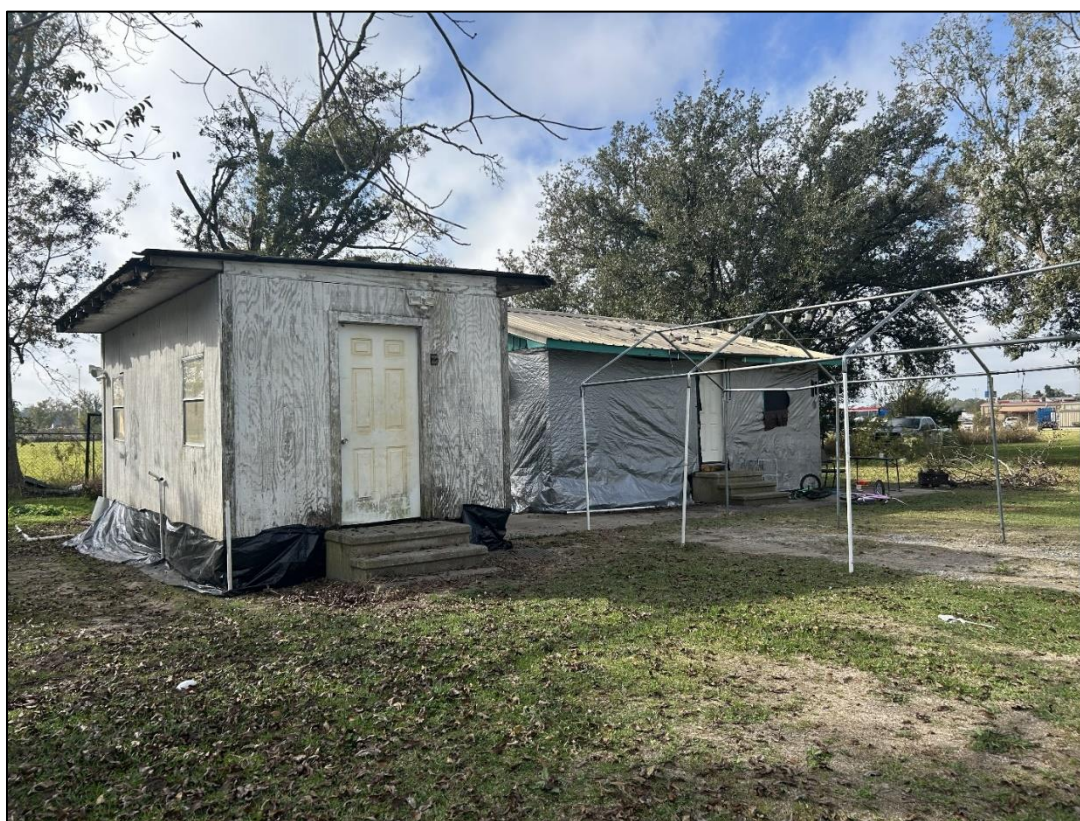
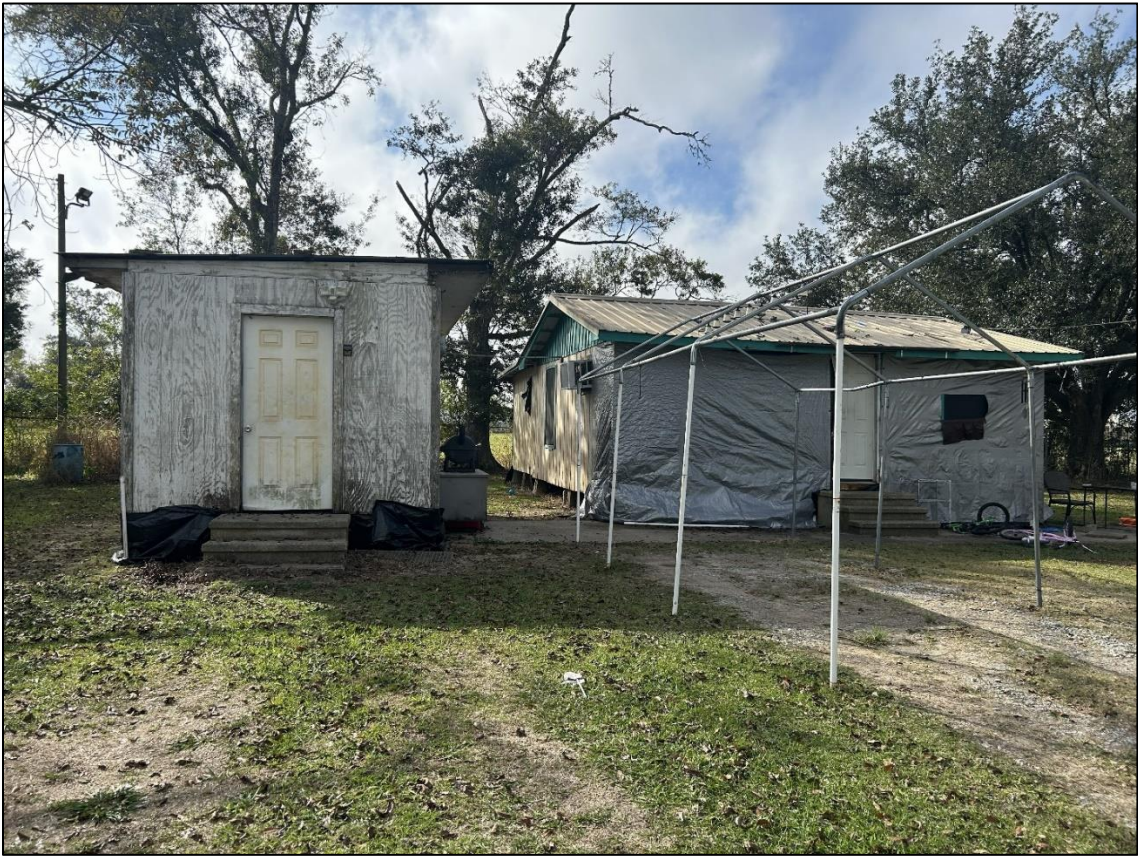
This resource consists of two one-story wood-framed buildings, a house and what appears to be a storage facility. The former has a broken-pitch, corrugated metal roof, while the second has a flat, corrugated metal roof. Both are elevated on concrete piers. The windows are double hung. The inhabited building has a tarp over the entire front of the structure. The generally poor condition of these two structures and their lack of a distinctive style makes them ineligible for the National Register under Criteria A-C.

Figure 52. Structure and outbuilding at 1028 Ameda Berard, looking southwest.  
(Resource No. 50-00803)

Figure 53. Structures at 1028 Ameda Berard, looking south. (Resource No. 50-00803)

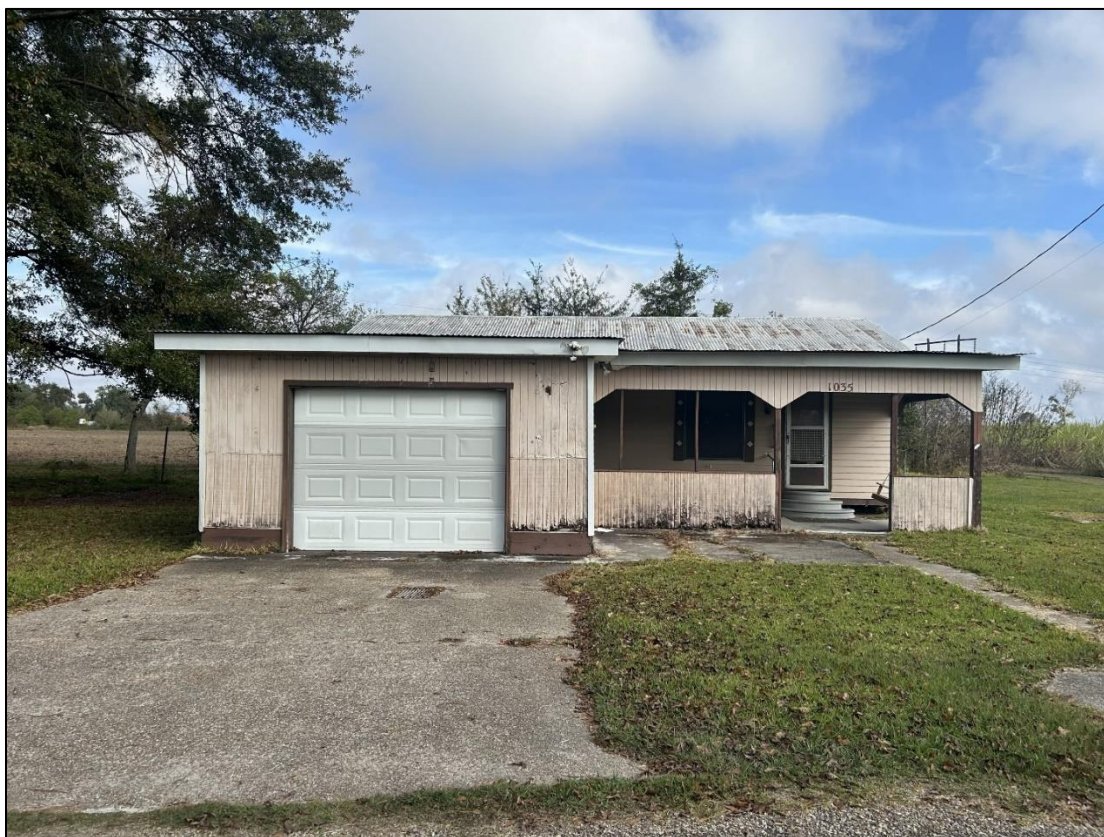
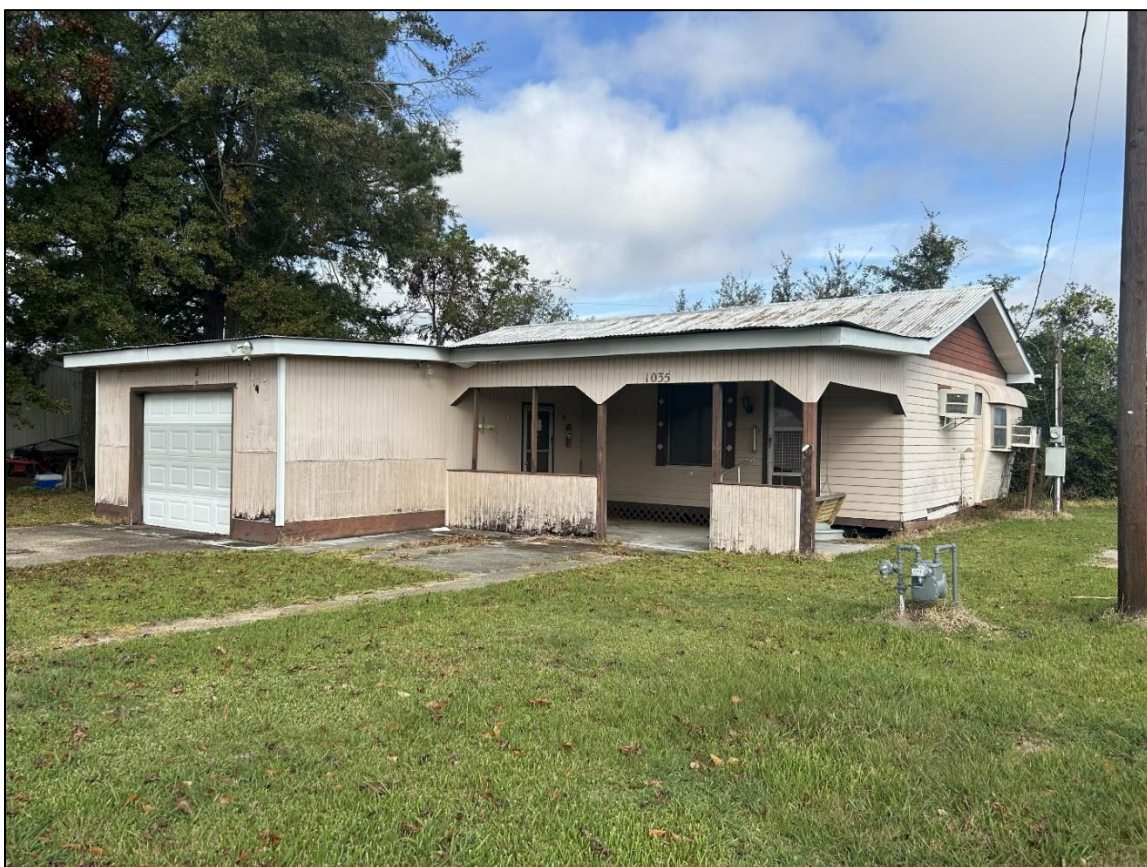
This is a one story modified mobile home with a corrugated metal, broken pitch roof with clapboard sides and plywood panels on the garage addition, which has a flat, corrugated metal roof. It is elevated on concrete piers and has aluminum frame, double hung windows and an aluminum storm door. There is a covered open porch area with a board wall. The home is inhabited and is in generally fair condition. It is unknown when this structure was constructed, but it looks to date to the 1960s. This structure would not be eligible for the National Register of Historic Places under Criteria A-C.

Figure 54. House at 1035 Ameda Berard Rd., facing north. (Resource No. 50-00804)

Figure 55. House at 1035 Ameda Berard Rd., facing northwest. (Resource No. 50-00804)

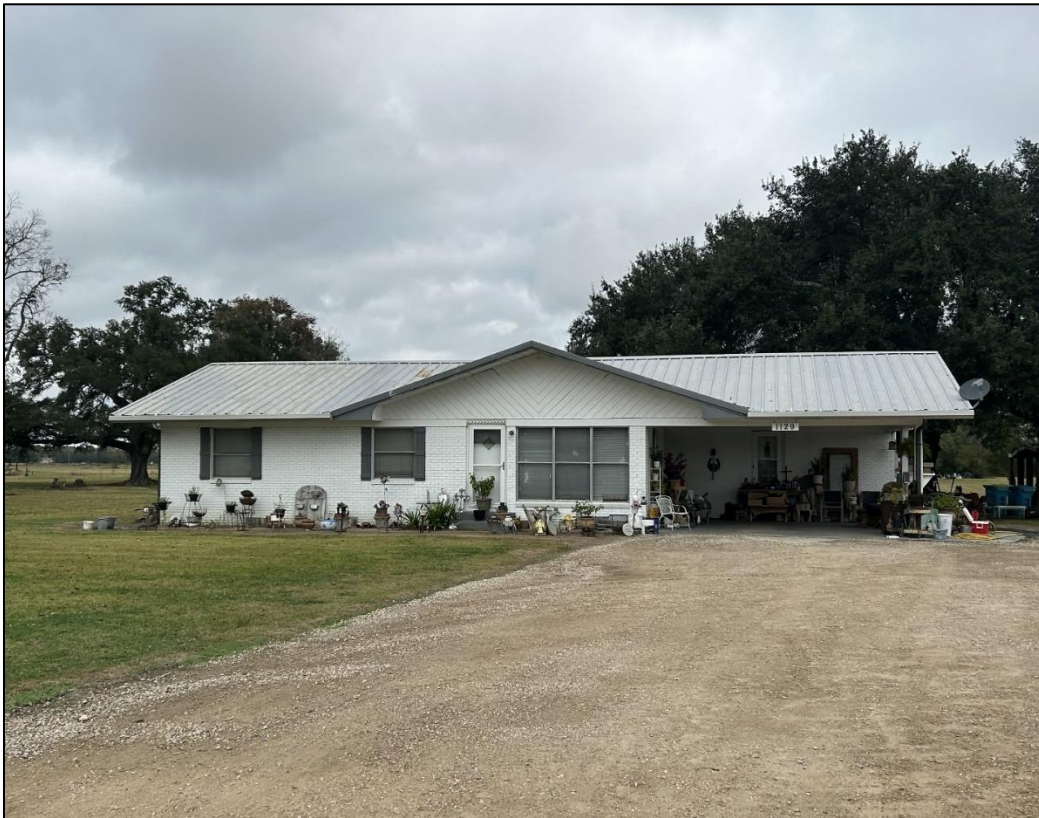
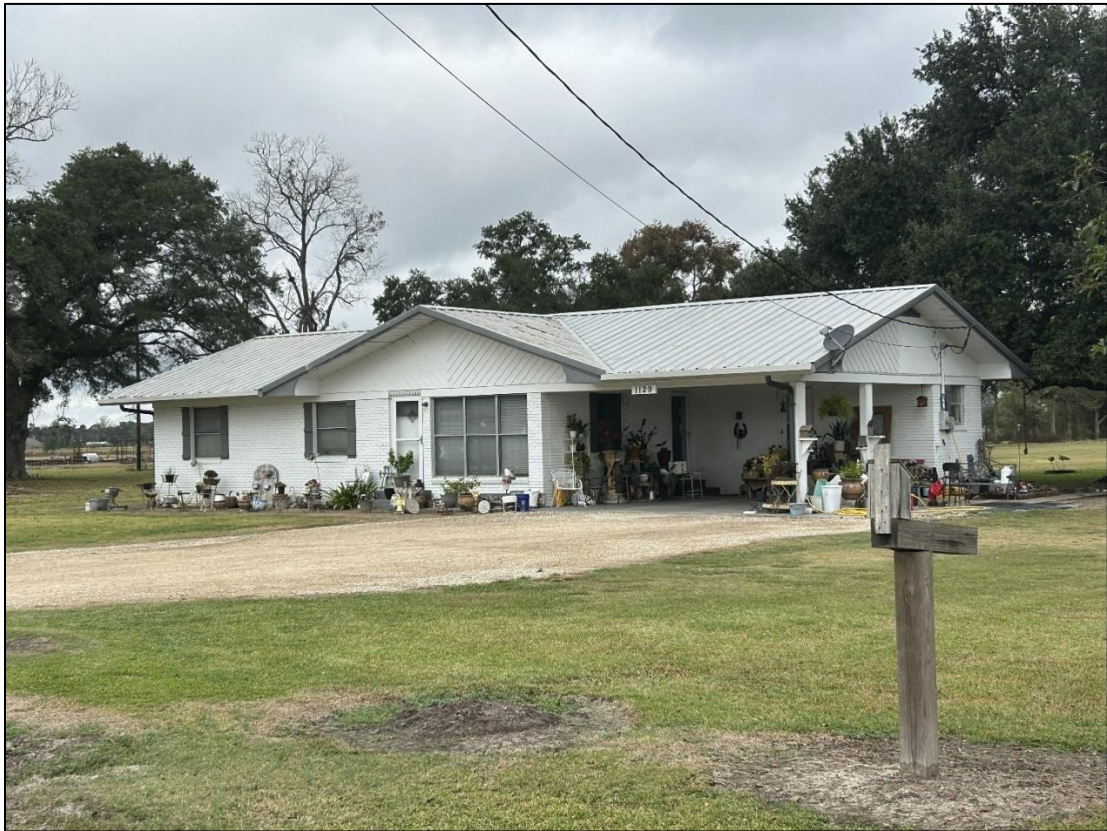
This is a one-story brick, ranch-style house with aluminum, double-hung windows. There is a gabled front addition with a larger six-pane picture window. It has a metal corrugated double-pitch roof. It is set on a slab. There is an open garage on the right. Condition is good. There is nothing to suggest this structure's eligibility for the National Register under Criteria A-C. It was constructed in 1976.

Figure 56. House at 1129 Melvin Dupuis Rd., facing northeast. (Resource No. 50-00812)

Figure 57. House at 1129 Melvin Dupuis Rd., facing north. (Resource No. 50-00812)

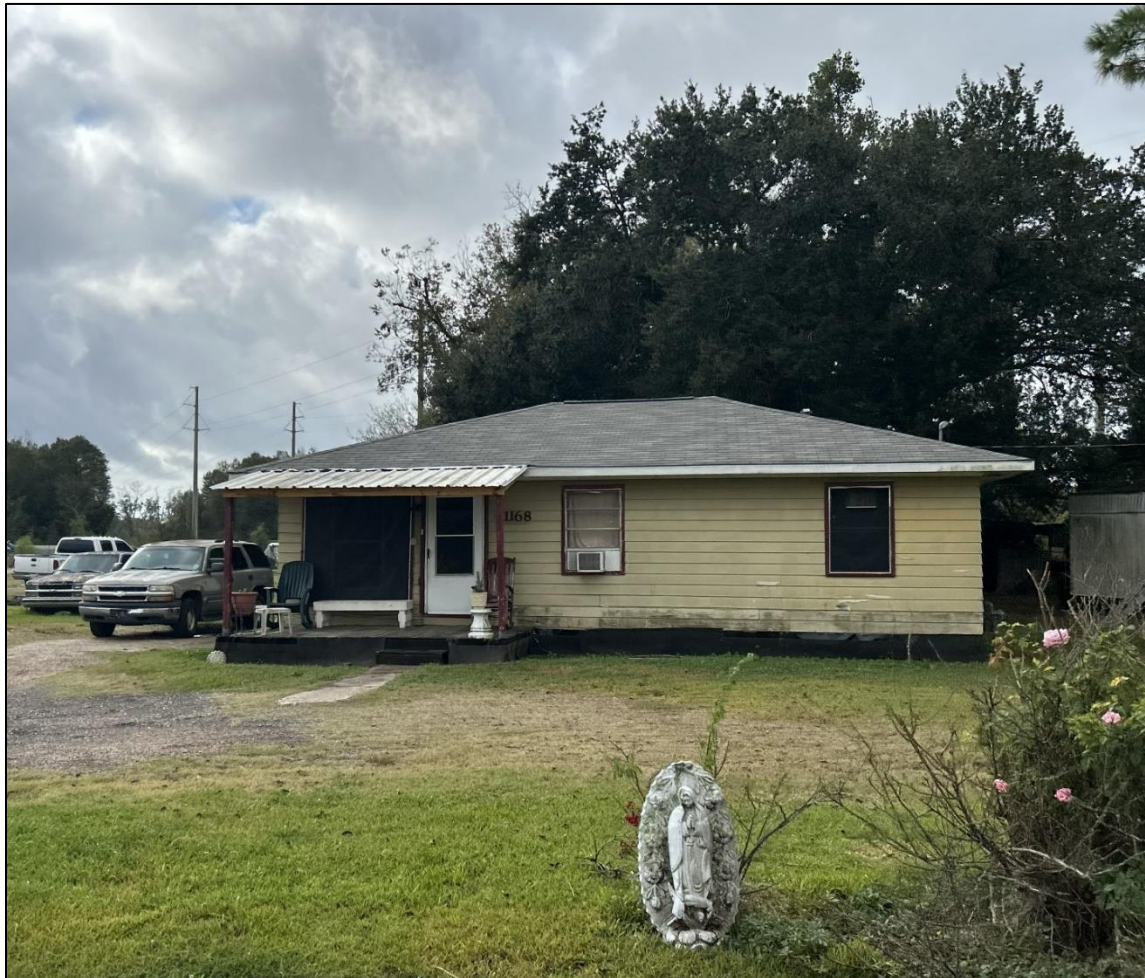
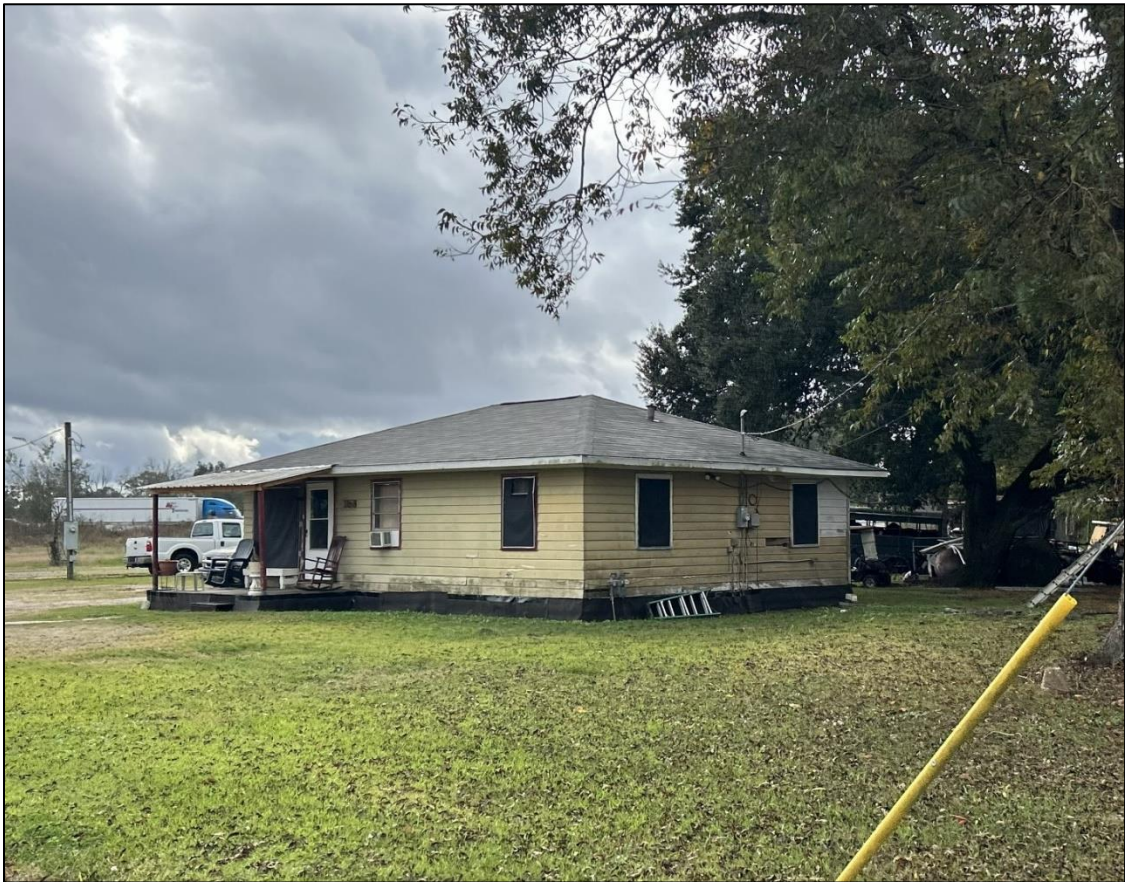
This is a one story clapboard-sided wood frame house on concrete piers. It has an asphalt shingle, hipped roof with a small front porch or portico shaded by a metal corrugated cover. Windows are aluminum, double-hung and it has an aluminum storm door. It is in fair condition. There is nothing about it to suggest eligibility under Criteria A-C of the National Register criteria considerations. The house is currently tenanted. It dates from 1976.

Figure 58. House at 1168 Melvin Dupuis Rd, facing southwest.

Figure 59. House at 1168 Melvin Dupuis Rd, facing south.

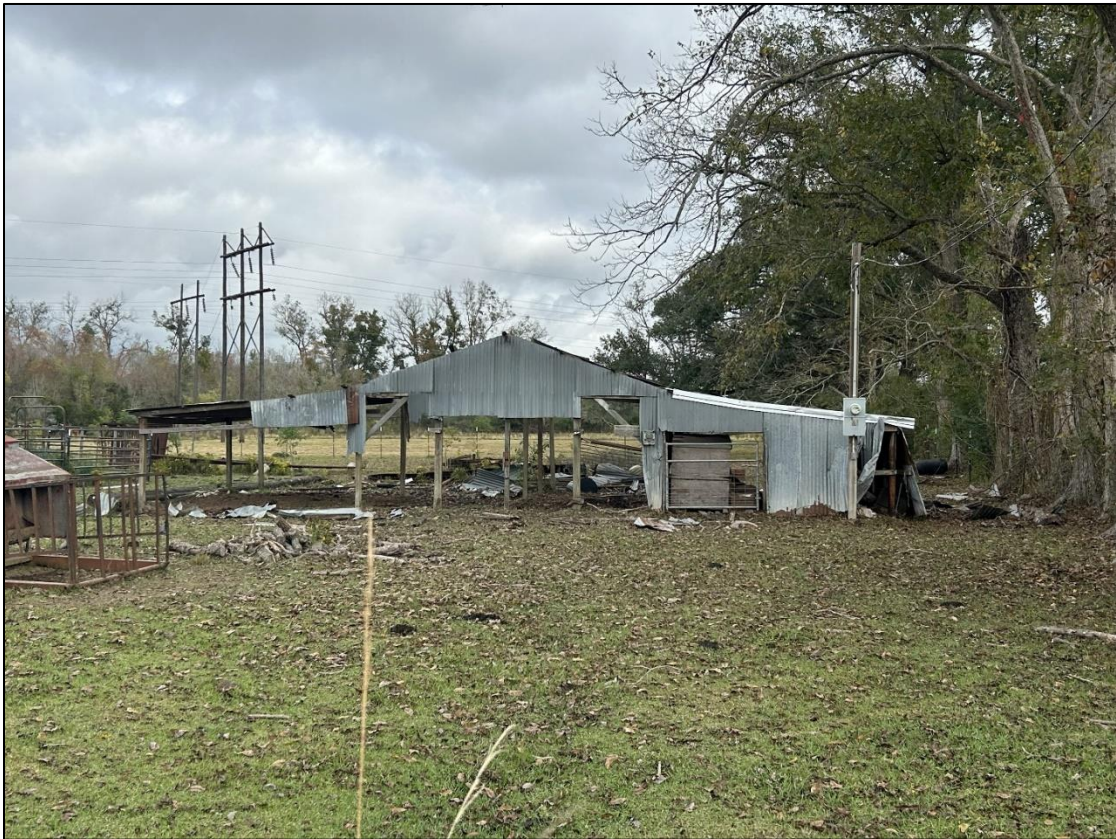
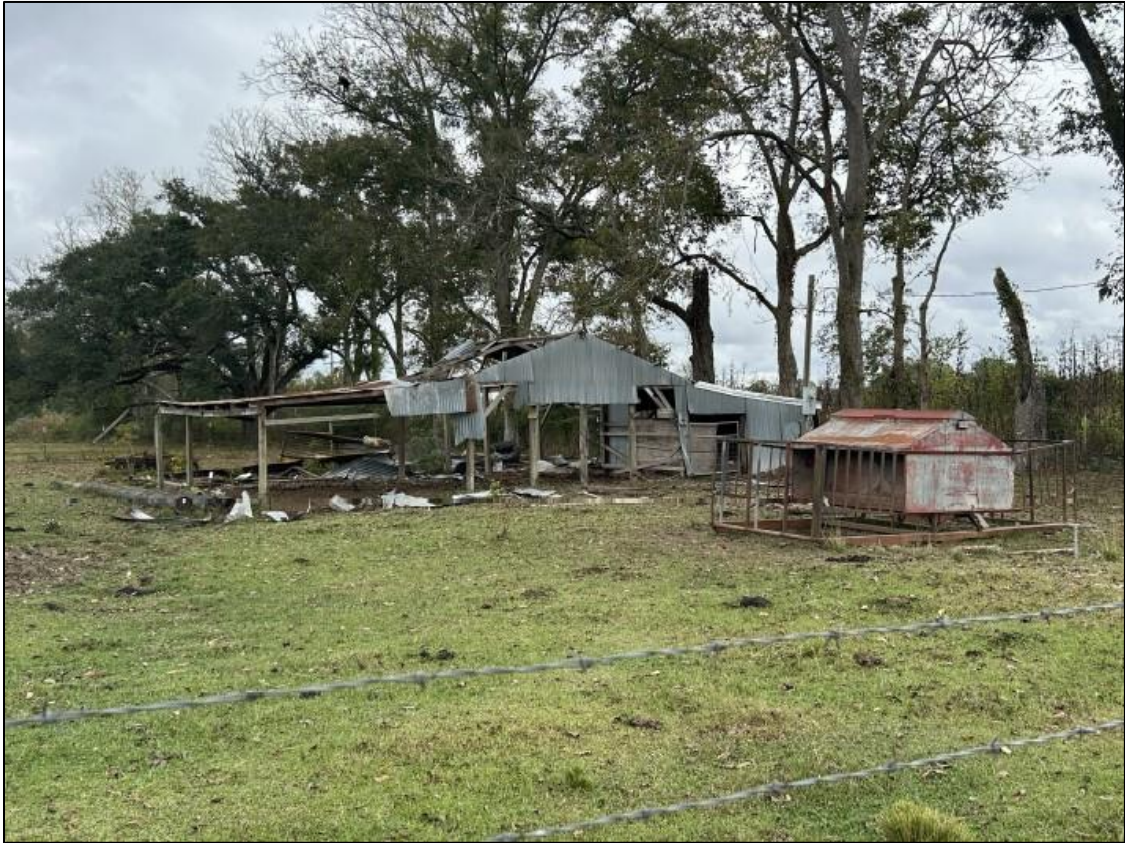
This transverse crib barn has a wooden frame and corrugated metal sides. The metal sides are falling off and the structure seems to be in a process of collapse. The structure lacks the integrity necessary for National Register eligibility.

Figure 60. Barn off Melvin Dupuis Rd., facing east.

Figure 61. Barn off Melvin Dupuis Rd., facing northeast.

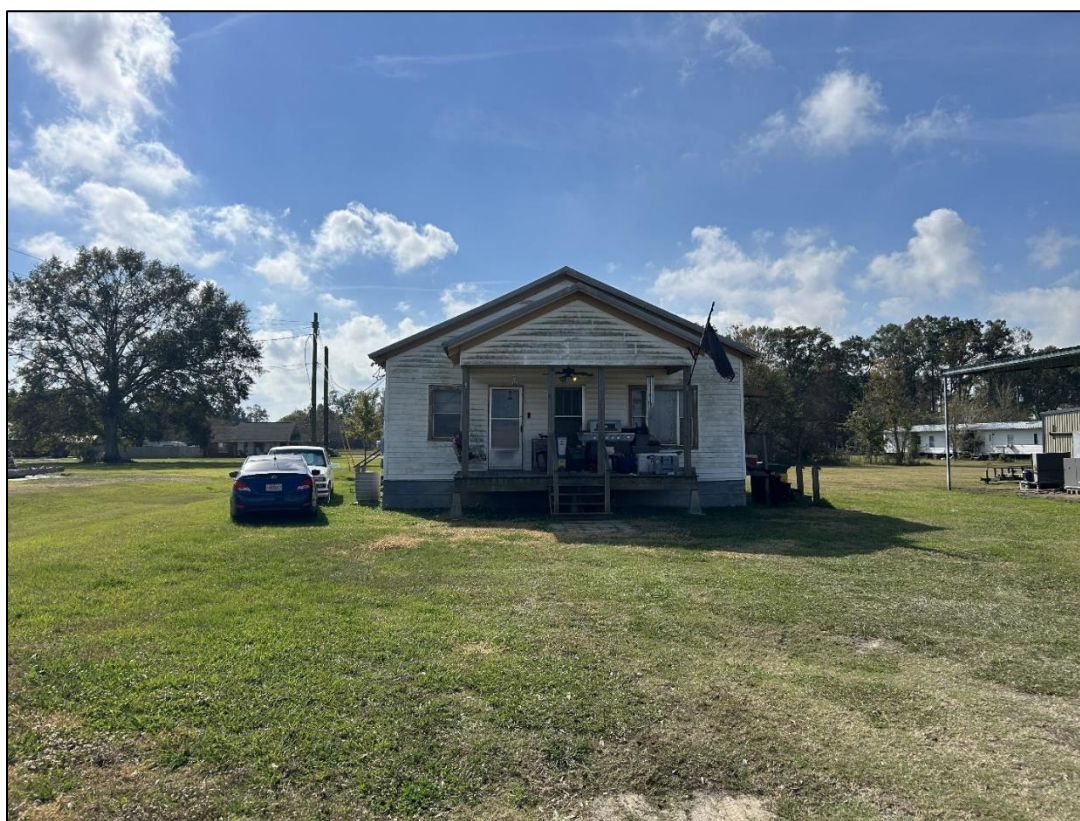
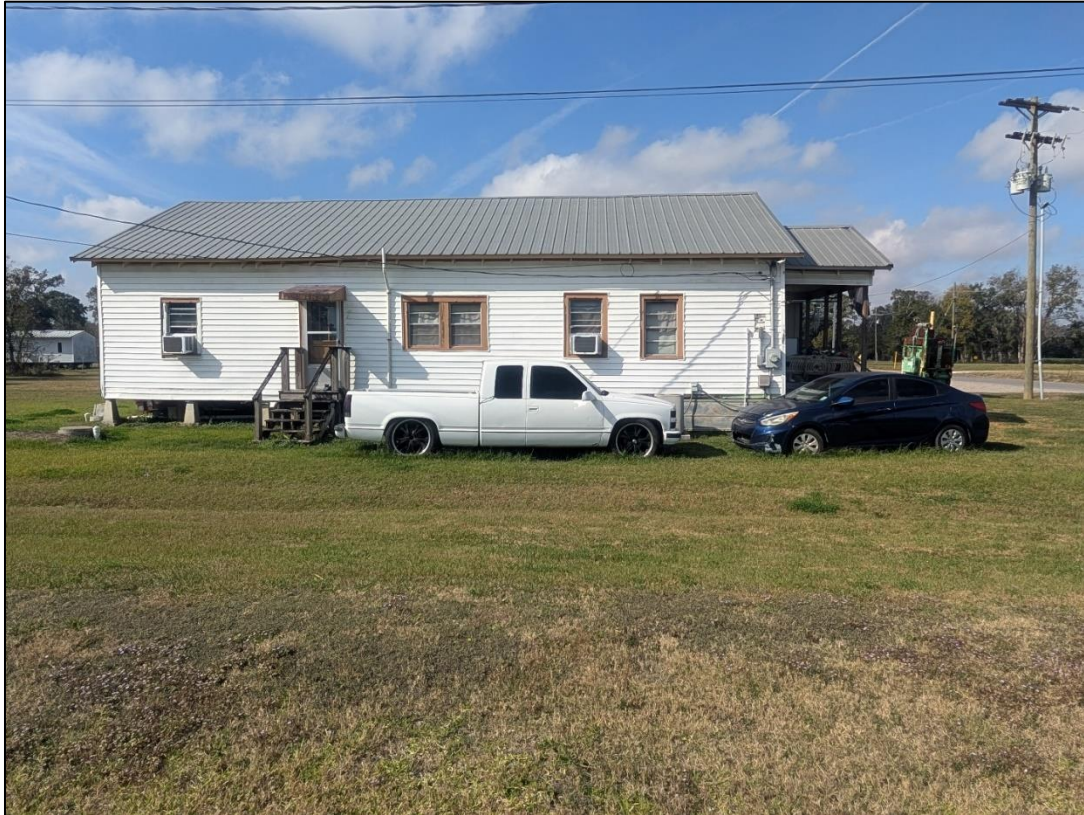
This 1940, one story house features elements of the dog-trot form, albeit without chimney. It has a central hallway and a front porch. The roof is corrugated metal and the construction is clapboard, wood frame. Windows are double hung and, and there is a gabled front porch. There is also a side entranceway with a metal awning. The structure is elevated on concrete piers. Its condition is fair and it is inhabited. There is a modern (ca. 21st century) garage to one side. It does not appear to qualify for the National Register under Criteria A-C).

Figure 62. House at 1276 Dermelie Callais, Facing south.

Figure 63. House at 1276 Dermelie Callais, facing west.

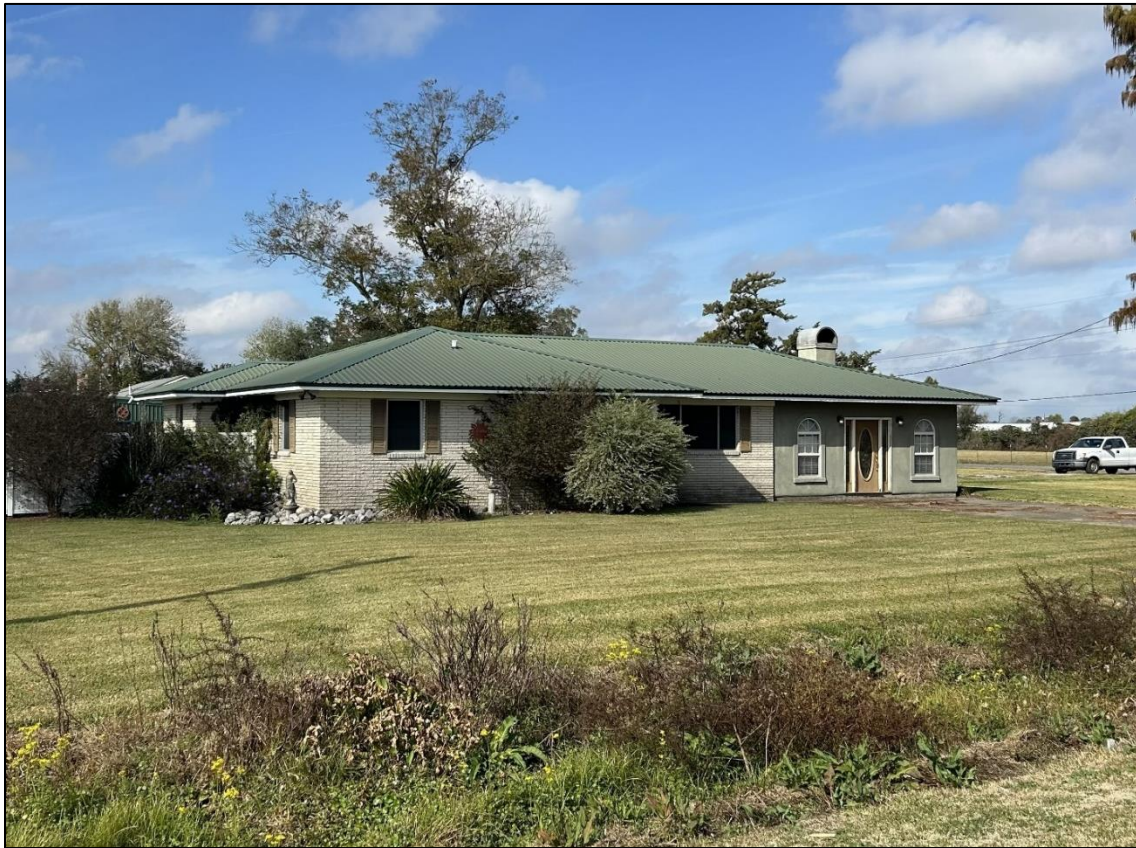
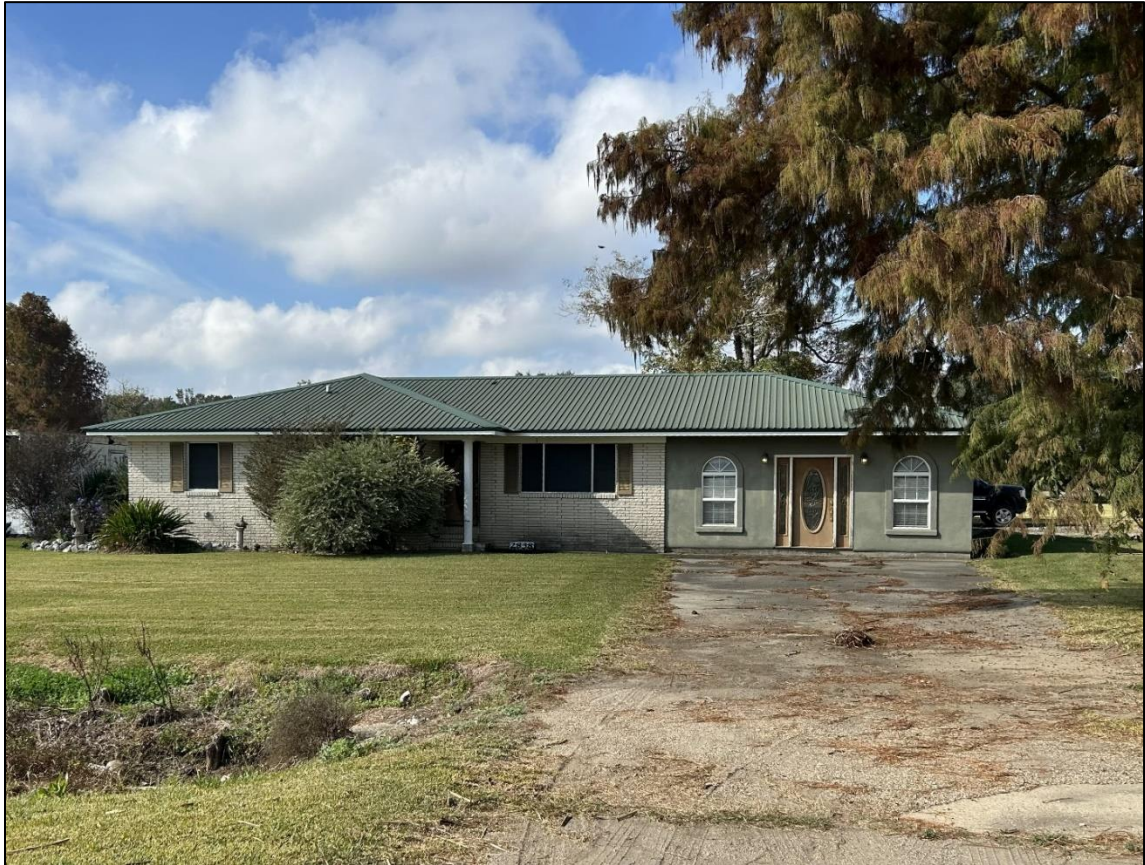
This 1968 structure is a one story, brick ranch-style house with a corrugated metal, hipped roof. The northern addition has half-round top double-hung windows. It is set on a slab foundation. It has double-hung aluminum windows. The house has an adjacent garage structure to the southwest. There is a chimney on the north end of the house. This house would not qualify for the National Register under Criteria A-C.

Figure 64. 2838 Grand Point Hwy, facing northwest.

Figure 65. 2838 Grand Point Hwy, facing west.

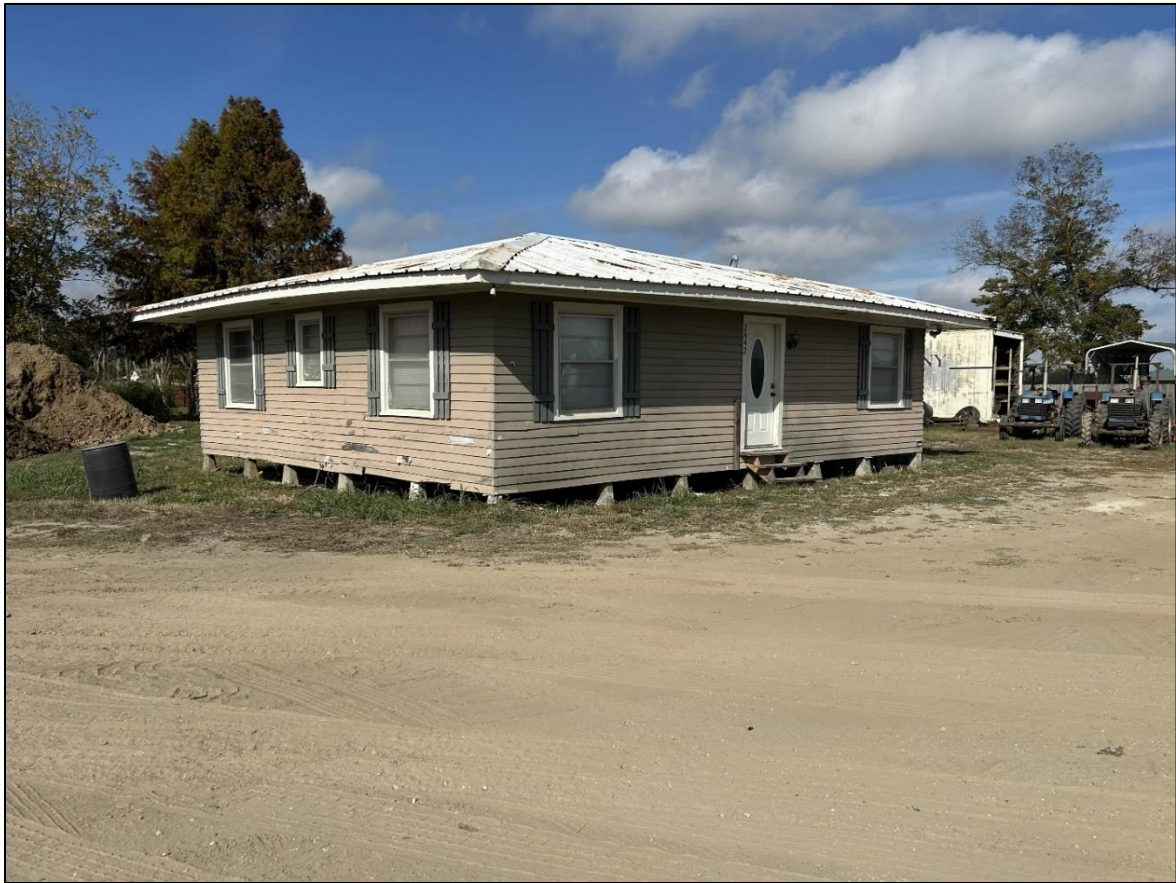
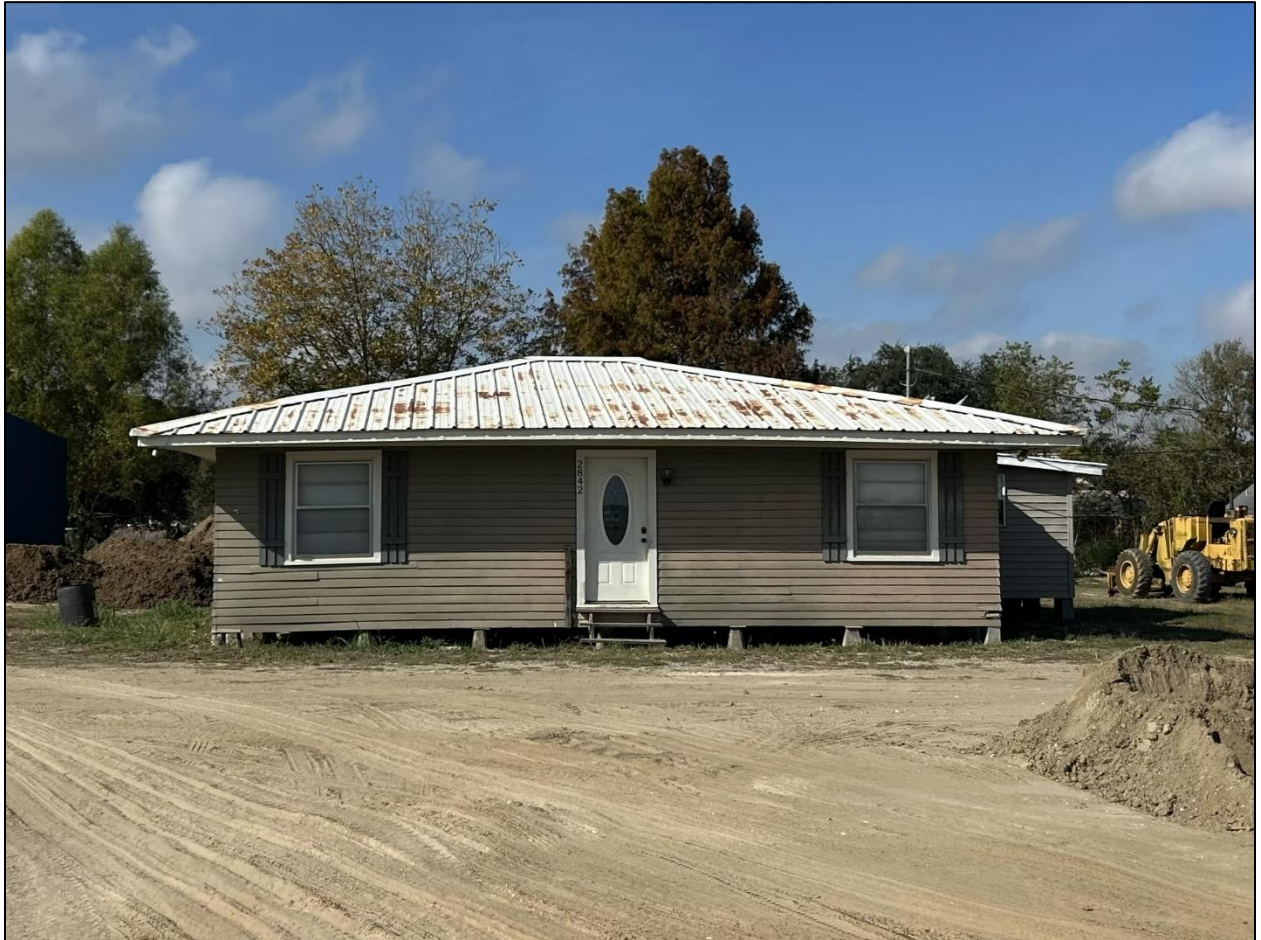
This one story, wood frame clapboard sided house has a corrugated metal, hipped roof and is set on concrete piers. Records suggest it was built in 1940. Today, it may be in use as a construction headquarters. An apparent bathroom with a single pitch corrugated metal roof is added on to the northwest side. The windows are double-hung and the front door is modern. Condition is good, but the surrounding construction suggests it may be in danger of being demolished or moved. There is nothing about this structure to suggest its eligibility for the National Register under Criteria A-C.

Figure 66. Building at 2842 Grand Point Hwy, facing northwest.

Figure 67. Building at 2842 Grand Point Hwy, facing west.

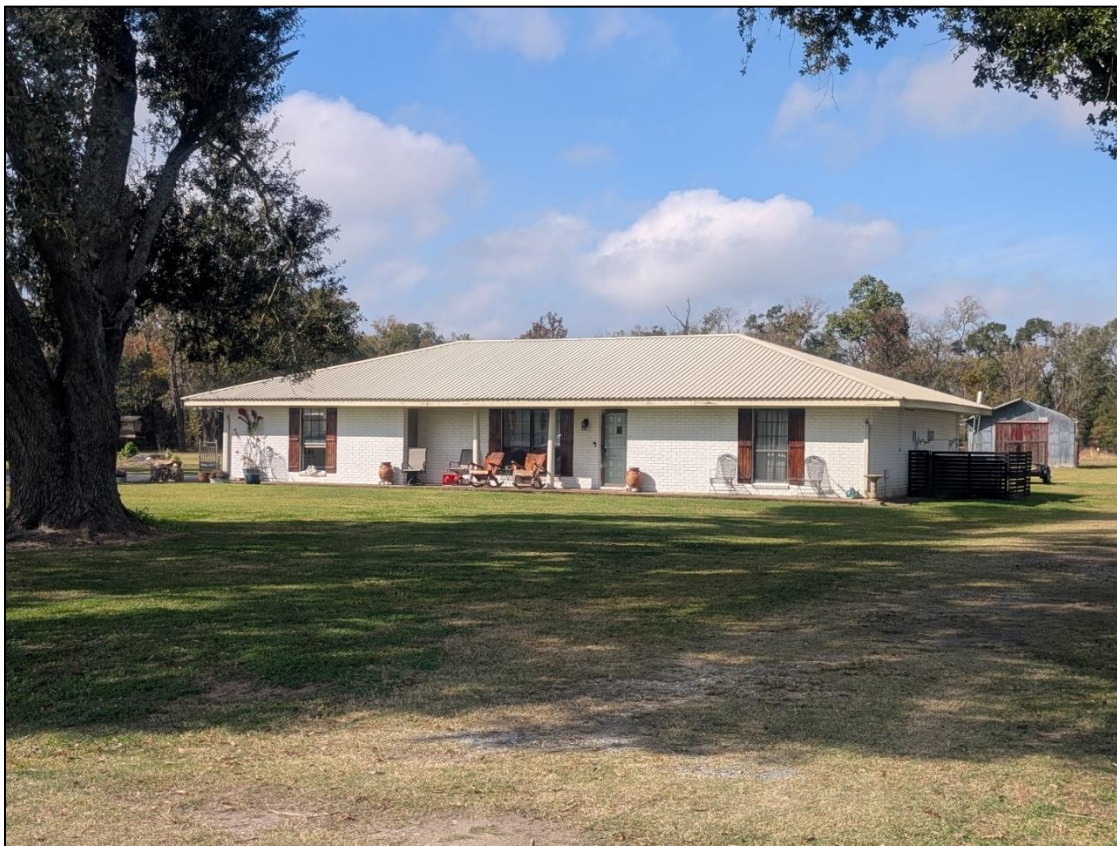
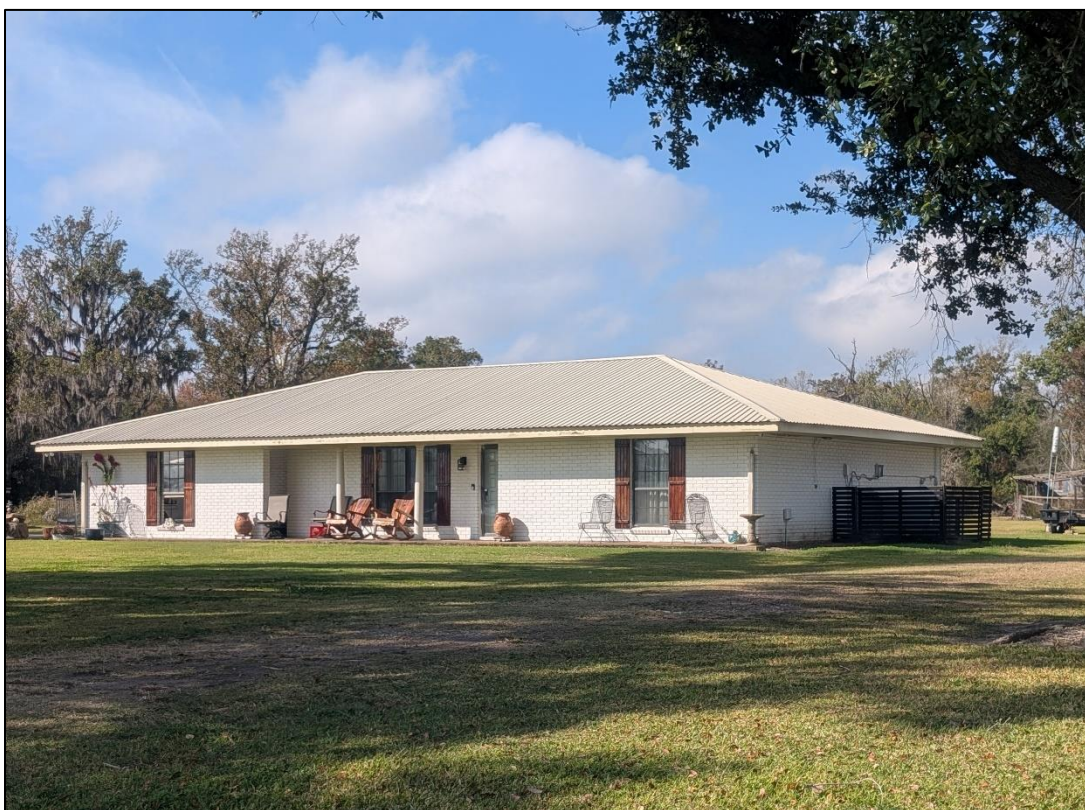
This structure was built in 1977. It is a one story brick home on a slab foundation. It has aspects of a ranch-style house but has a hipped corrugated metal roof. It has double-hung aluminum windows. There is a small brick outbuilding with corrugated roof adjacent to southeast. It has an interior garage and a north-facing picture window just to the left of the main door, on the front. There is nothing to suggest this structure to be eligible for the National Register under Criteria A-C.

Figure 68. House at 2868 Grand Point Hwy, facing southwest.

Figure 69. House at 2868 Grand Point Hwy, facing southwest.

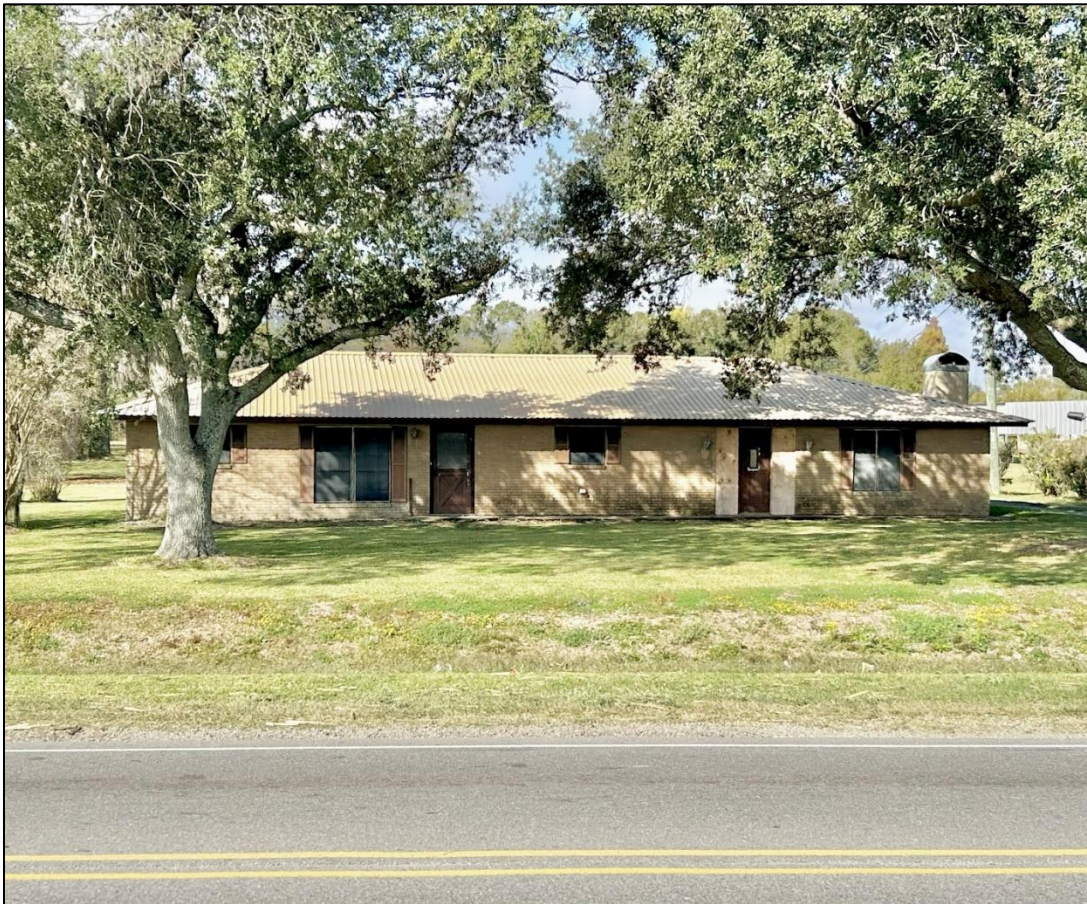
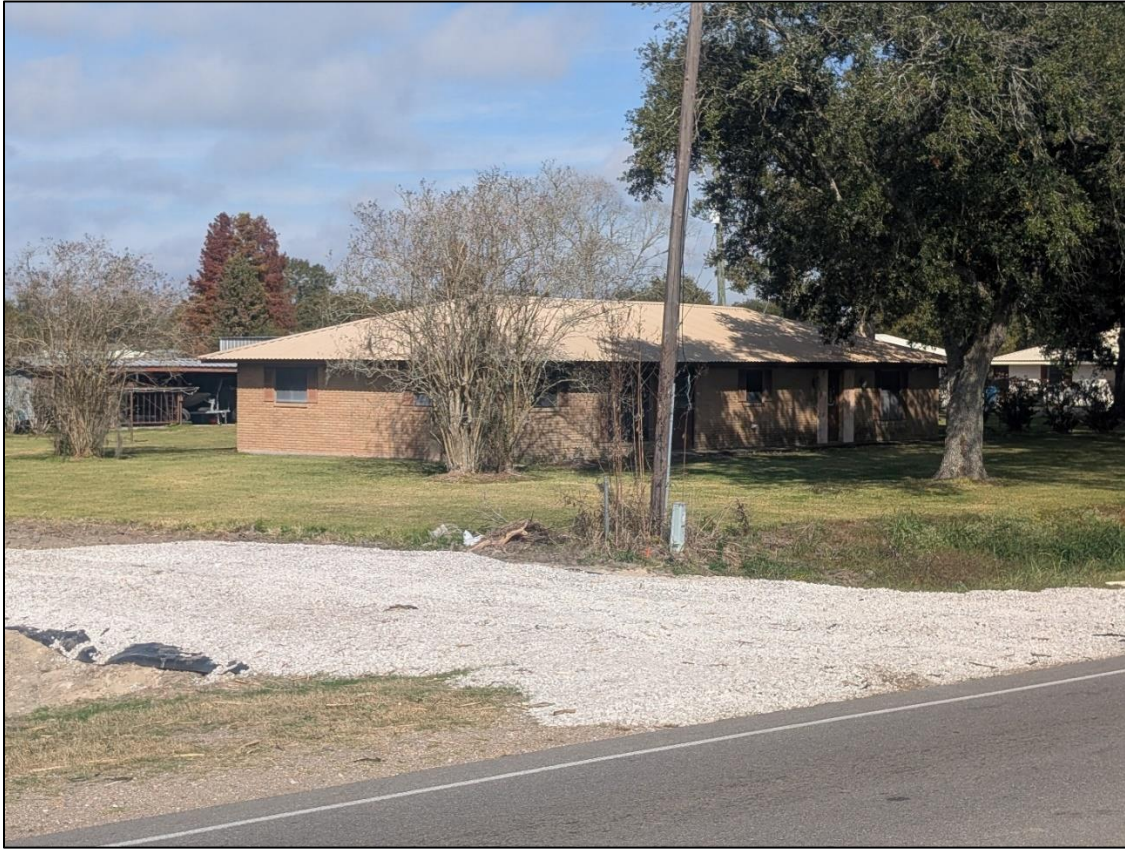
This one story brick structure is in the ranch style. It is set on a slab and has aluminum double-hung windows and a corrugated metal, hipped roof. Behind it is a corrugated metal boat shed. It is inhabited and in good condition. There is no aspect of it that would qualify it for the National Register under Criteria A-C. It dates to 1972.

Figure 70. Structure at 2876 Grand Point Hwy, facing west.

Figure 71. Structure at 2876 Grand Point Hwy, facing northwest.
