# Henderson I-10 Site Phase I Cultural Resources Assessment Report

**PHASE I CULTURAL RESOURCES SURVEY  
OF 147 ACRES (59.5 HECTARES)  
NEAR BREAUX BRIDGE, ST. MARTIN PARISH, LOUISIANA**

**Draft Report**

**January 2026**

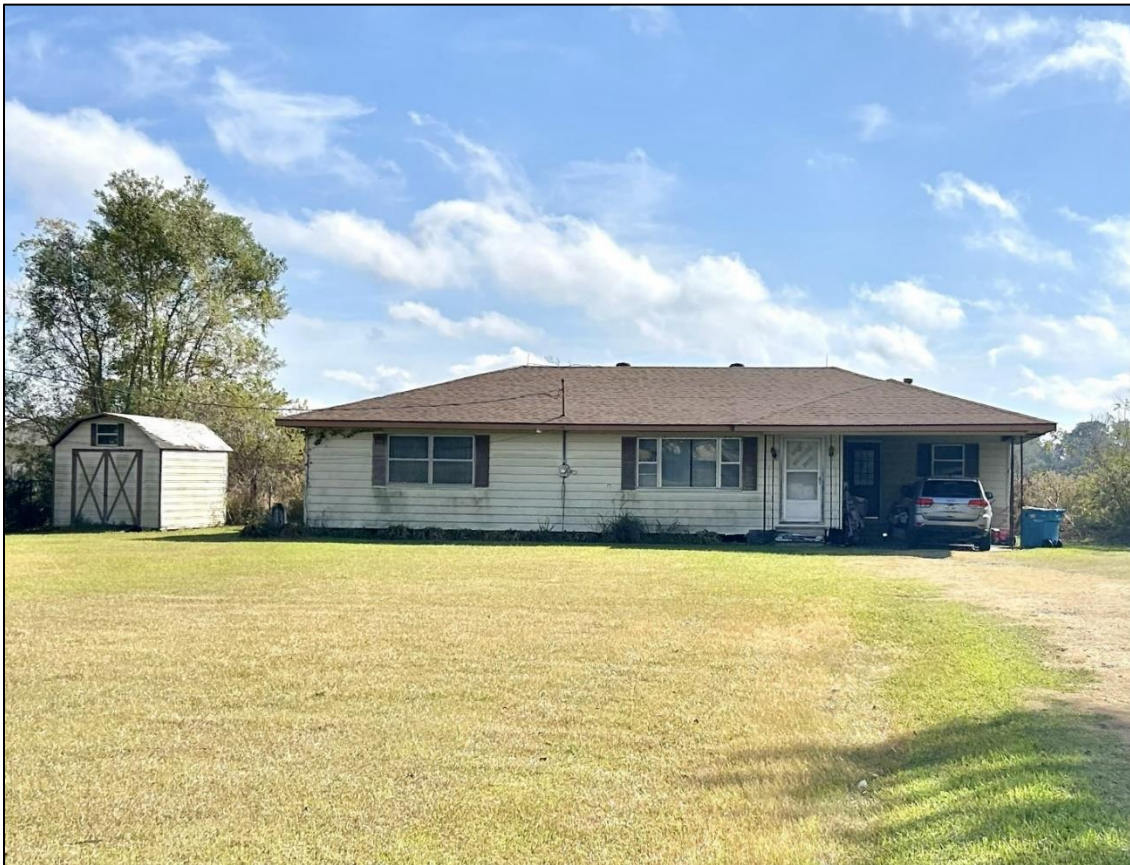
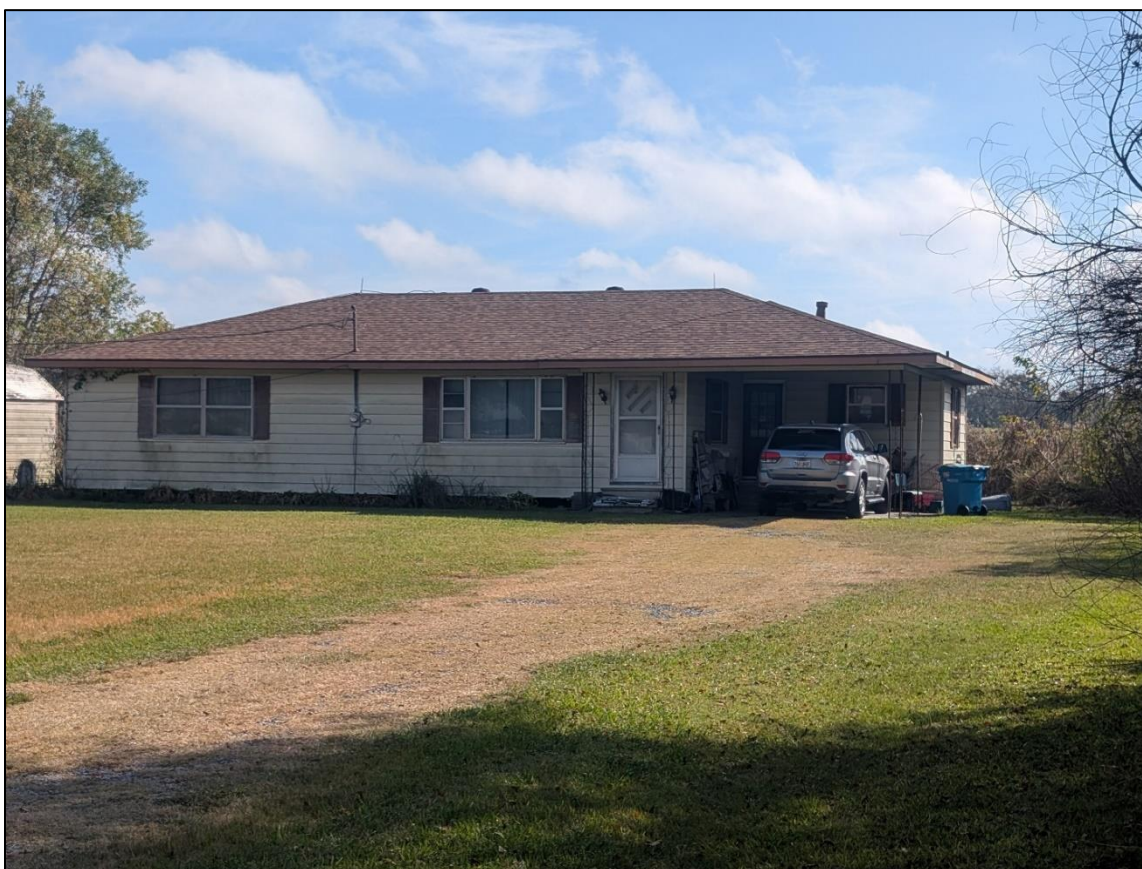
This is a 1960 one story, wood frame, clapboard sided ranch-style building with an asphalt shingle hipped roof. It has an open garage on one end and aluminum double-hung windows, except for one small picture window on the front, bracketed by double-hung windows. It is on a slab, and there is a metal prefabricated storage shed to the left. There is nothing about this structure to suggest its eligibility for the National Register under Criteria A-C

Figure 72. Structure at 2877 Grand Point Hwy, facing east.

Figure 73. Structure at 2877 Grand Point Hwy, facing east-south-east.

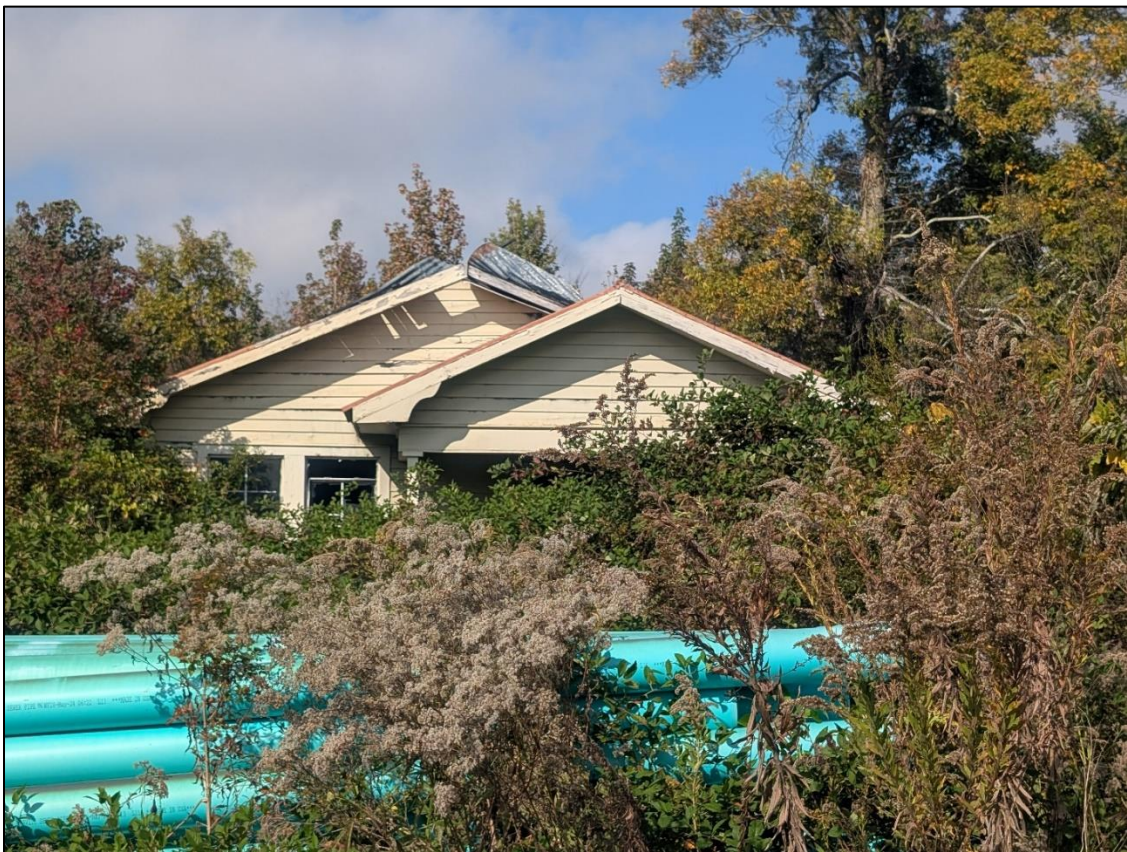
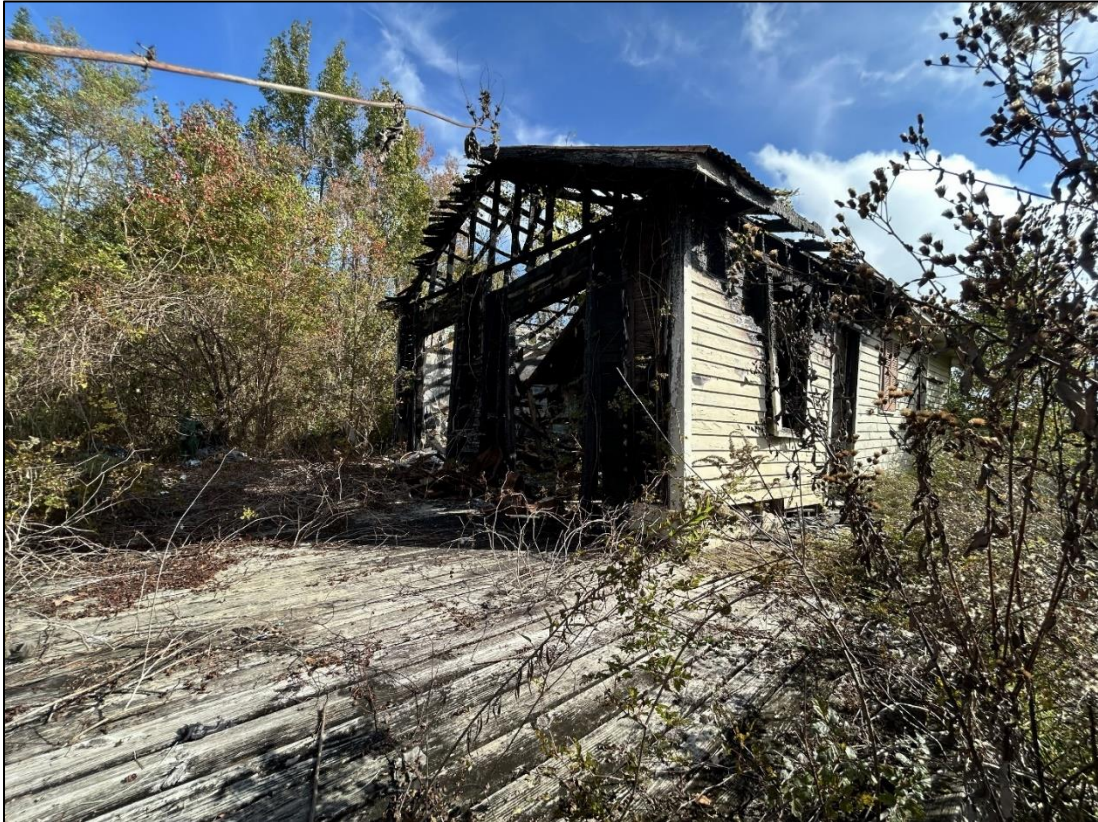
This one story, clapboard-sided wood-frame house is within the direct APE (Figure 49). It has been abandoned and is in a state of collapse, being overgrown by weeds and briars. It has apparently suffered fire damage to the attic area. It sits on concrete piers and has a corrugated, double-pitch metal roof and a gabled entranceway. It is in poor condition and is not eligible for the National Register under Criteria A-C, due to lack of integrity.

Figure 74. Building at 2894 Grand Point Hwy, facing west.

Figure 75. Building at 2894 Grand Point Hwy, facing northeast.

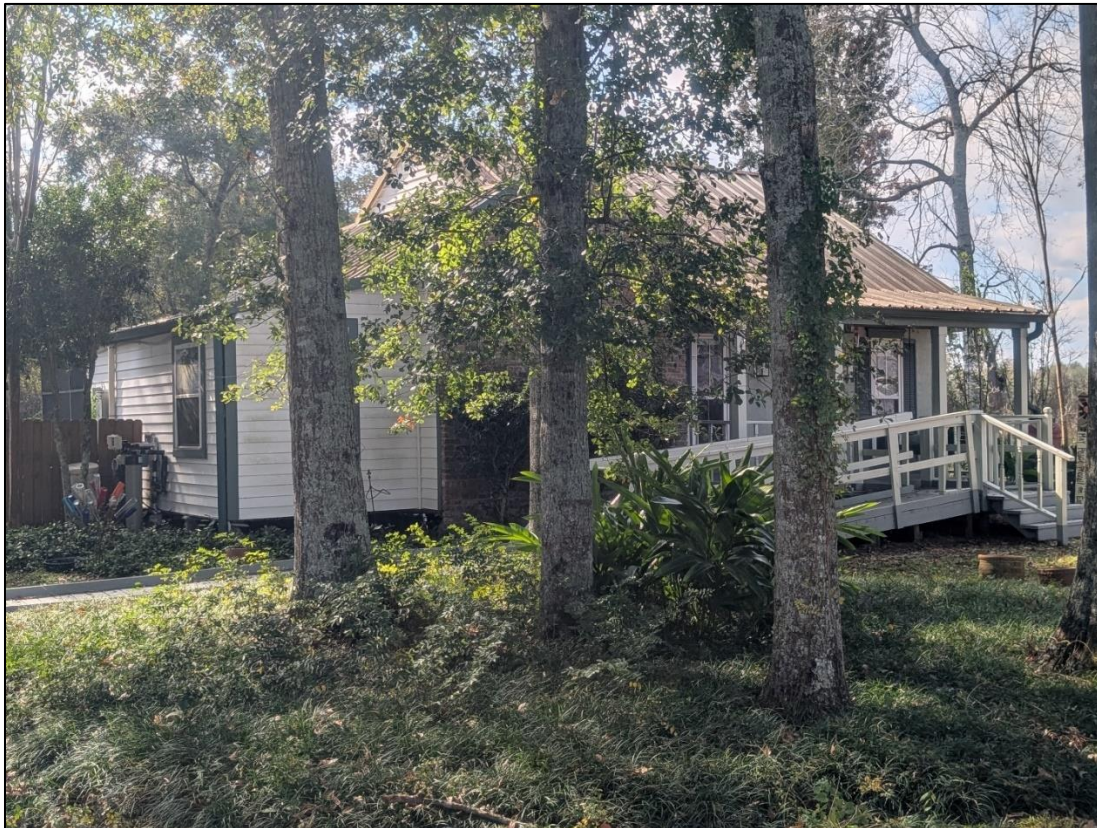
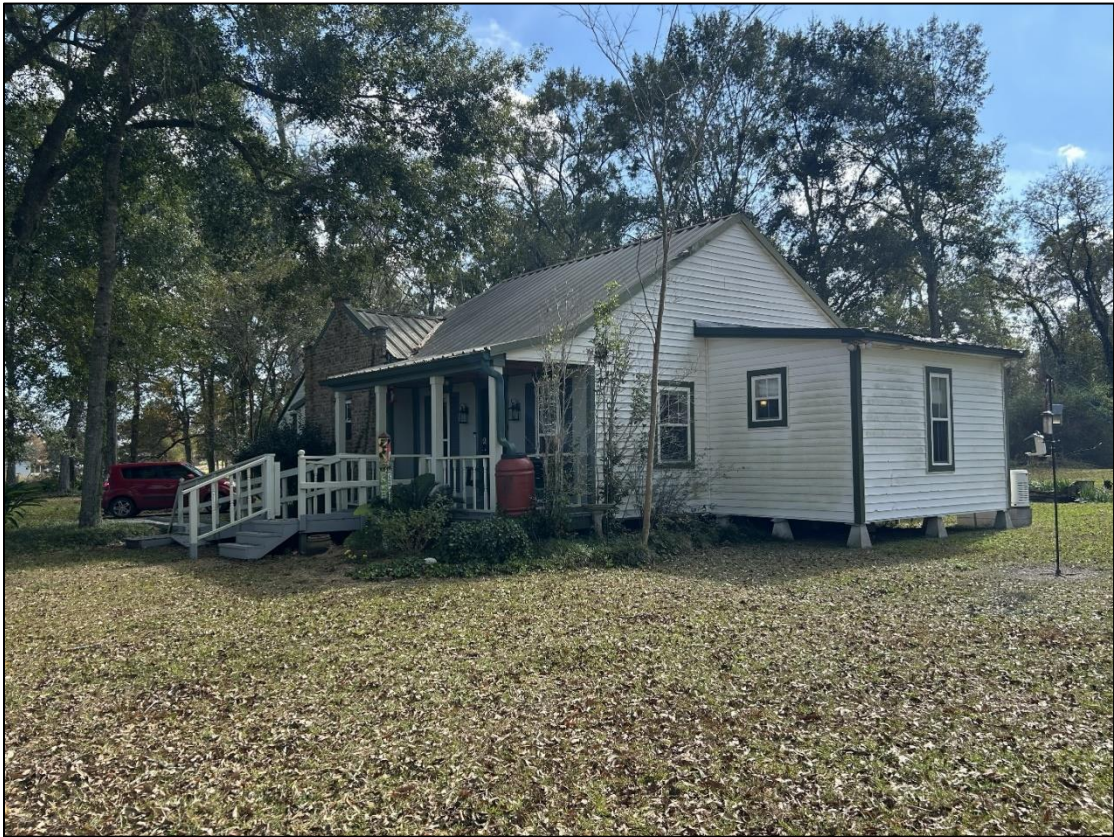
This structure was built in 1960. It is a one-story wood frame home with brick cladding; the exterior walls are covered by vinyl. It is elevated on concrete blocks and has a broken-pitch corrugated metal roof, and a wooden wheelchair ramp. There is a room added to the west side. This one story addition has a single-pitch corrugated metal roof. An open garage with a corrugated metal roof is to the east side of the main house. Its windows are double-hung. It is currently inhabited by Elaine Reilly Taylor. It is in good condition. It would not qualify for the National Register under Criteria A-C.

Figure 76. House at 1028 Shady Oaks Dr., facing south.

Figure 77. Structure at 1028 Shady Oaks Dr., facing northeast.

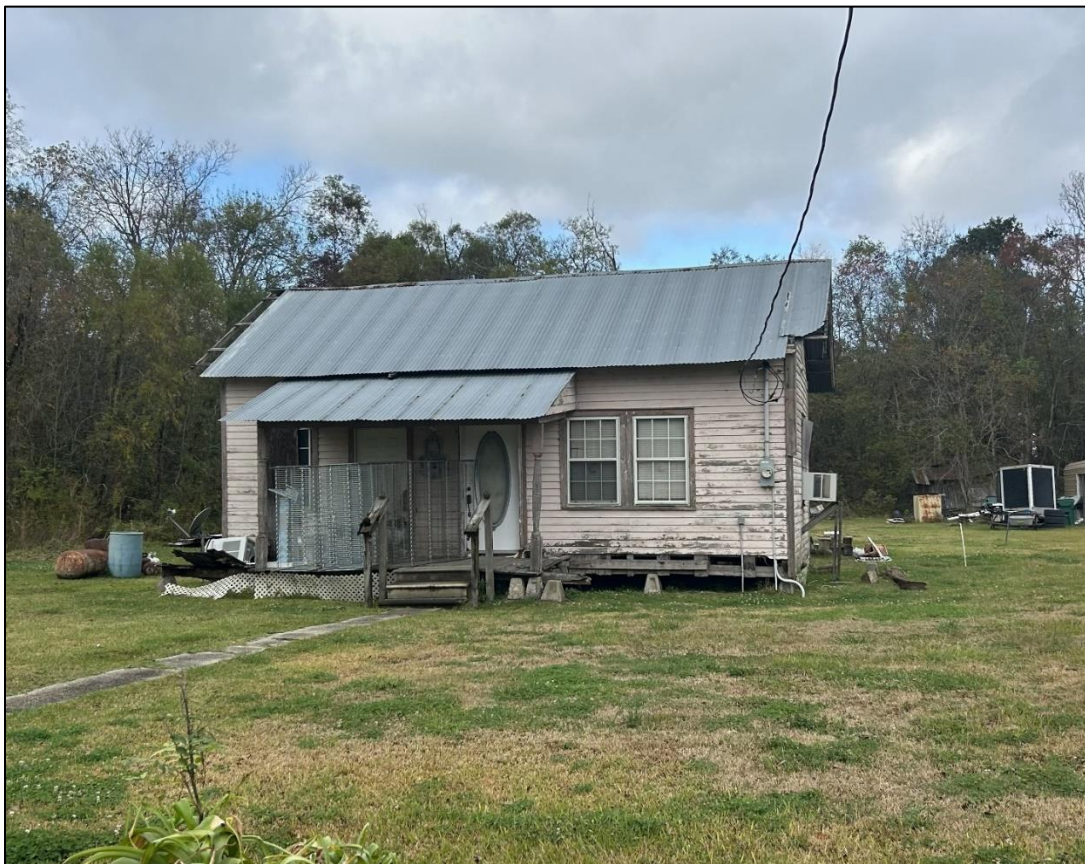
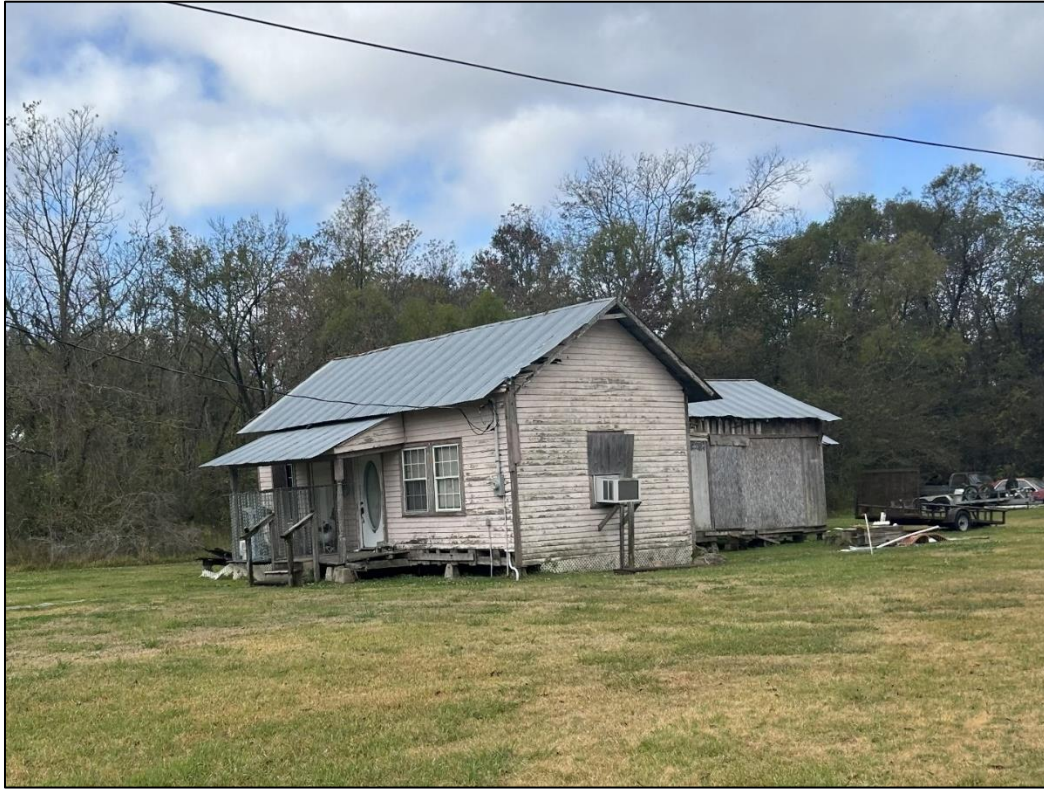
This is a single-story clapboard sided, wood frame house with a rear addition having plywood walls. The roofs are corrugated metal, pitched. There is a small, corrugated metal-covered portico in front of the front door. Windows are double hung. House and addition are elevated on concrete piers. Structure is inhabited but the condition is poor. This structure is ineligible for the National Register under Criteria A-C of the National Register.

Figure 78. House at 1062 Paul Rd., facing south.

Figure 79. House at 1062 Paul Rd., facing southeast
