**Exhibit GG. Livingston Industrial
Park Wetlands Delineation Report
& Transmittal Letter**

RE:
WETLAND DELINEATION REPORT
LEDC INDUSTRIAL PARK 77-ACRE TRACT
LIVINGSTON PARISH, LOUISIANA

**WETLAND DELINEATION REPORT
LEDC INDUSTRIAL PARK
77 – ACRE TRACT
LIVINGSTON PARISH,
WALKER, LOUISIANA**

GEC Project Number: 0013.2122013.009

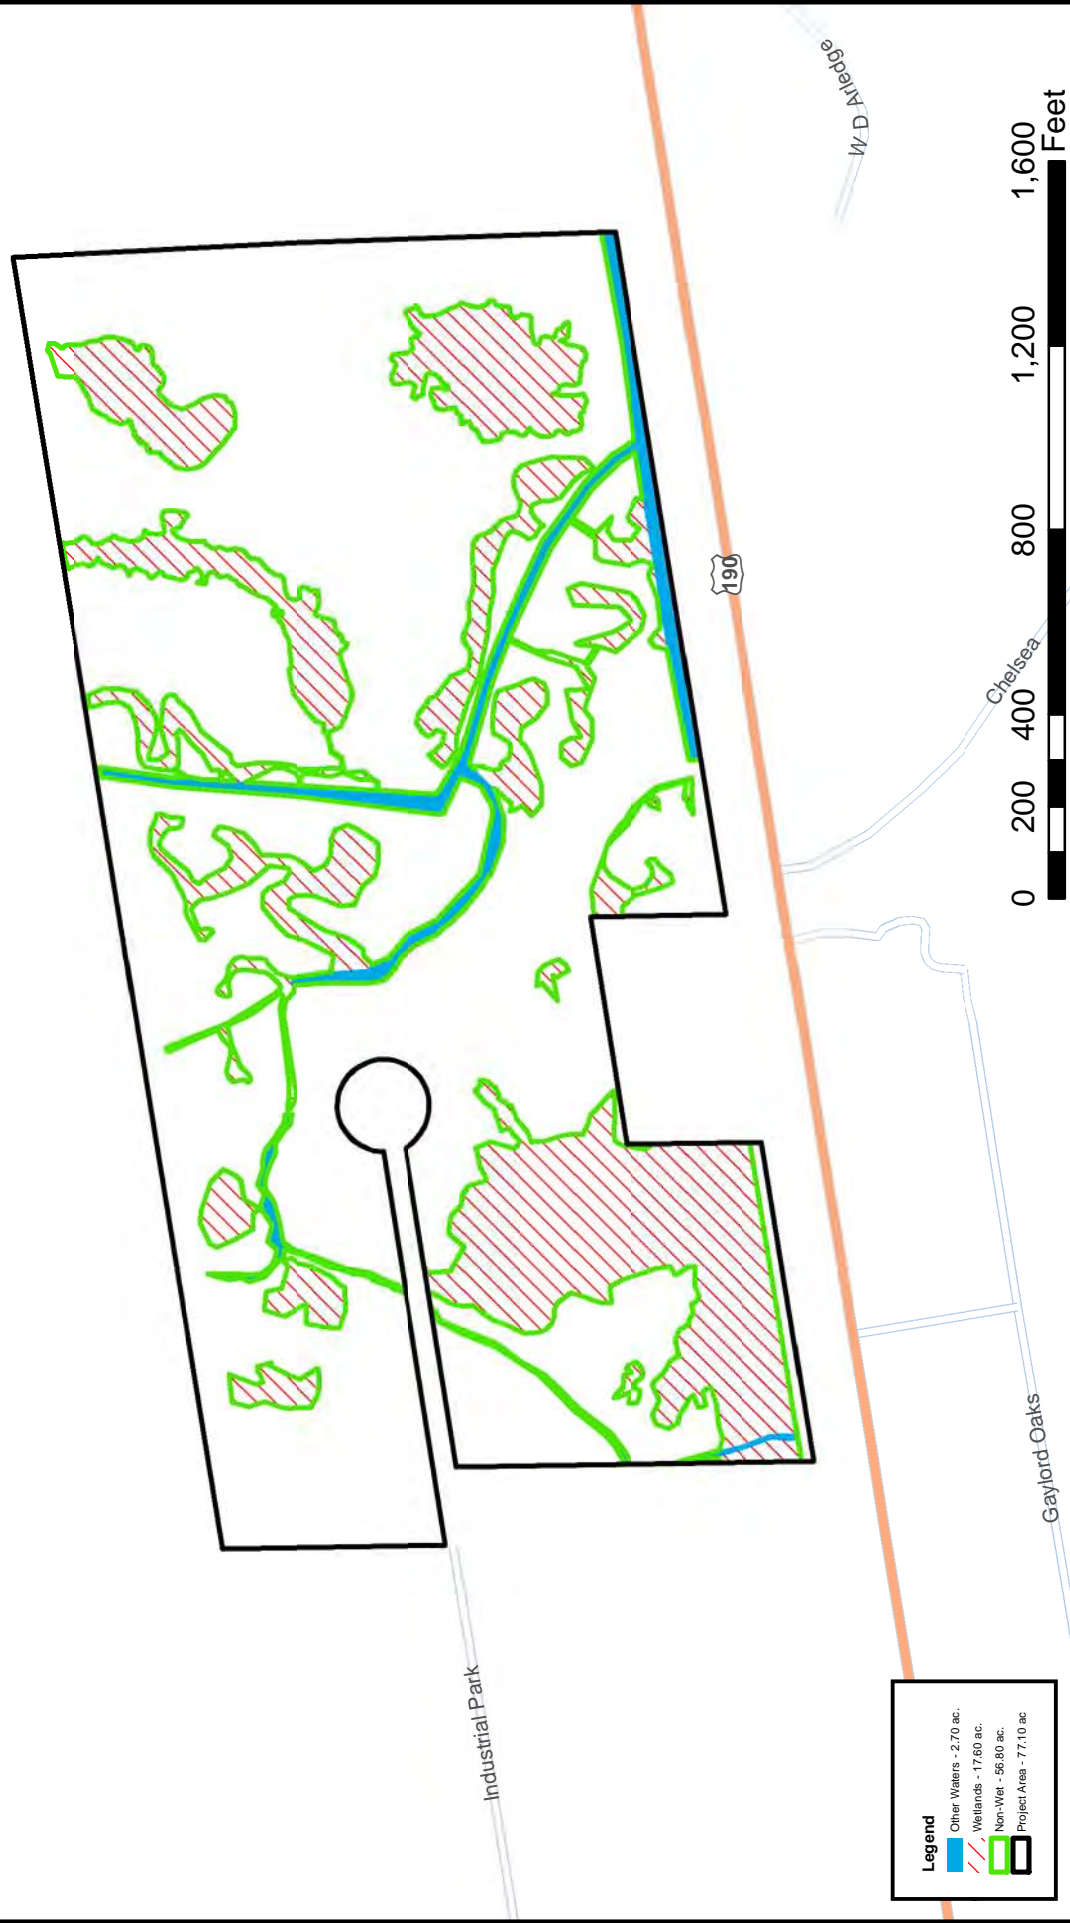
Figure: 3A

- Other Waters - 2.70 ac.
- Wetlands - 17.60 ac.
- Non-Wet - 56.80 ac.
- Project Area - 77.10 ac.

WETLAND MAP - JD

During the field investigation of the approximately 77-acre site in Livingston Parish, Louisiana, GEC mapped several wetland areas which can be grouped into those areas impacted by ponding associated with the bayou and areas impacted by past logging activities up slope consisting of wetland/upland mosaics where the hydrology is driven by rainfall. The total acreage of the wetland areas associated with the bayou total 4.40 acres. Two wetland areas mapped in yellow on figure 3 are wetland mosaics where approximately 50% of the acreage meets the criteria for a wetland. The wetlands in these two areas total approximately 1.70 acres of wetlands. In addition to those areas, there is a second area of wetland mosaic where an estimated 80percent of the acreage meets the definition of a wetland and encompasses approximately 0.96 acres. There are approximately 7.06 acres of wetlands within the project area.

In addition to the wetlands on site, are other waters and streams. The total acreage of the bayou is approximately 1.00 acre while the stream extending to the northeast and the ditches cut into the natural bank encompass approximately .40 acres within the project area. The remainder of the project area consists of non-wetland mature pine/hardwood forest.

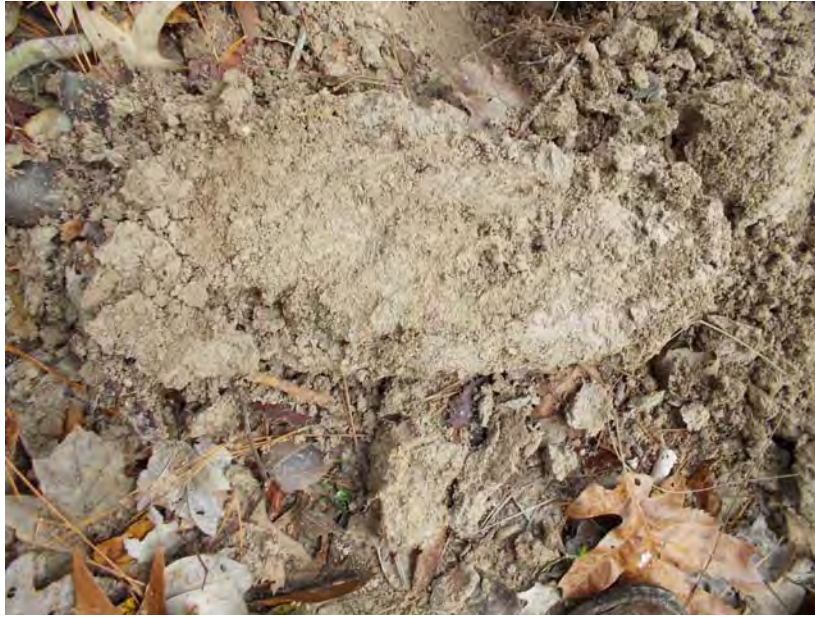
Photograph 1. Soil Profile Observed at Plot 1

The soil series mapped at this plot is the Ouachita, Ochlockonee, Guyton association, described as frequently flooded by the NRCS. Within this association, the Guyton series is listed on the National Hydric Soils list and the Ouachita and Guyton series are listed on the Louisiana Hydric Soils list. The hydric soils criterion is met at this plot due to the presence of a depleted matrix. Primary indicators of hydrology include water-stained leaves (B9) and aquatic fauna (B13) while secondary indicators include a positive FAC-neutral test (D5). It is GEC's opinion that this sample plot is within a wetland, based on the presence of hydric vegetation, hydric soils, and wetland hydrology within the plot (see Data Form Plot - 1).

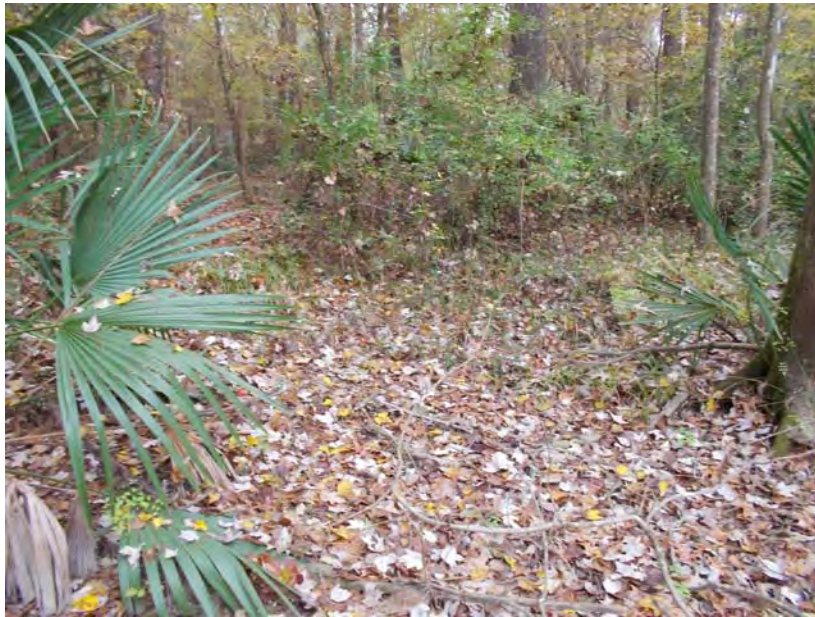
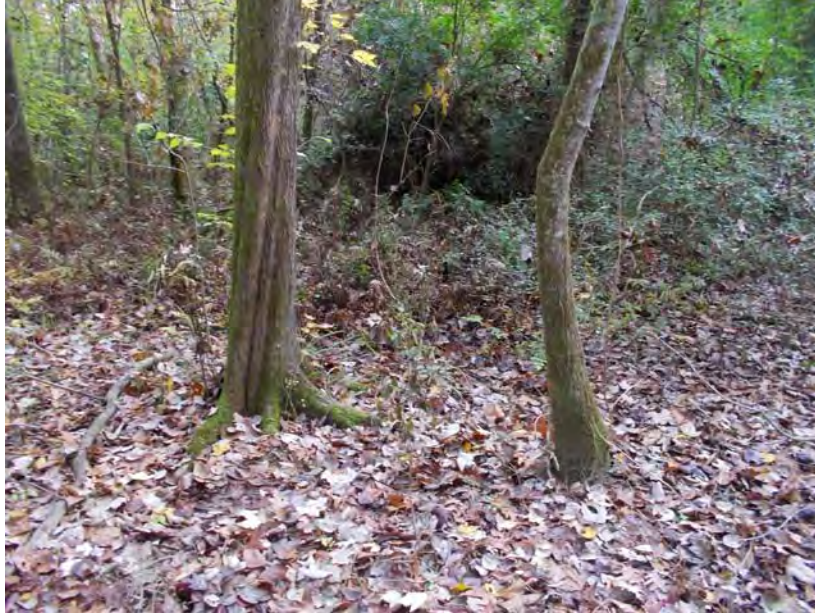
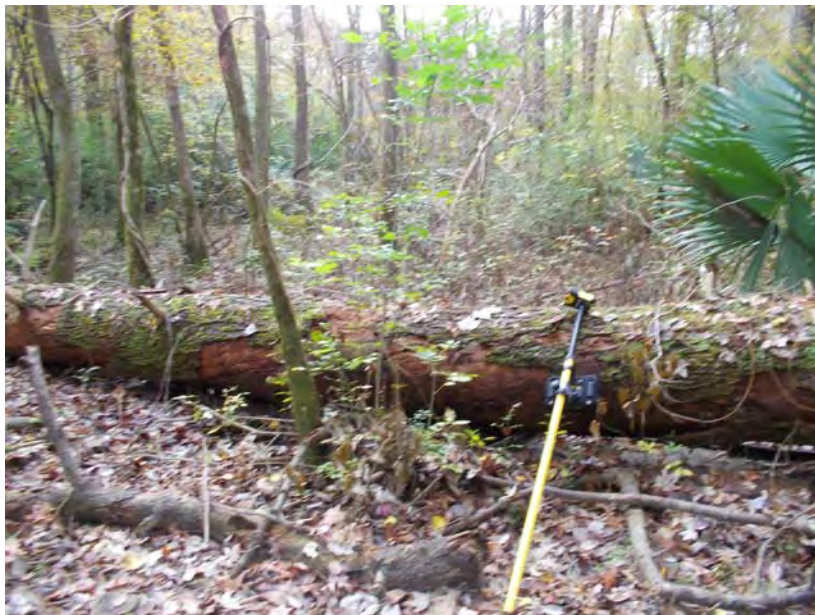
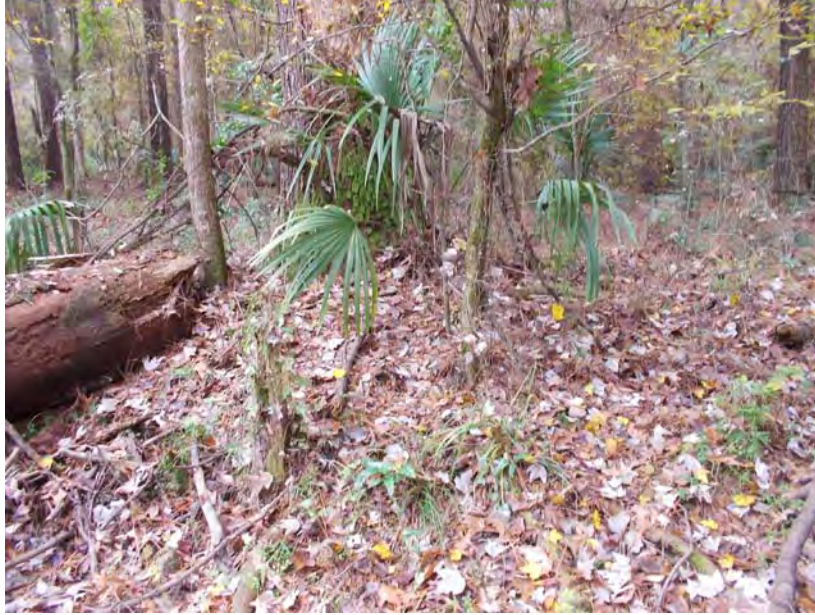
**Photograph 2. Overview of the Habitat Observed at Plot 1,
Facing North**

**Photograph 3. Overview of the Habitat Observed at Plot 1,
Facing East**

**Photograph 4. Overview of the Habitat Observed at Plot 1,
Facing South**

**Photograph 5. Overview of the Habitat Observed at Plot 1,
Facing West**

Sample Plot - 1: Sample Plot 1 is located within a backwater depression (Figure 3). The tree stratum is dominated by red maple (*Acer rubrum*), and black tupelo (*Nyssa aquatica*) while the sapling/shrub stratum is dominated by persimmon (*Diospyros virginiana*), and winged elm (*Ulmus rubra*). The herbaceous stratum is dominated by lizards tail (*Saururus cernuus*). The woody vine stratum is absent from this plot. The hydrophytic vegetation criterion is met within this sample plot.

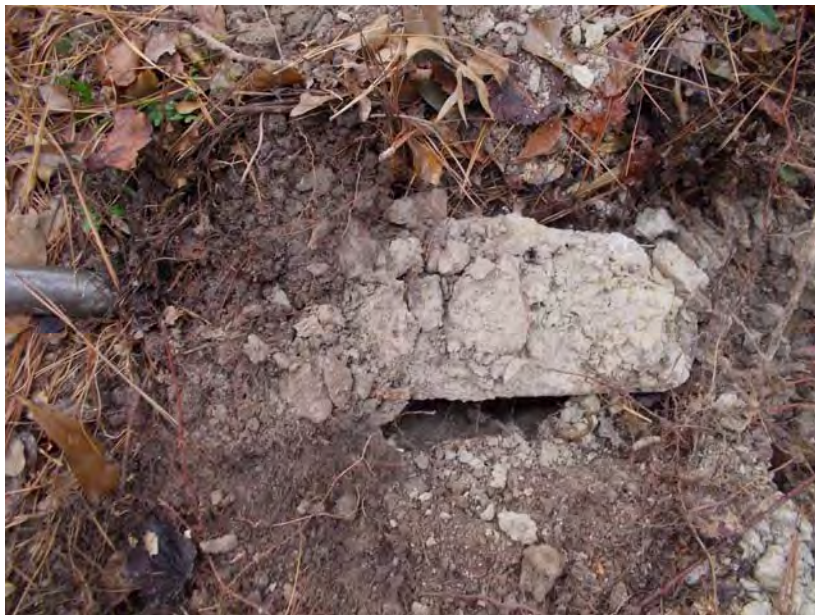
Photograph 6. Soil Profile Observed at Plot 2

The soil series mapped at this plot is the Ouachita, Ochlockonee, Guyton association, described as frequently flooded by the NRCS. Within this association, the Guyton series is listed on the National Hydric Soils list and the Ouachita and Guyton series are listed on the Louisiana Hydric Soils list. The hydric soils criterion is not met at this plot due to the absence of hydric soil indicators. Primary indicators of hydrology are lacking at this plot while the one secondary indicator includes a positive FAC-neutral test (D5). It is GEC's opinion that this sample plot is not within a wetland, based on the lack of hydric soils, and wetland hydrology within the plot (see Data Form Plot - 2).

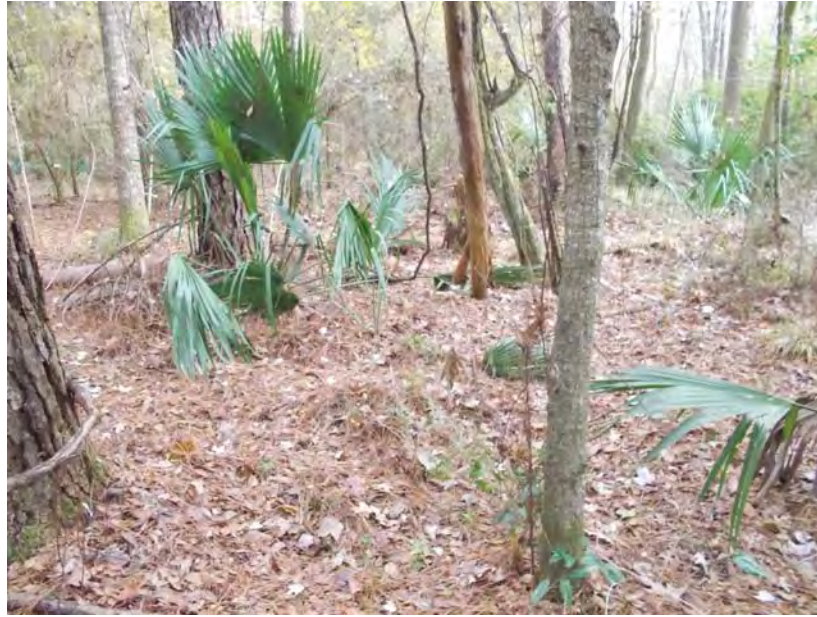
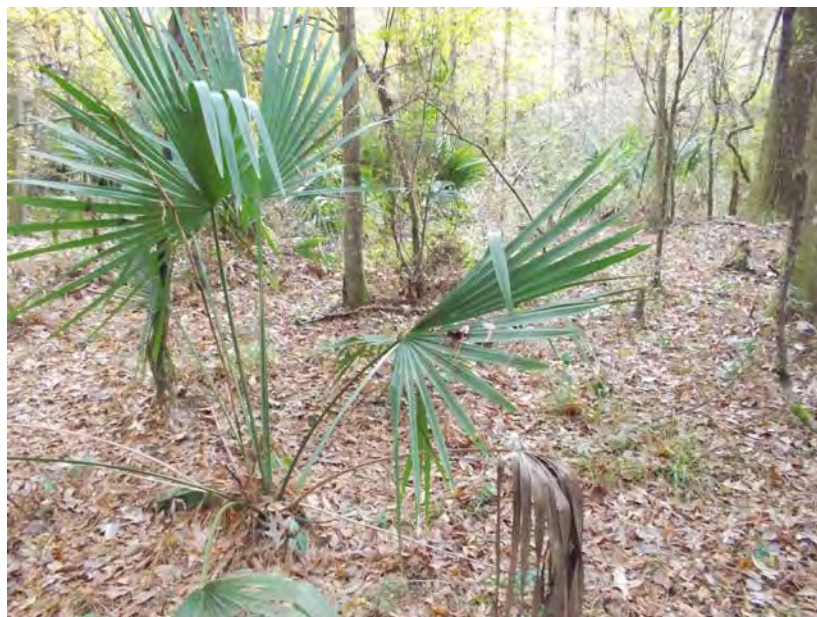
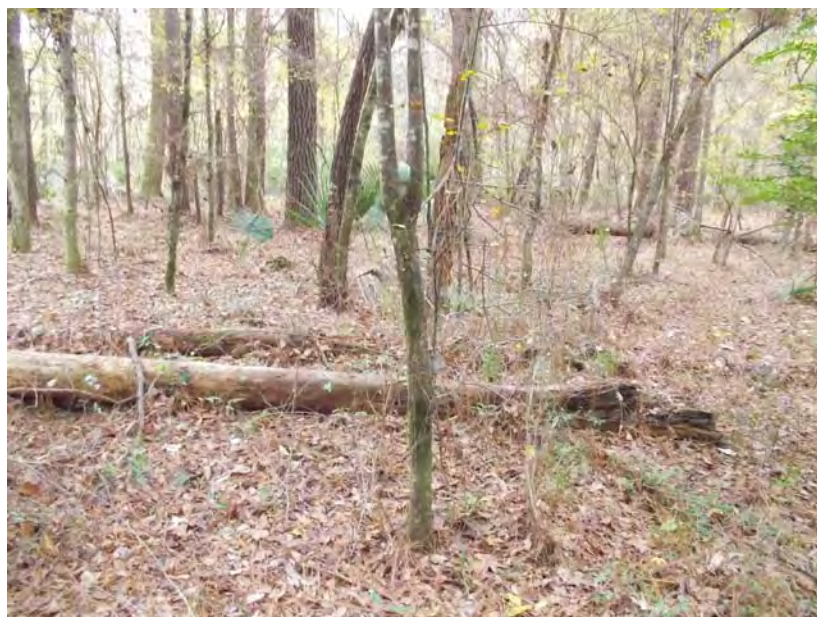
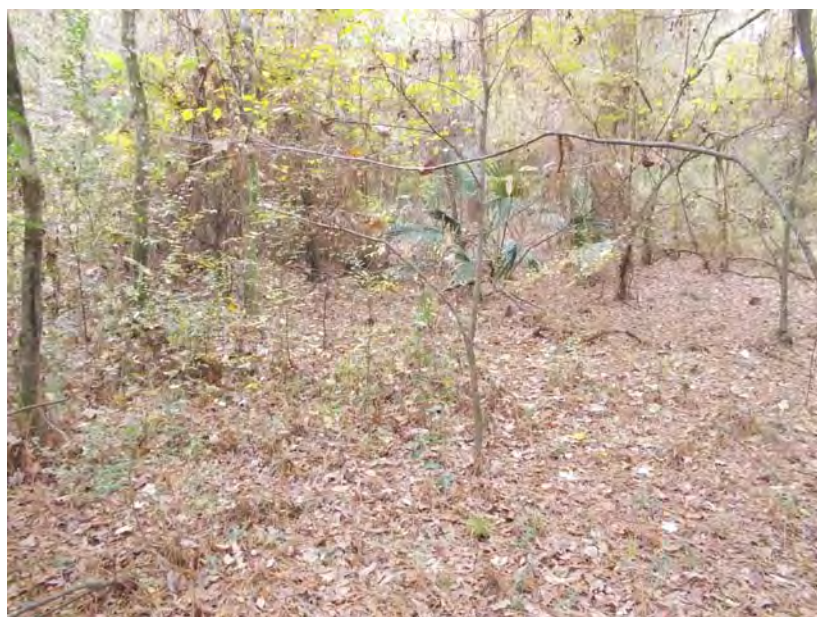
**Photograph 7. Overview of the Habitat Observed at Plot 2,
Facing North**

**Photograph 8. Overview of the Habitat Observed at Plot 2,
Facing East**

**Photograph 9. Overview of the Habitat Observed at Plot 2,
Facing South**

**Photograph 10. Overview of the Habitat Observed at Plot 2,
Facing West**

Sample Plot - 2: Sample Plot 2 is located in a mature pine/hardwood forest next to the wetland in plot 1 (Figure 3). The tree stratum is dominated loblolly pine (*Pinus taeda*) while the sapling/shrub stratum is dominated by winged elm, and American hornbeam (*Carpinus caroliniana*). The herbaceous stratum is dominated by dwarf palmetto (*Sabal minor*), and long-leaf wood oats (*Chasmanthium sessiliflorum*). The woody vine stratum is dominated by muscadine grape (*Vitis rotundifolia*). The hydrophytic vegetation criterion is met within this sample plot.

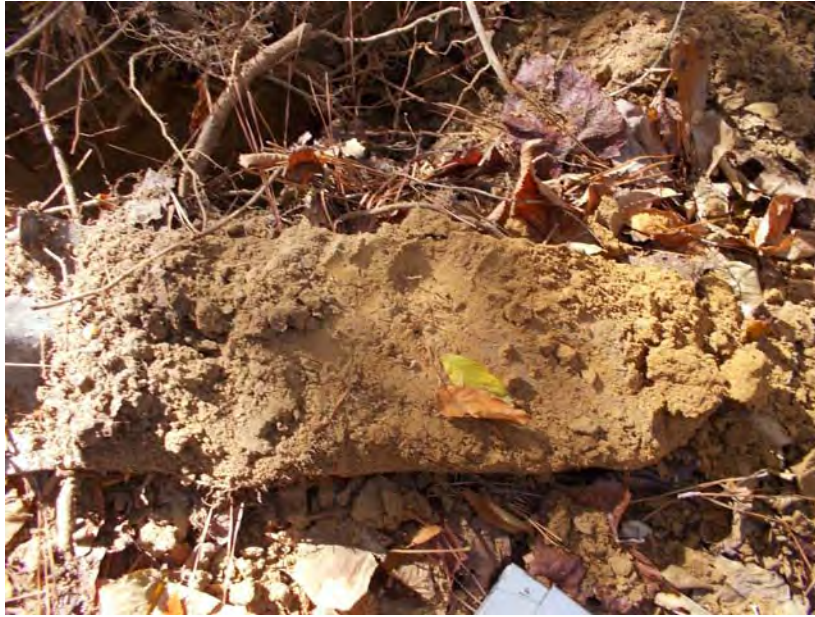
Photograph 11. Soil Profile Observed at Plot 3

The soil series mapped at this plot is the Ouachita, Ochlockonee, Guyton association, described as frequently flooded by the NRCS. Within this association, the Guyton series is listed on the National Hydric Soils list and the Ouachita and Guyton series are listed on the Louisiana Hydric Soils list. The hydric soils criterion is not met at this plot due to the absence of hydric soil indicators. Primary and secondary indicators of hydrology are lacking at this plot. It is GEC's opinion that this sample plot is not within a wetland, based on the lack of hydric soils, and wetland hydrology within the plot (see Data Form Plot - 3).

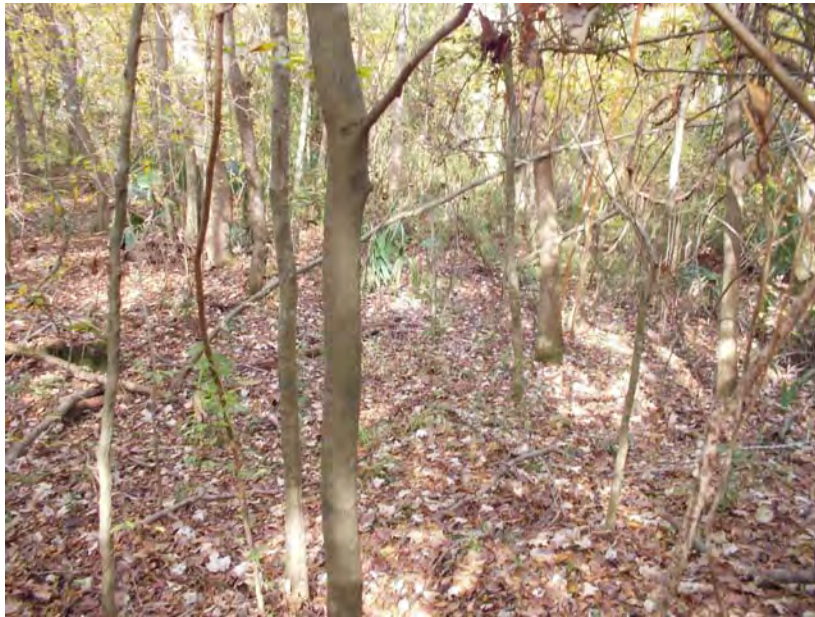
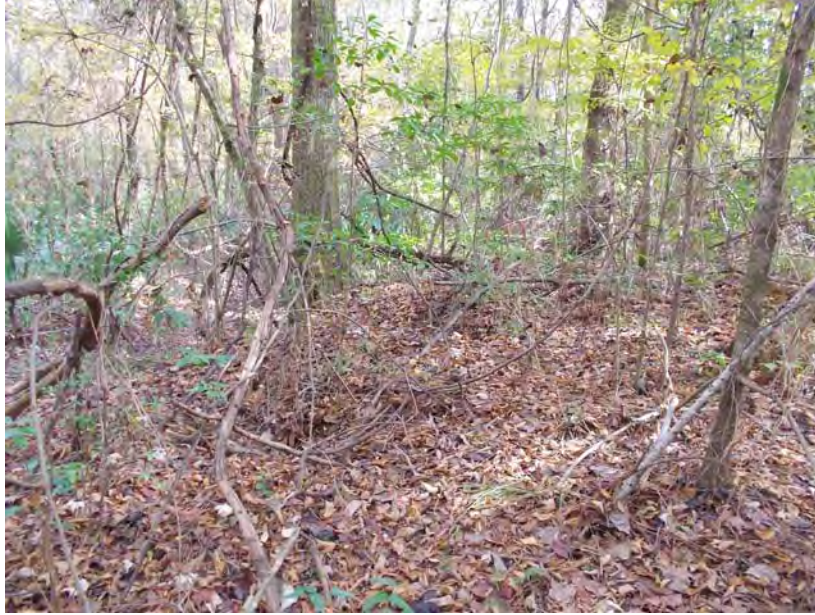
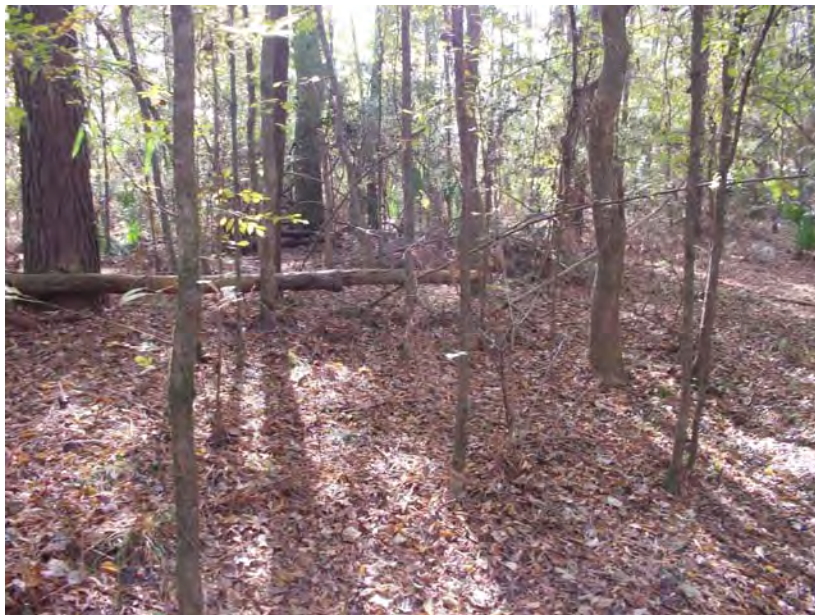
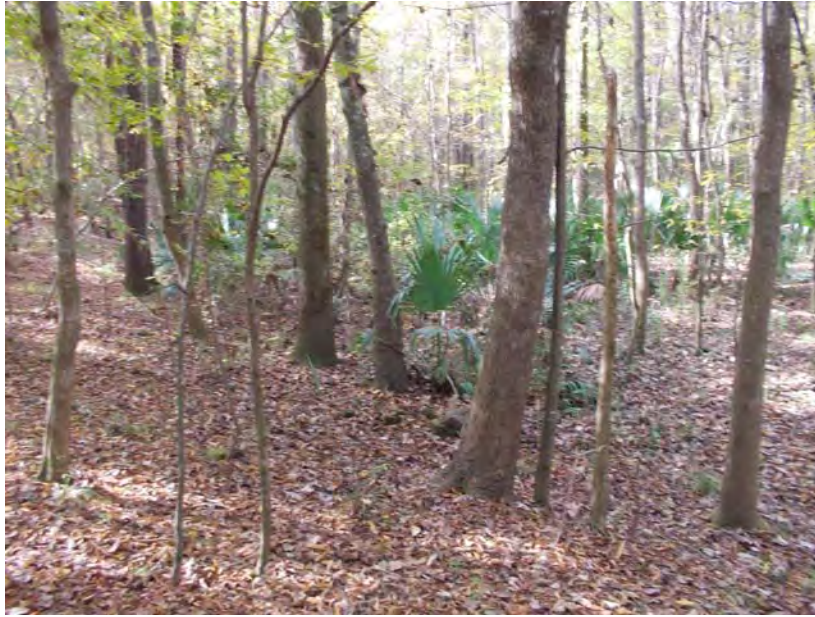
**Photograph 12. Overview of the Habitat Observed at Plot 3,
Facing North**

**Photograph 13. Overview of the Habitat Observed at Plot 3,
Facing East**

**Photograph 14. Overview of the Habitat Observed at Plot 3,
Facing South**

**Photograph 15. Overview of the Habitat Observed at Plot 3,
Facing West**

Sample Plot - 3: Sample Plot 3 is located in a mature pine/hardwood forest next to the wetland in plot 4 (Figure 3). The tree stratum is dominated loblolly pine, and winged elm while the

sapling/shrub stratum is dominated by American hornbeam. The herbaceous stratum is dominated by long-leaf wood oats. The woody vine stratum is dominated by muscadine grape. The hydrophytic vegetation criterion is met within this sample plot.

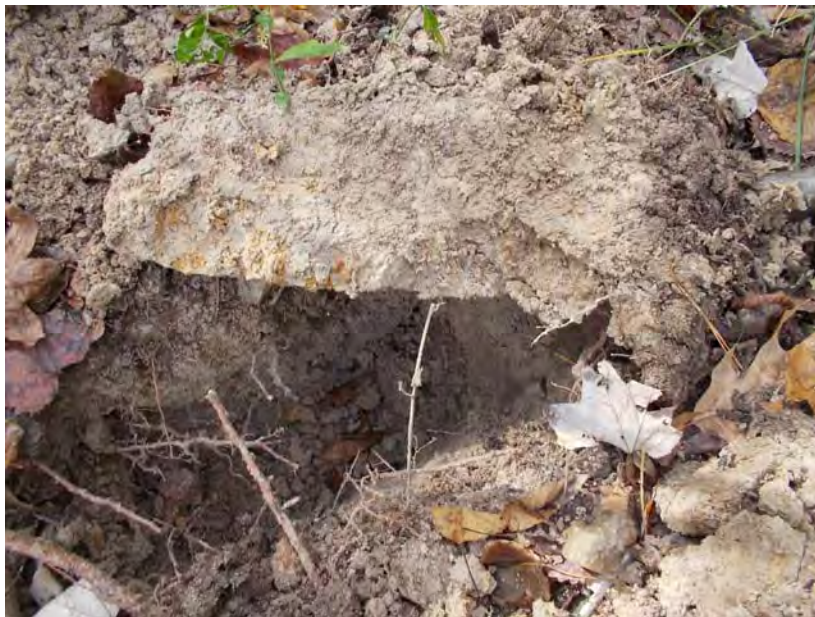
Photograph 16. Soil Profile Observed at Plot 4

The soil series mapped at this plot is the Ouachita, Ochlockonee, Guyton association, described as frequently flooded by the NRCS. Within this association, the Guyton series is listed on the National Hydric Soils list and the Ouachita and Guyton series are listed on the Louisiana Hydric Soils list. The hydric soils criterion is met at this plot due to the presence of a depleted matrix. Primary indicators of hydrology include moss trim lines (B16), crayfish burrows (C8), and a positive FAC-neutral test (D5). It is GEC's opinion that this sample plot is within a wetland, based on the presence of hydric vegetation, hydric soils, and wetland hydrology within the plot (see Data Form Plot - 4).

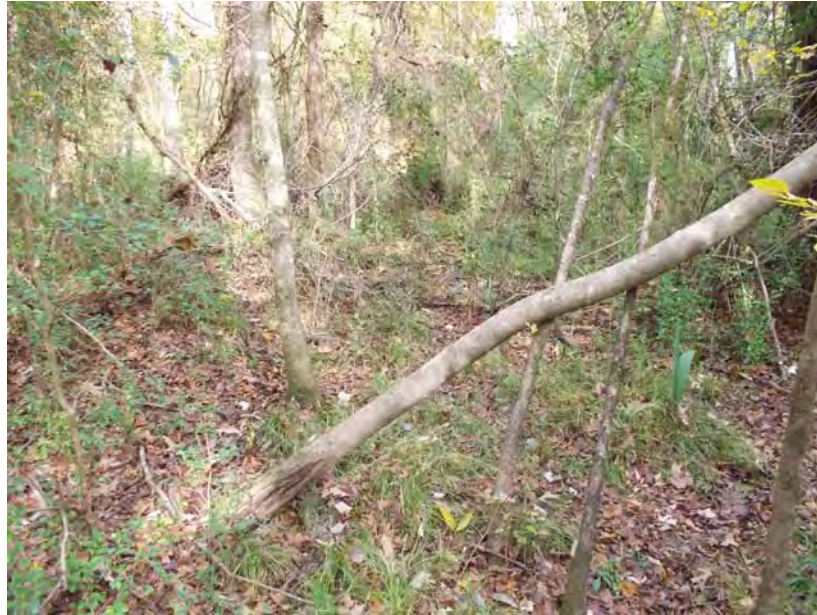
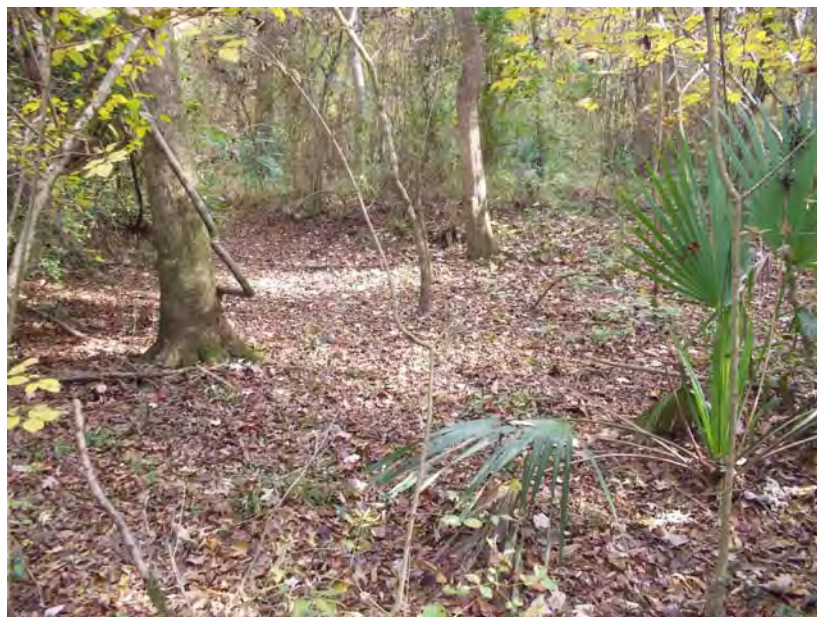
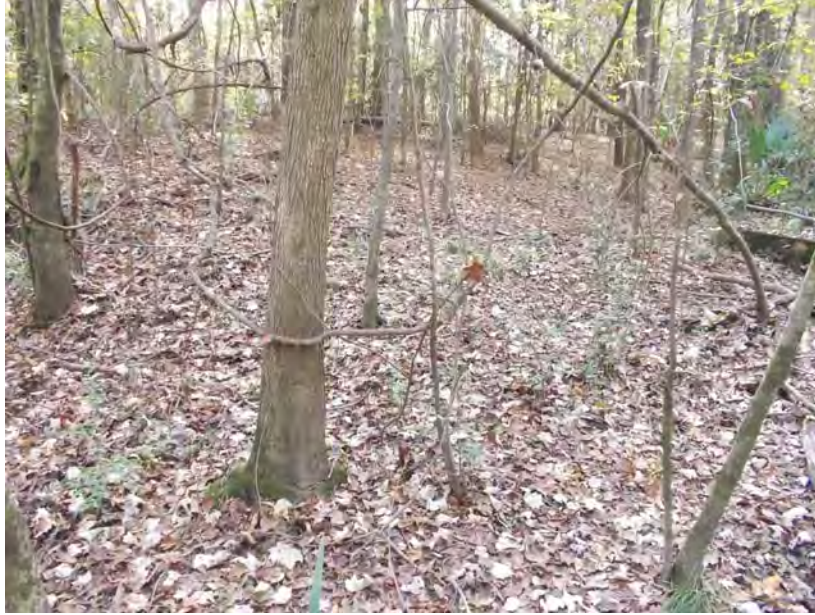
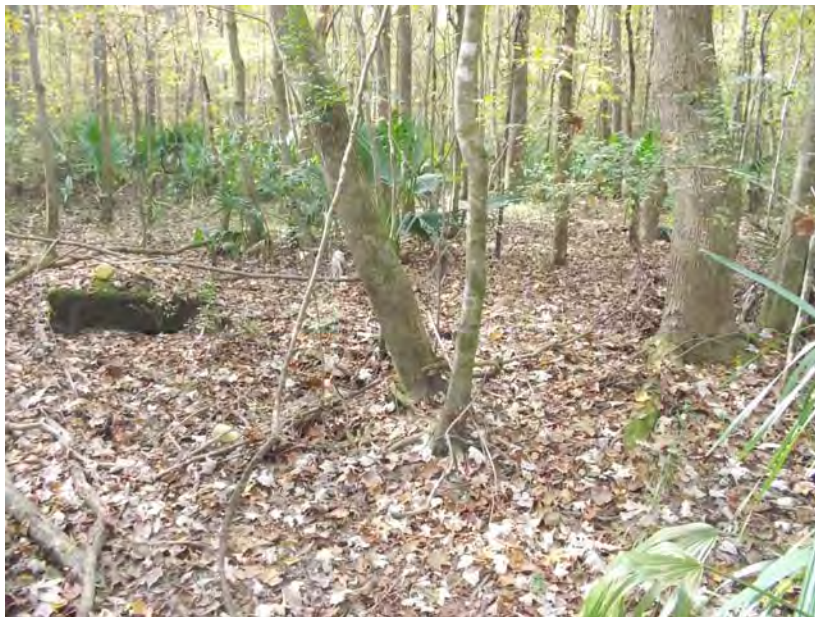
**Photograph 17. Overview of the Habitat Observed at Plot 4,
Facing North**

**Photograph 18. Overview of the Habitat Observed at Plot 4,
Facing East**

**Photograph 19. Overview of the Habitat Observed at Plot 4,
Facing South**

**Photograph 20. Overview of the Habitat Observed at Plot 4,
Facing West**

Sample Plot - 4: Sample Plot 4 is located within a backwater depression (Figure 3). The tree stratum is dominated by Chinese tallow (*Triadica sebifera*), and black tupelo while the sapling/shrub stratum is dominated by red maple, and green ash (*Fraxinus pensylvanica*). The herbaceous stratum is dominated by dwarf palmetto, and thicket sedge (*Carex abscondita*). The woody vine stratum is dominated by muscadine grape. The hydrophytic vegetation criterion is met within this sample plot.

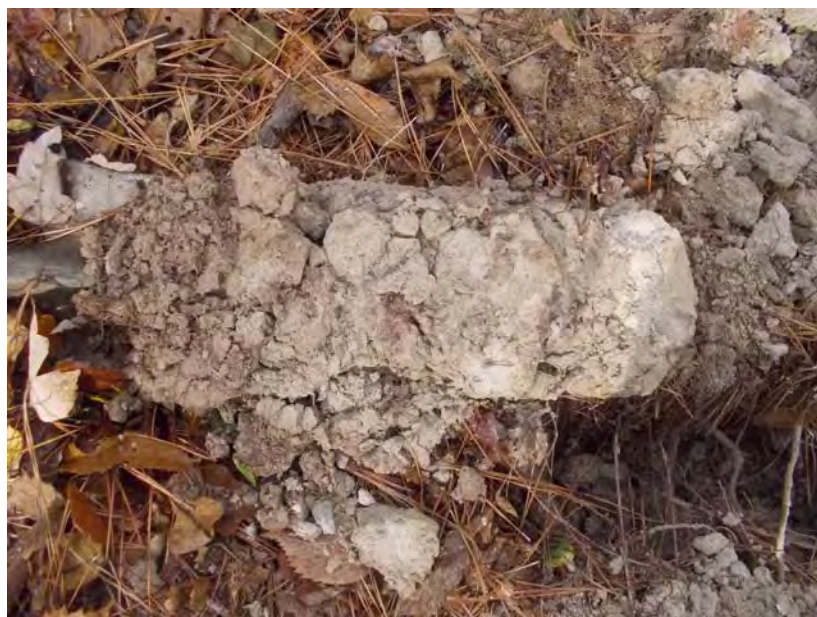
Photograph 21. Soil Profile Observed at Plot 5

The soil series mapped at this plot is the Ouachita, Ochlockonee, Guyton association, described as frequently flooded by the NRCS. Within this association, the Guyton series is listed on the National Hydric Soils list and the Ouachita and Guyton series are listed on the Louisiana Hydric Soils list. The hydric soils criterion is met at this plot due to the presence of a depleted matrix. Primary indicators of wetland hydrology are lacking at this plot while secondary indicators of hydrology include sparsely vegetated concave surface (B8), and crayfish burrows (C8). It is GEC's opinion that this sample plot is within a wetland, based on the presence of wetland hydrology, hydrophytic vegetation and hydric soils within the plot (see Data Form Plot - 5).

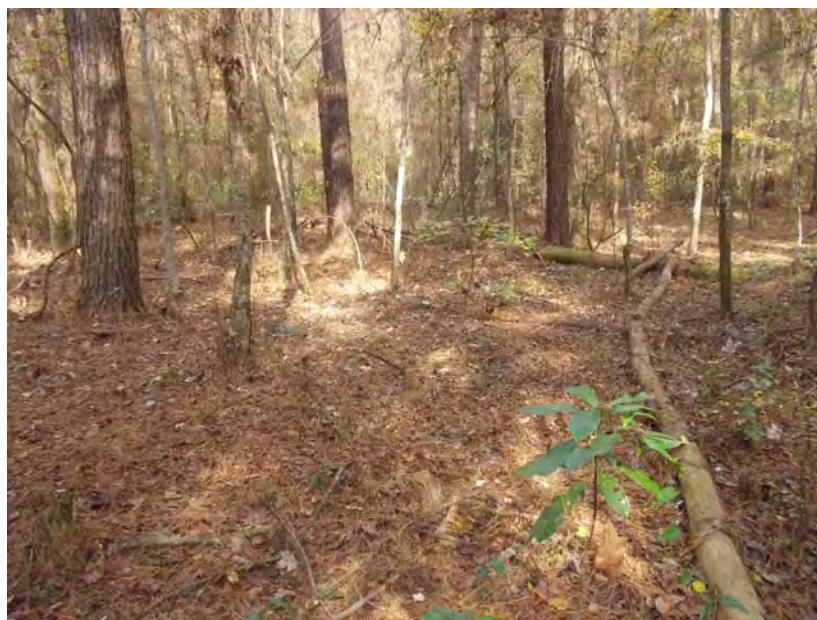
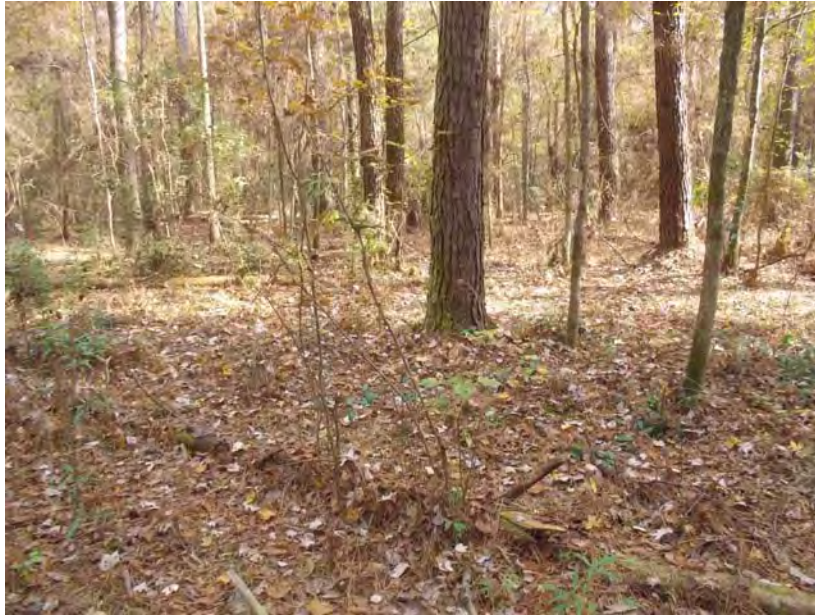
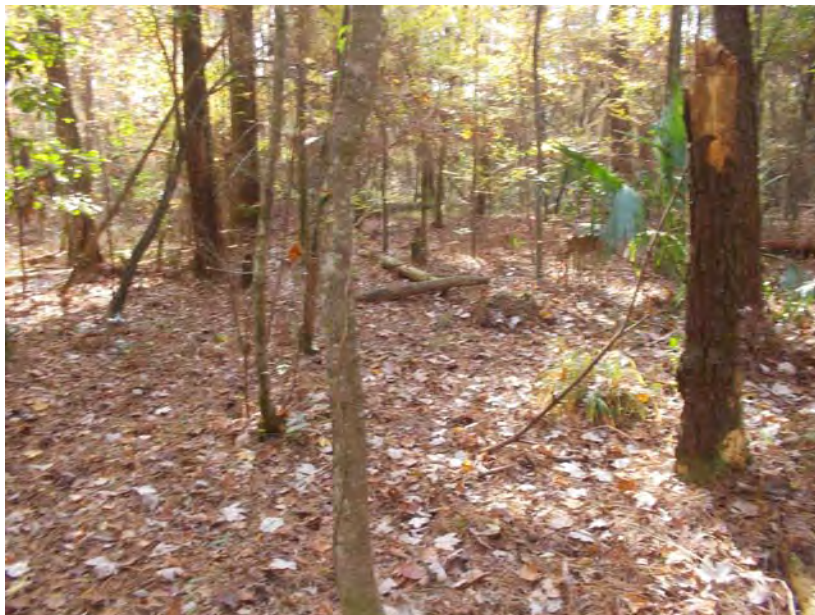
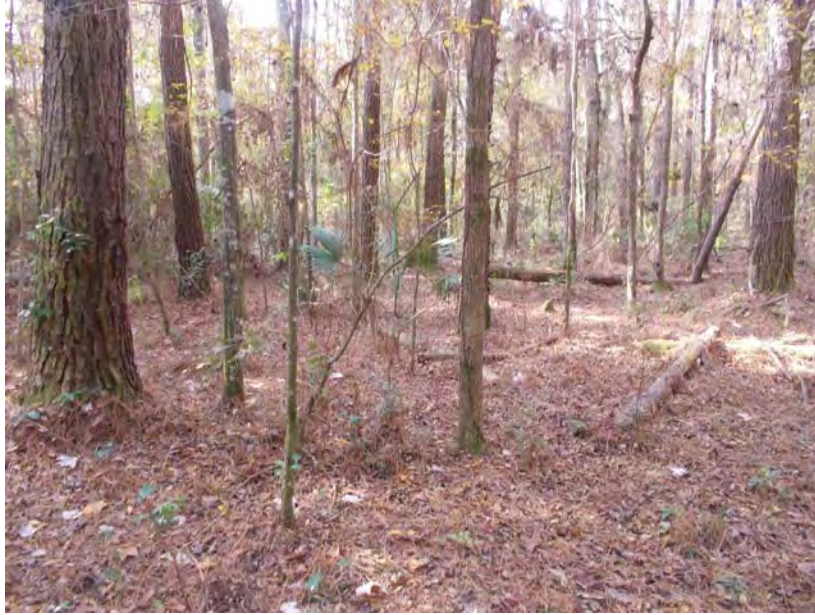
**Photograph 22. Overview of the Habitat Observed at Plot 5,
Facing North**

**Photograph 23. Overview of the Habitat Observed at Plot 5,
Facing East**

**Photograph 24. Overview of the Habitat Observed at Plot 5,
Facing South**

**Photograph 25. Overview of the Habitat Observed at Plot 5,
Facing West**

Sample Plot - 5: Sample Plot 5 is located in a mature pine/hardwood forest within a wet/nonwet mosaic area. This area looks to have been impacted by past silver culture activities leaving the ground topography uneven with many areas where wetland hydrology is either present or lacking (Figure 3). The tree stratum is dominated loblolly pine, while the sapling/shrub stratum is dominated by American hornbeam, and sweetgum (*Liquidambar styraciflua*). The herbaceous stratum is dominated by water oak (*Quercus nigra*), and long-leaf basket grass (*Oplismenus hirtellus*). The woody vine stratum is dominated by cat greenbrier (*Smilax hispida*). The hydrophytic vegetation criterion is met within this sample plot.

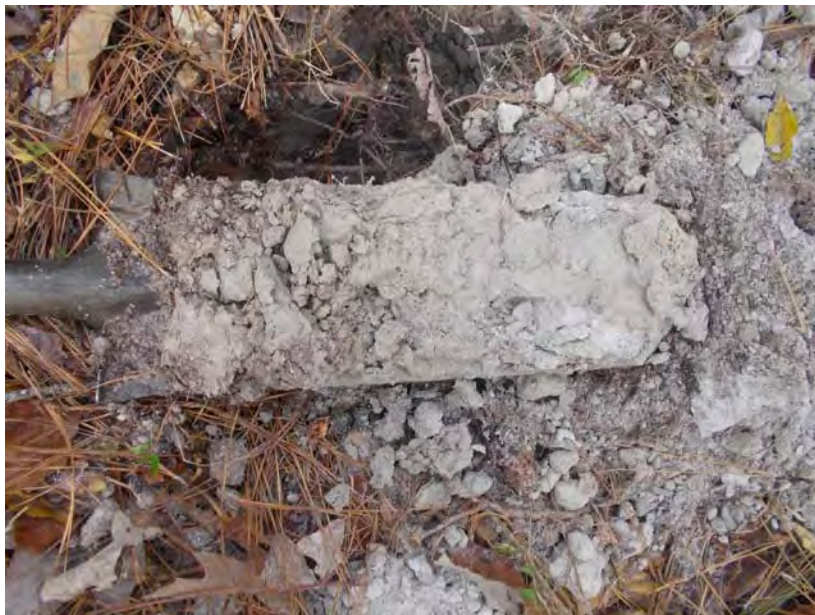
Photograph 26. Soil Profile Observed at Plot 6

The soil series mapped at this plot is the Ouachita, Ochlockonee, Guyton association, described as frequently flooded by the NRCS. Within this association, the Guyton series is listed on the National Hydric Soils list and the Ouachita and Guyton series are listed on the Louisiana Hydric Soils list. The hydric soils criterion is met at this plot due to the presence of a depleted matrix. Primary indicators of wetland hydrology are lacking at this plot while the only secondary indicator of hydrology observed is a positive FAC-neutral test (D5). It is GEC's opinion that this sample plot is not within a wetland, based on the lack of wetland hydrology within the plot (see Data Form Plot - 5).

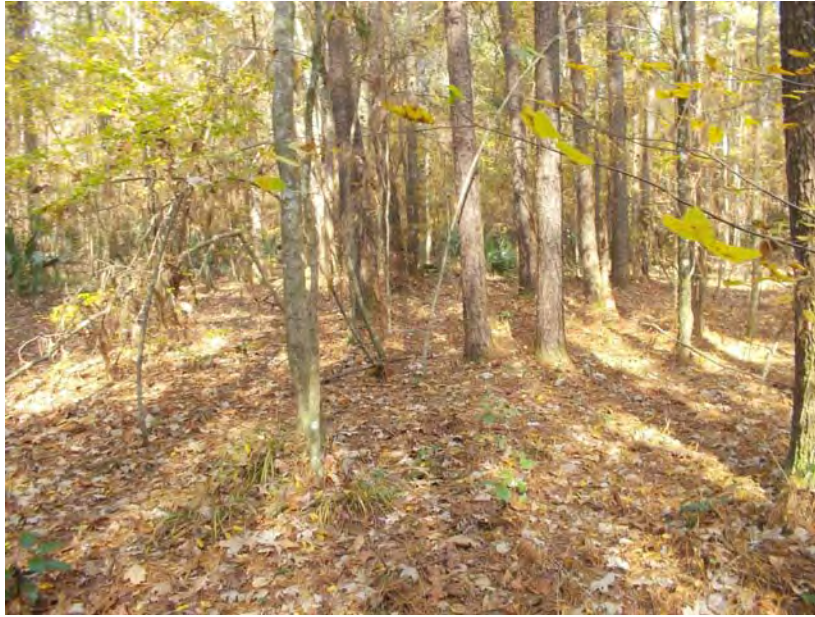
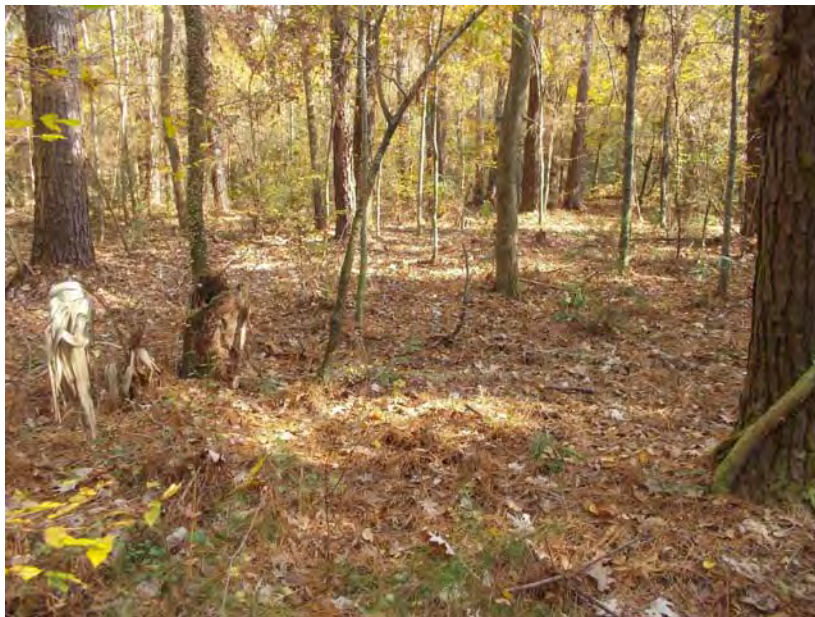
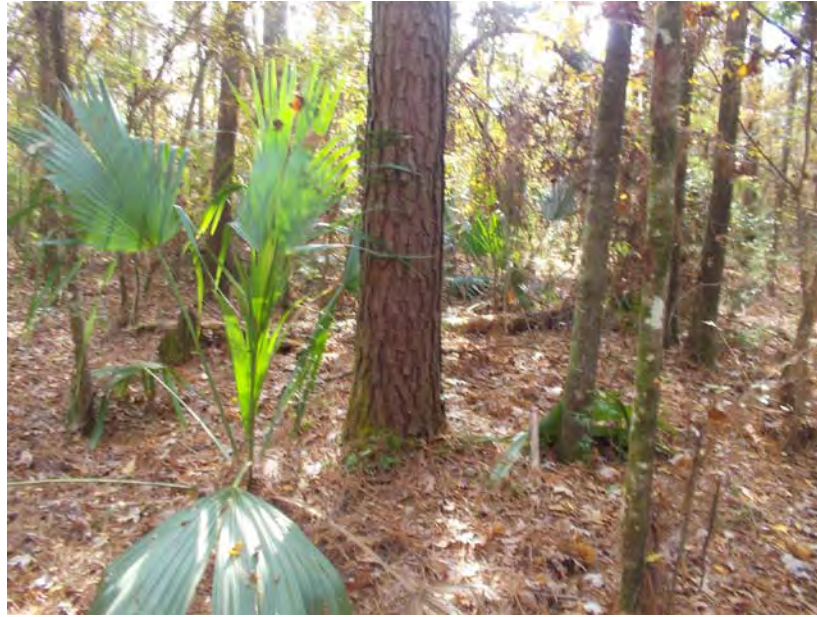
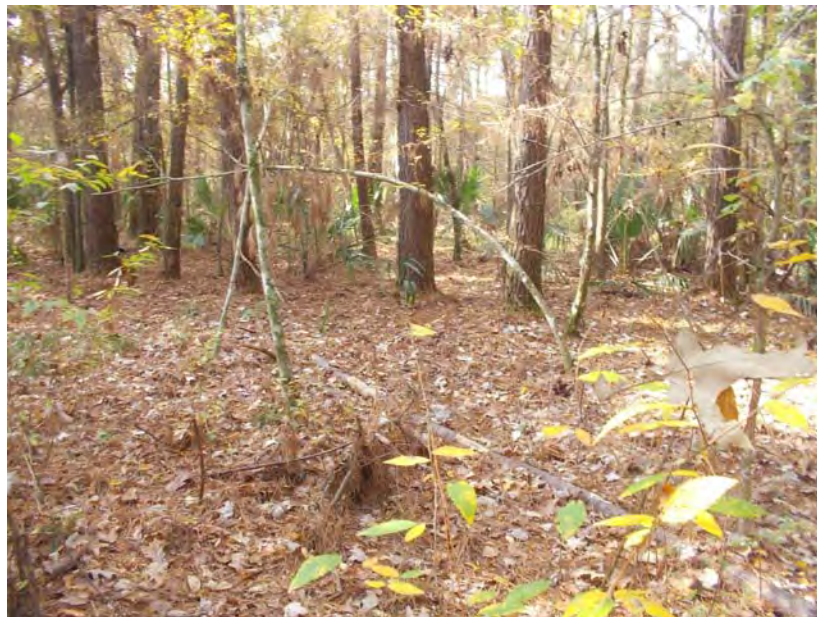
**Photograph 27. Overview of the Habitat Observed at Plot 6,
Facing North**

**Photograph 28. Overview of the Habitat Observed at Plot 6,
Facing East**

**Photograph 29 Overview of the Habitat Observed at Plot 6,
Facing South**

**Photograph 30. Overview of the Habitat Observed at Plot 6,
Facing West**

Sample Plot - 6: Sample Plot 6 is located in a mature pine/hardwood forest within a wet/nonwet mosaic area. This area looks to have been impacted by past logging activities leaving the ground topography uneven with many areas where wetland hydrology is either present or lacking

(Figure 3). The tree stratum is dominated loblolly pine, while the sapling/shrub stratum is dominated by red maple, and winged elm. The herbaceous stratum is dominated by spruce pine (*Pinus glabra*), and dwarf palmetto. The woody vine stratum is dominated by trumpet vine (*Campsis radicans*). The hydrophytic vegetation criterion is met within this sample plot.

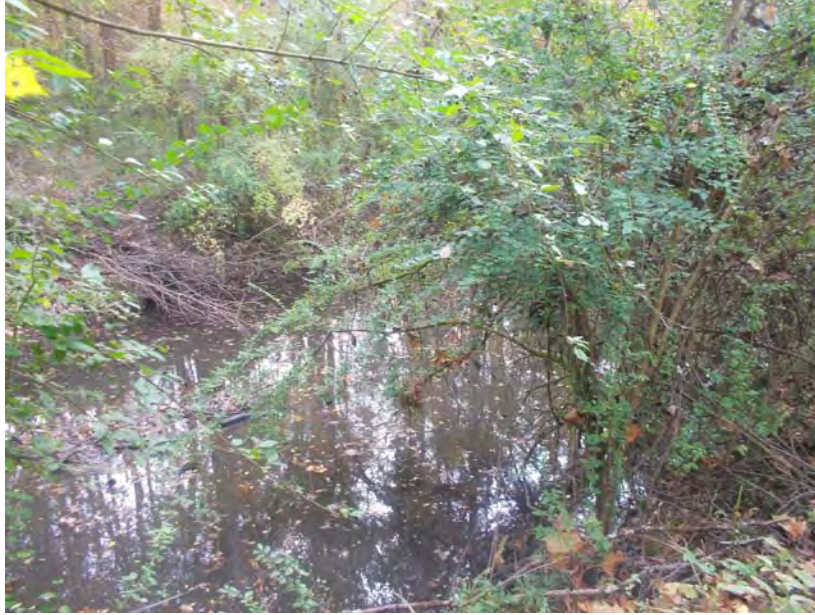
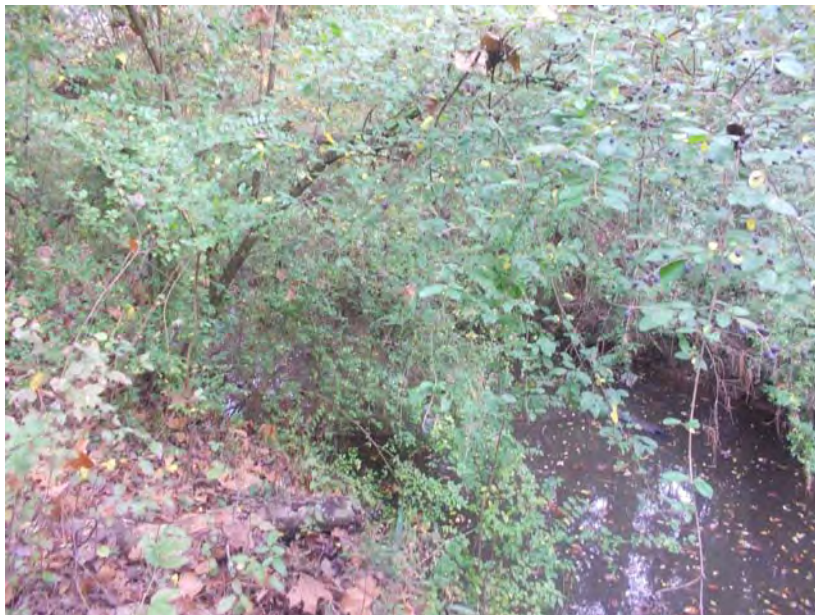
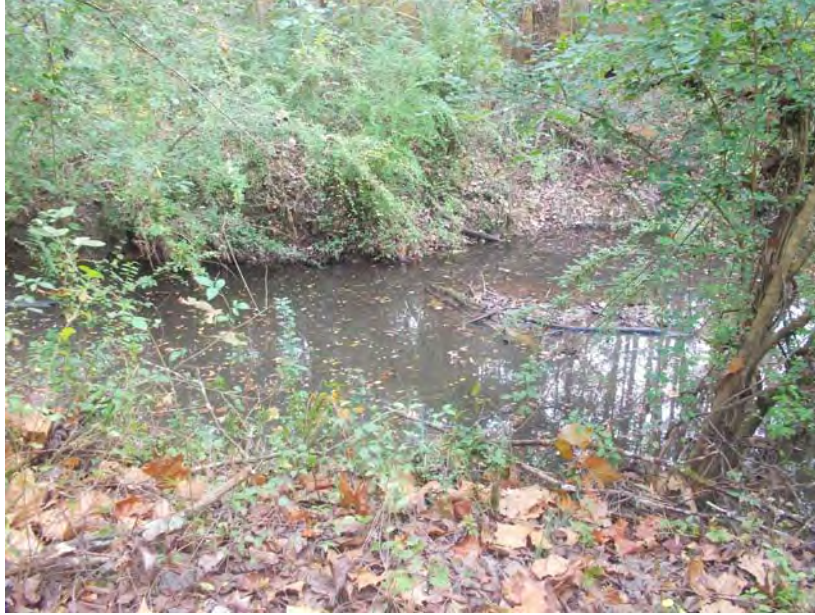
**Photograph 31. Overview of the Habitat Observed Around Bayou,
Facing Across**

**Photograph 32. Overview of the Habitat Observed Around Bayou,
Facing Up Stream**

Photograph 33. Overview of the Habitat Observed Around Bayou, Facing Down Stream
