# Exhibit BB: Red River Parish Port Site Preliminary Geotechnical Engineering Report

Preliminary Geotechnical Site Characterization Report

Red River Parish Port Site

ECS Project Number 65-1510

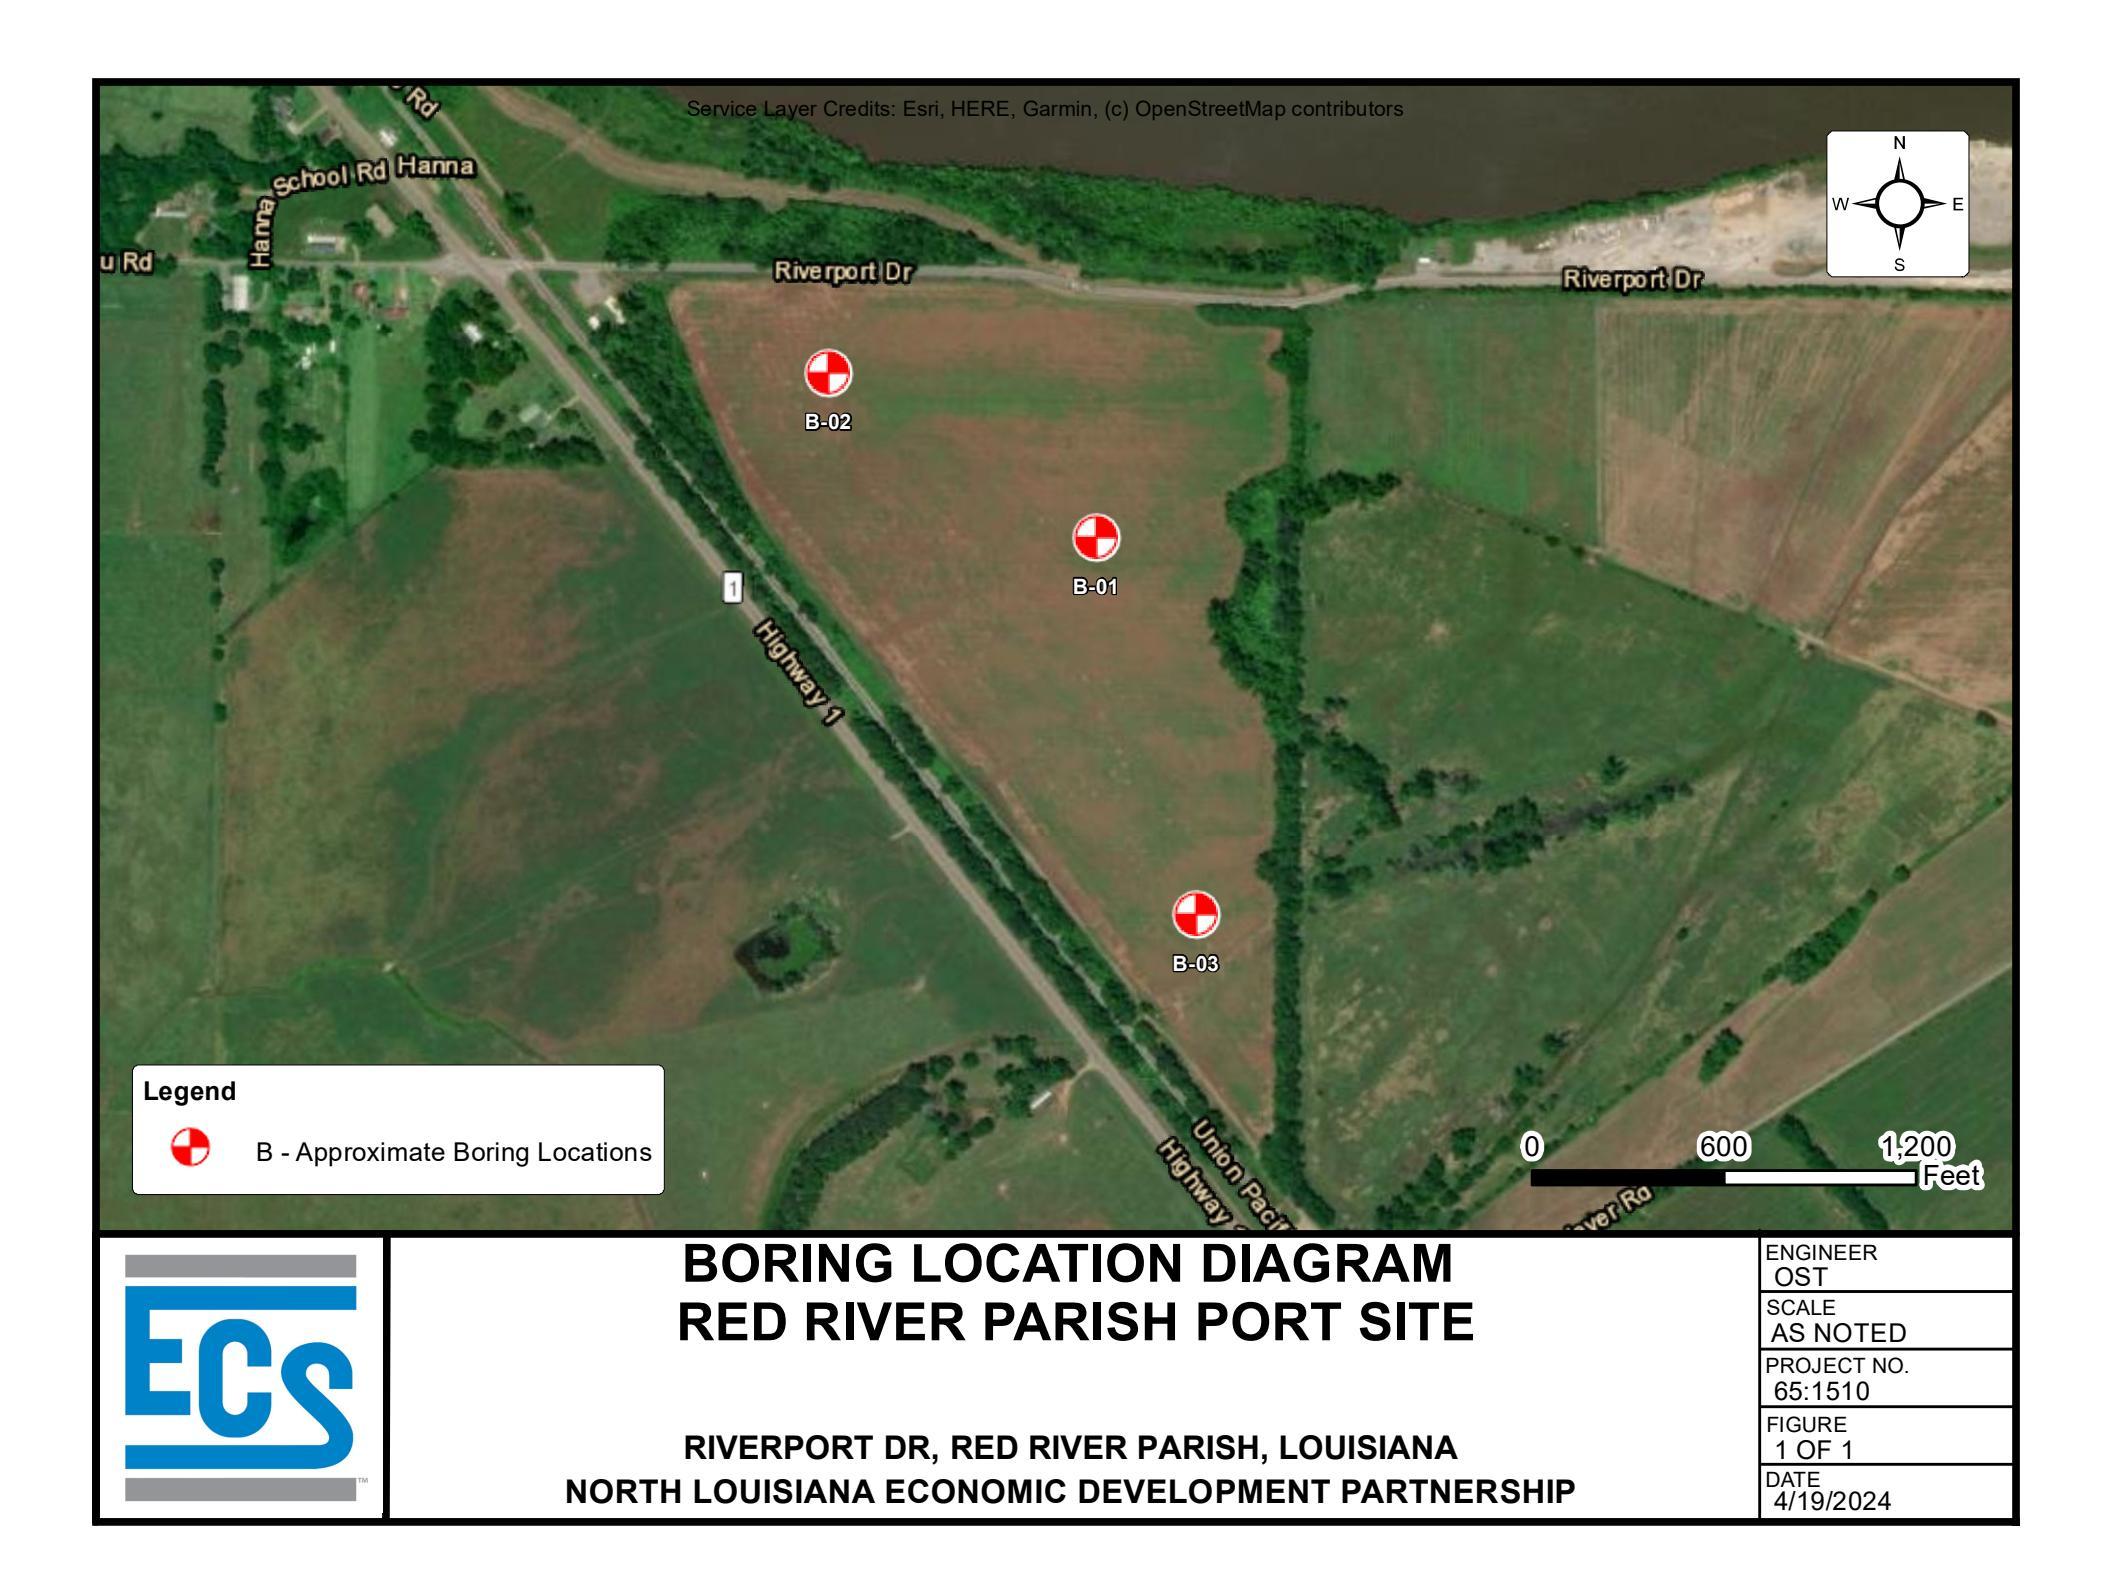
Site Location Diagram Boring Location Diagram(s)

The boring locations were selected by ECS based on the site plan provided by the client and identified in the field by ECS personnel using the supplied diagram and handheld GPS unit. The approximate as-drilled boring locations are shown on the Boring Location Diagram in Appendix A. The approximate ground surface elevations noted in this report were obtained from Google Earth©.

To obtain the necessary geotechnical information required for preliminary evaluation of subsurface soil conditions, three (3) soil test borings were drilled in total, with one boring located in the center of the site, one boring located in the northeast corner of the site, and one boring located in the southwest corner of the site. One (1) test boring was proposed to extend to a depth of 100 feet, but auger refusal was encountered at a depth of 45 feet below existing grades due to a suspected dense flowable sand layer. One (1) test boring extended to a depth of 50 feet, and one (1) test boring site grades. A laboratory-testing program was also implemented to characterize the physical and geotechnical engineering properties of the subsurface soils.
